RE: Ellie Schiller Homosassa Springs Wildlife State Park – Lease No. 3786

**Ellie Schiller Homosassa
Springs Wildlife State Park
Approved Unit Management
Plan**

**ELLIE SCHILLER HOMOSASSA
SPRINGS WILDLIFE STATE PARK**

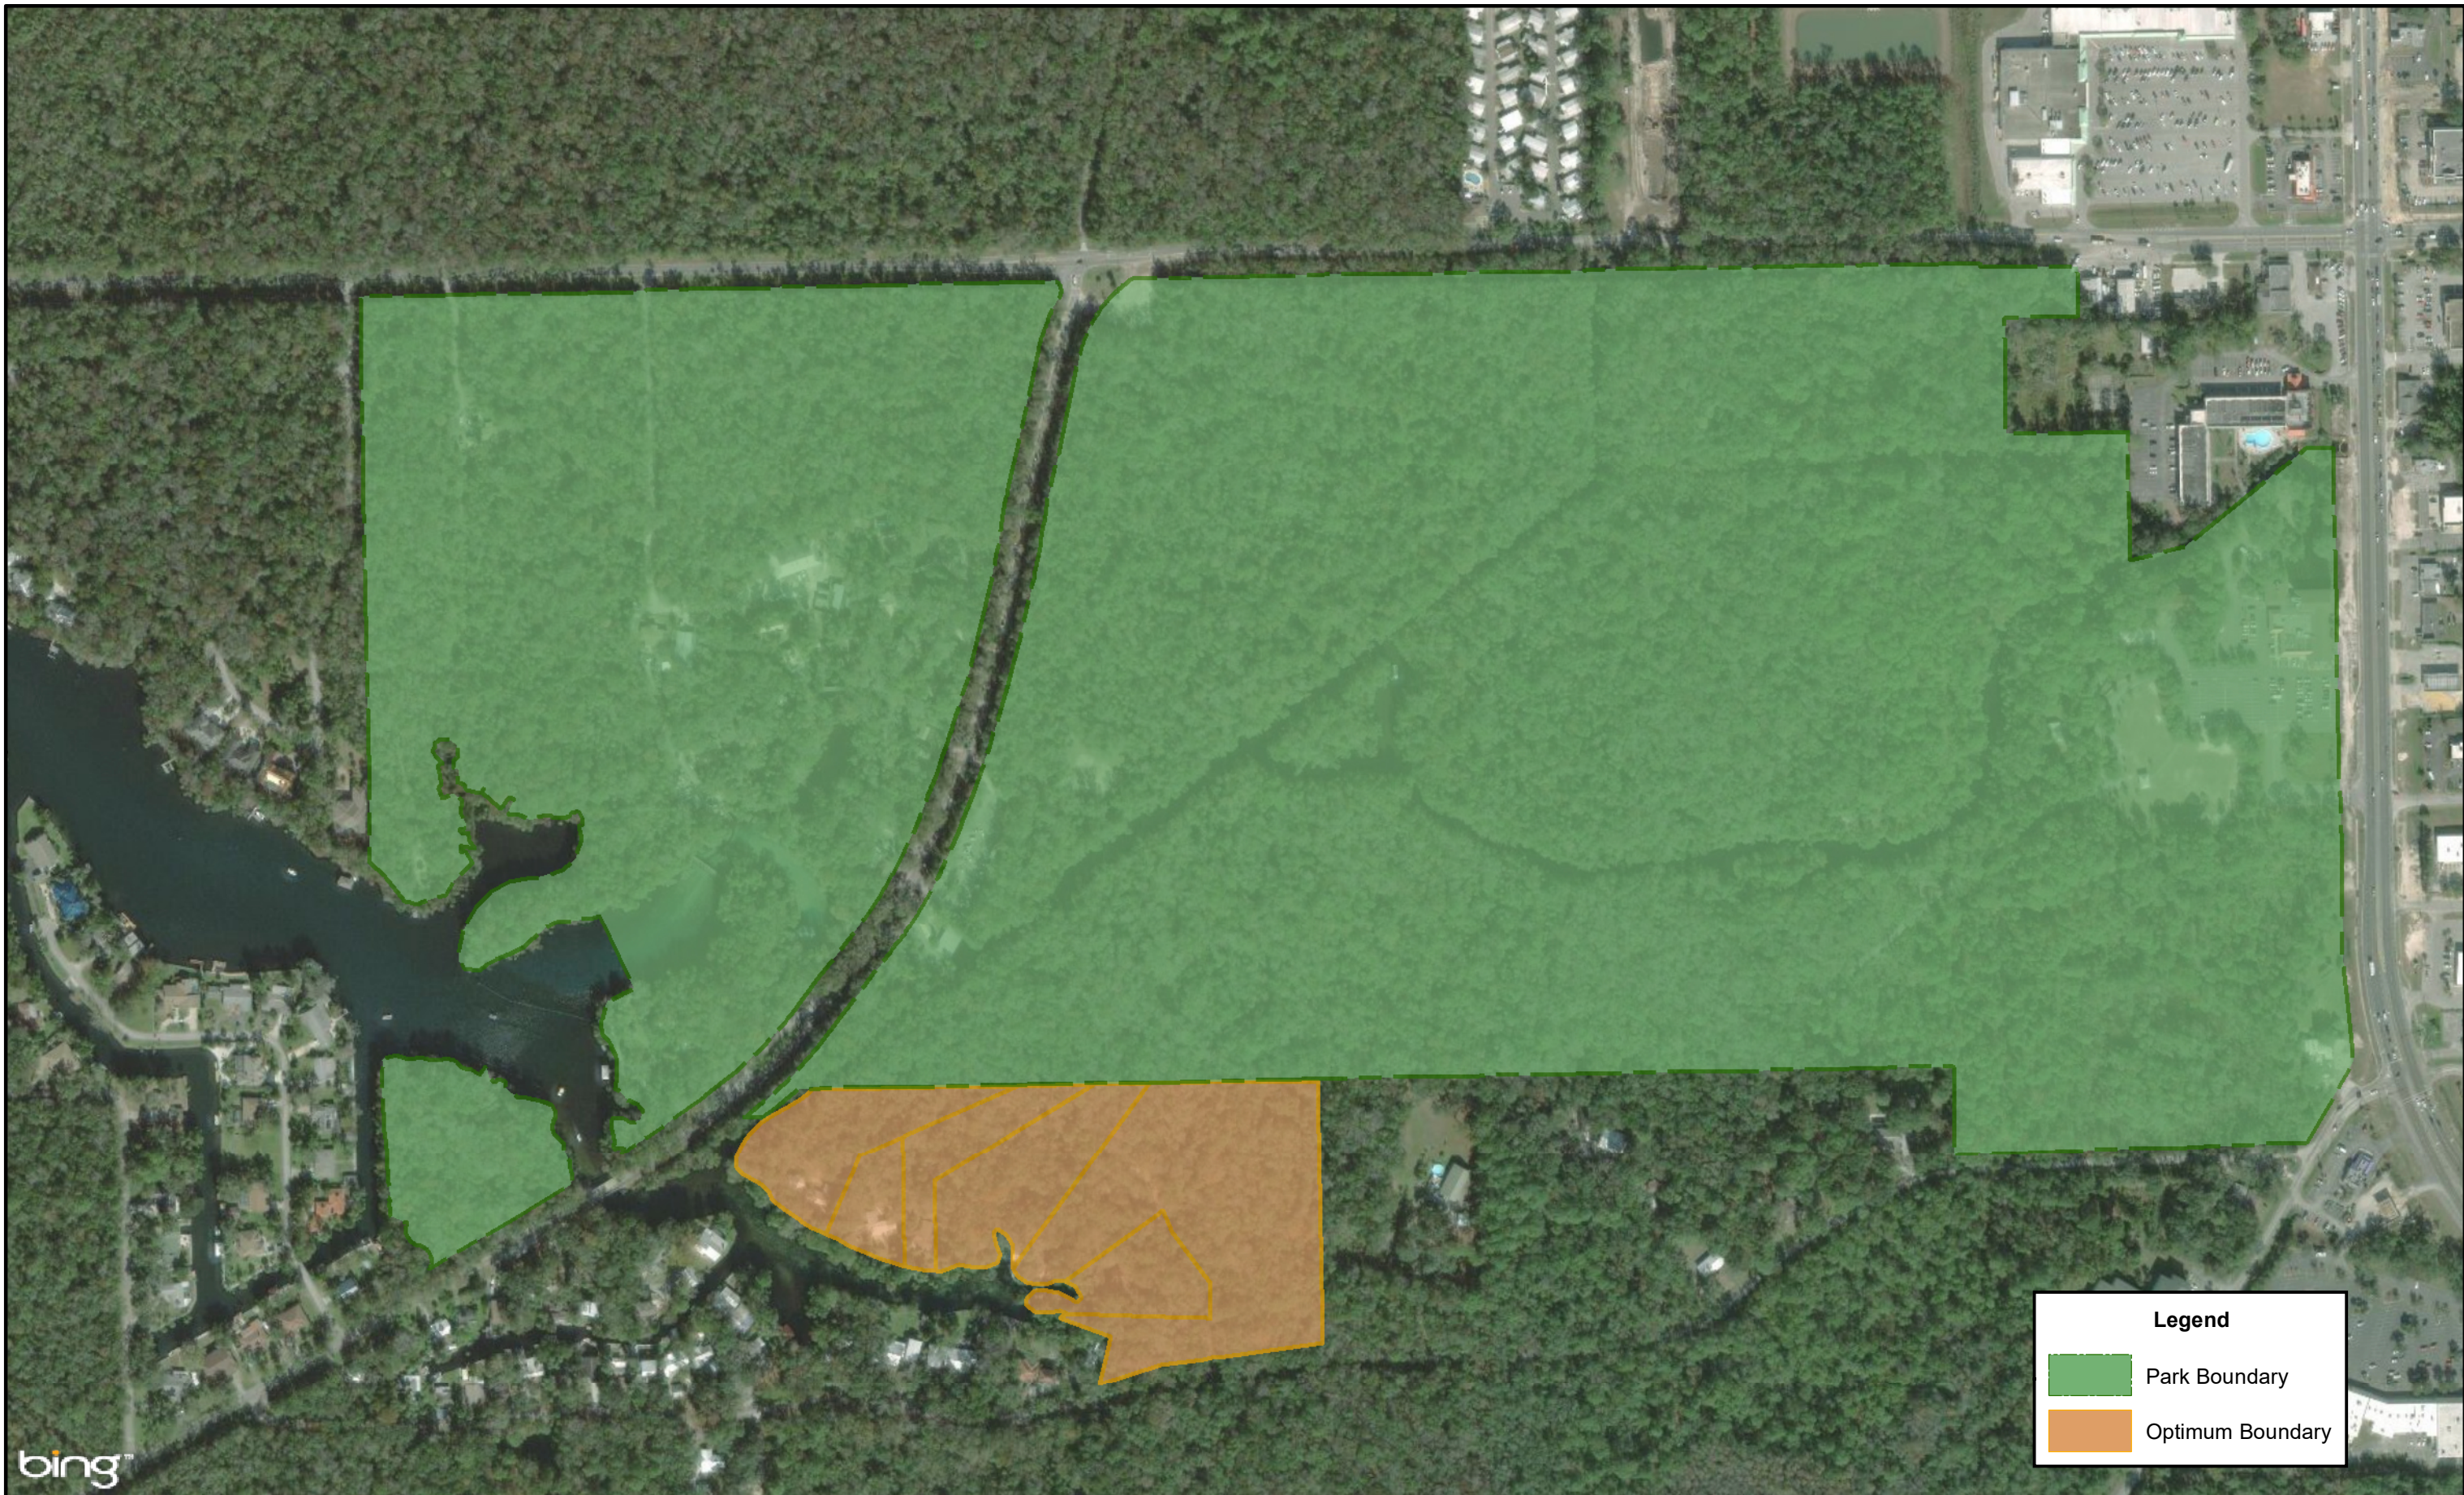
OPTIMUM BOUNDARY MAP

Various properties adjacent to the southern portion of the park on the east side of Fishbowl Drive were highlighted due to the significance of protecting the various springs, protecting manatees, protecting the security of the park, and possible willing sellers.
