Critically Eroded Beaches in Florida

**Office of Resilience and Coastal Protection
Florida Department of Environmental Protection
June 2026**

June 2026

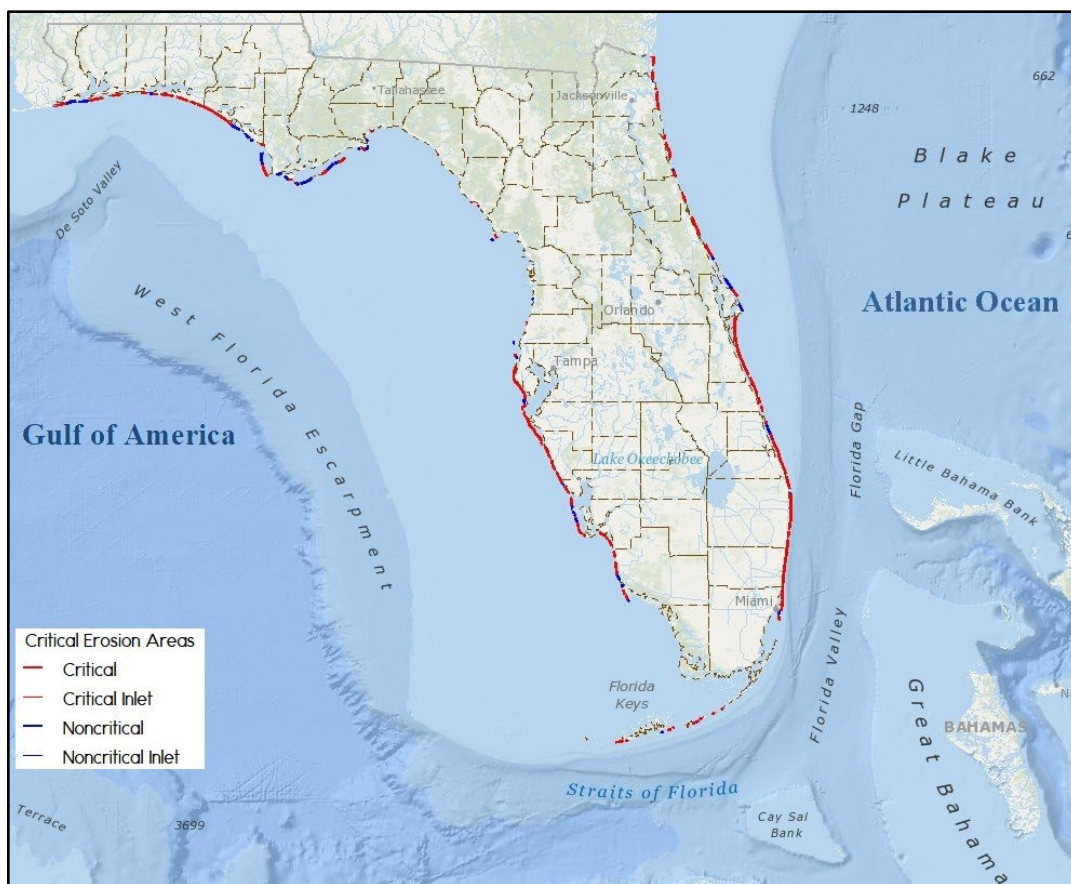
The 2026 report list includes 457.8 miles of critically eroded beach, 9.1 miles of critically eroded inlet shoreline, 88.9 miles of non-critically eroded beach and 3.2 miles of non-critically eroded inlet shoreline statewide, as shown in Figure 1.

Figure 1. Statewide areas of critically and non-critically eroded shoreline [Graphic from [ROSSI](#) database]. View an [interactive map](#) with aerial imagery showing R monuments and the critical erosion areas.

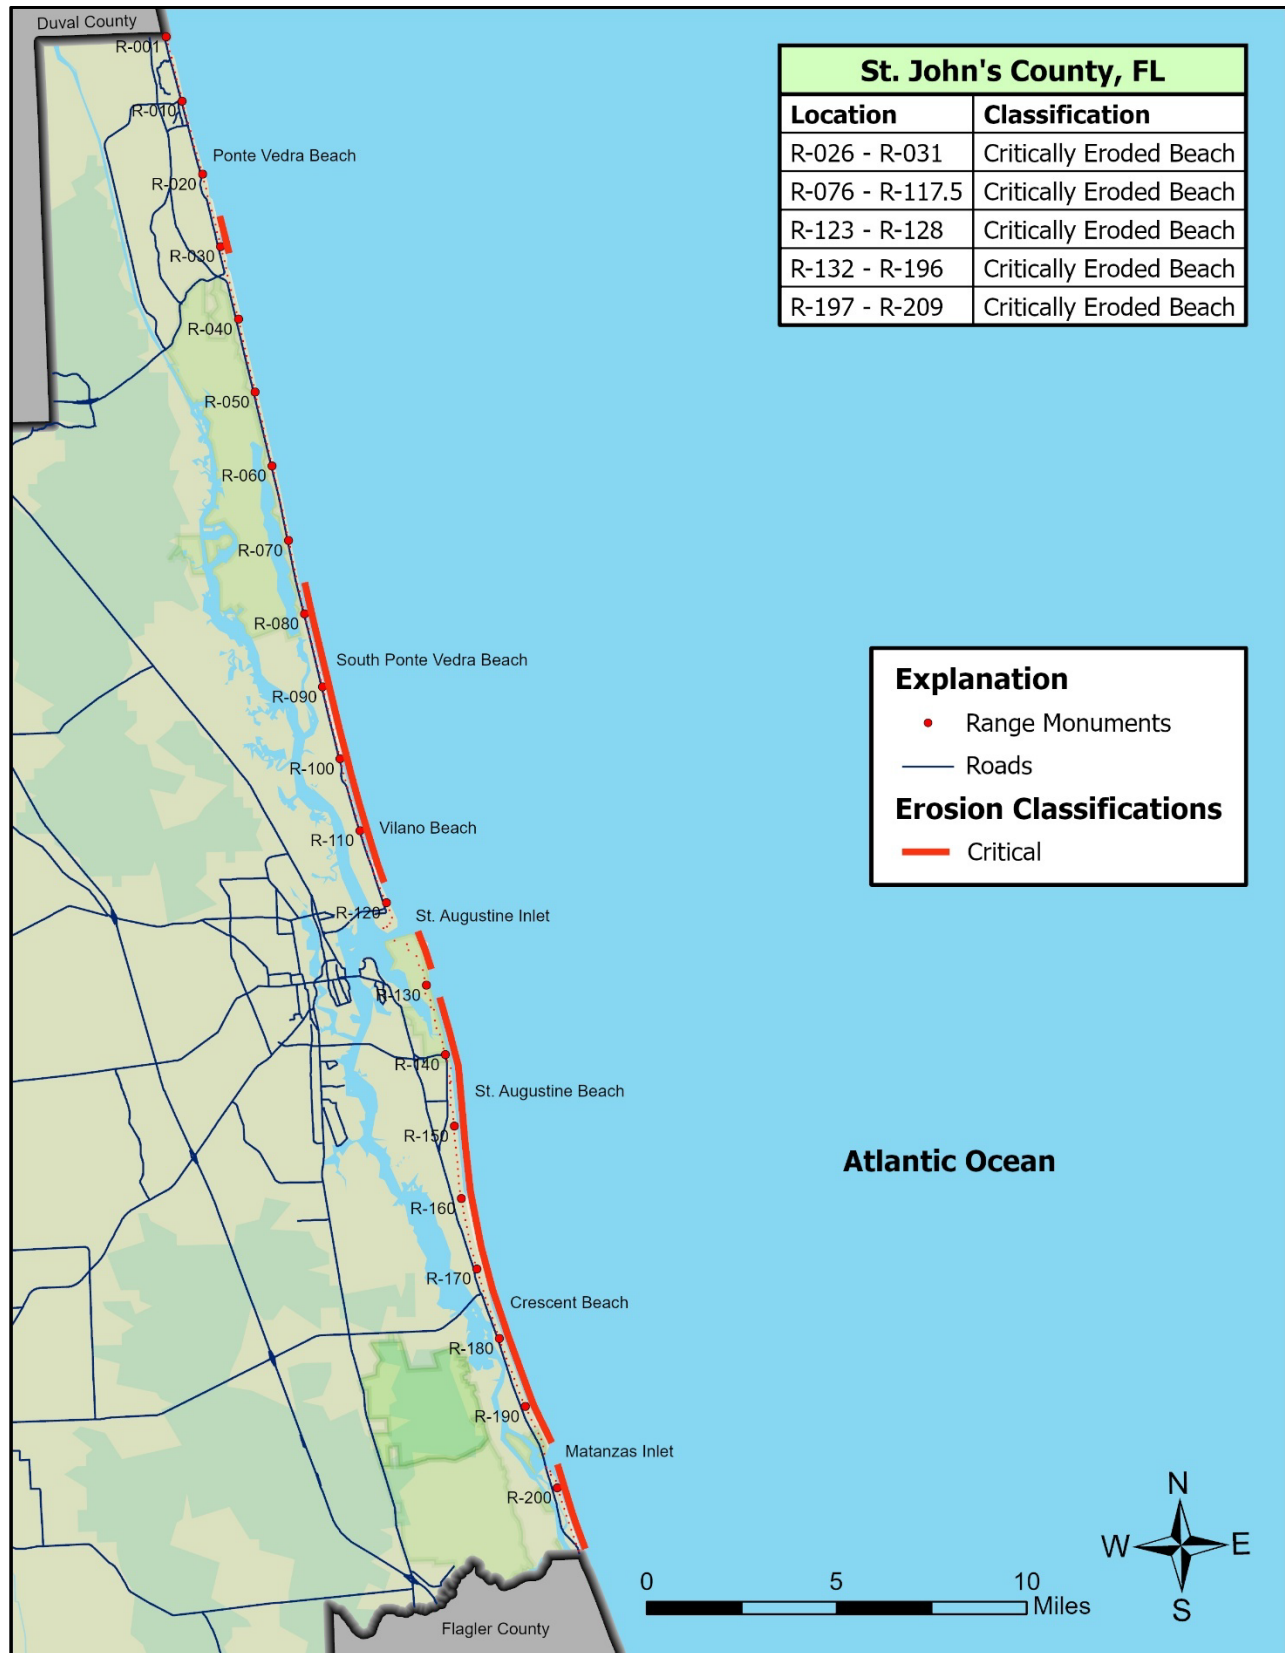
The southern 2.5 miles of St. Johns County beaches (R197 – R209/county line) located between Matanzas Inlet and the Flagler County line, are also critically eroded. The northern portion threatens State Road A1A and private development. Although the State Road A1A roadbed has been abandoned along the southern portion, wildlife habitat within the Matanzas River lagoon remains threatened. This area has been nourished from Atlantic Intracoastal Waterway dredge disposal and the river restoration at Summer Haven.

Figure 4. Critically eroded shoreline within St. Johns County.

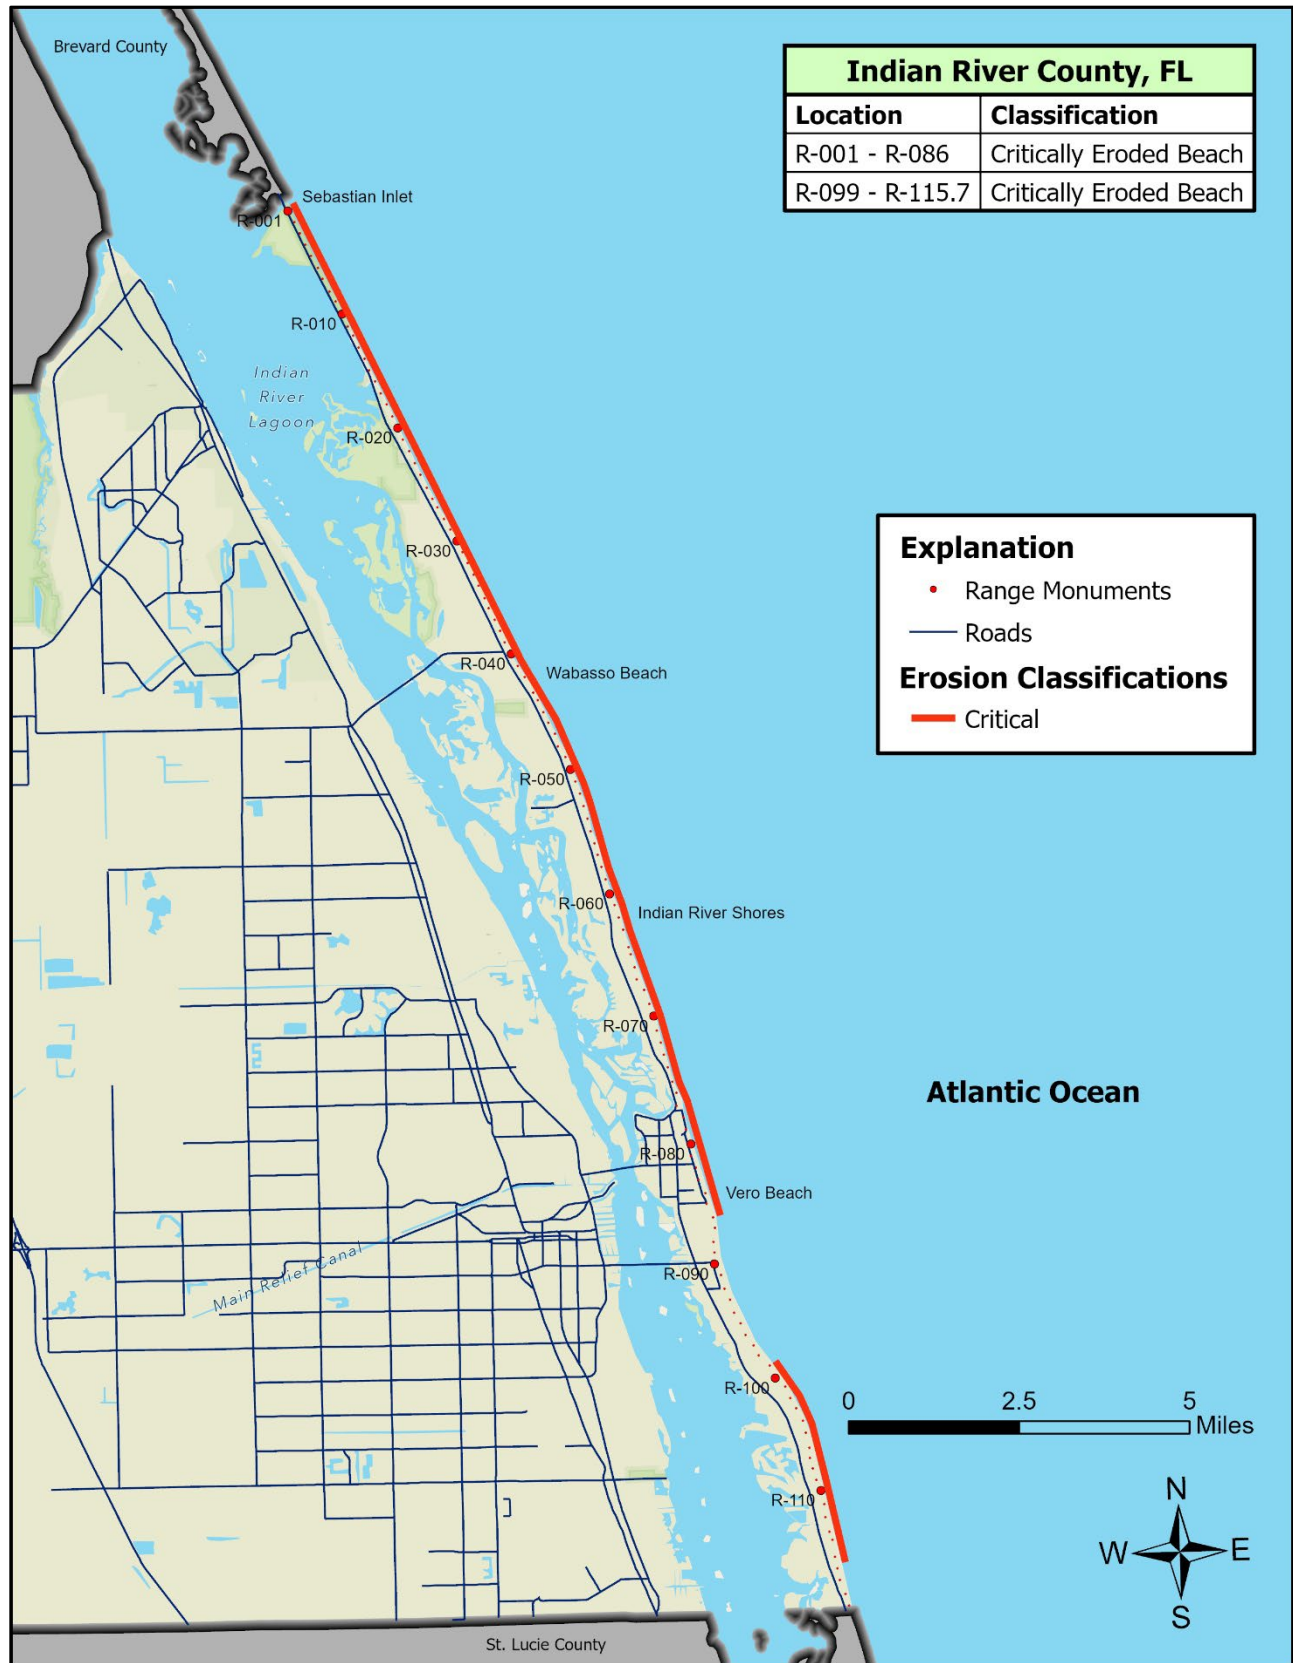
In southern Indian River County, a 3.1-mile segment in Sector 7 and Sector 8 (R99 – R115.7) is critically eroded, threatening development interests. A beach and dune restoration project have been constructed along portions of this segment due to storm erosion.

Figure 8. Critically eroded shoreline within Indian River County.

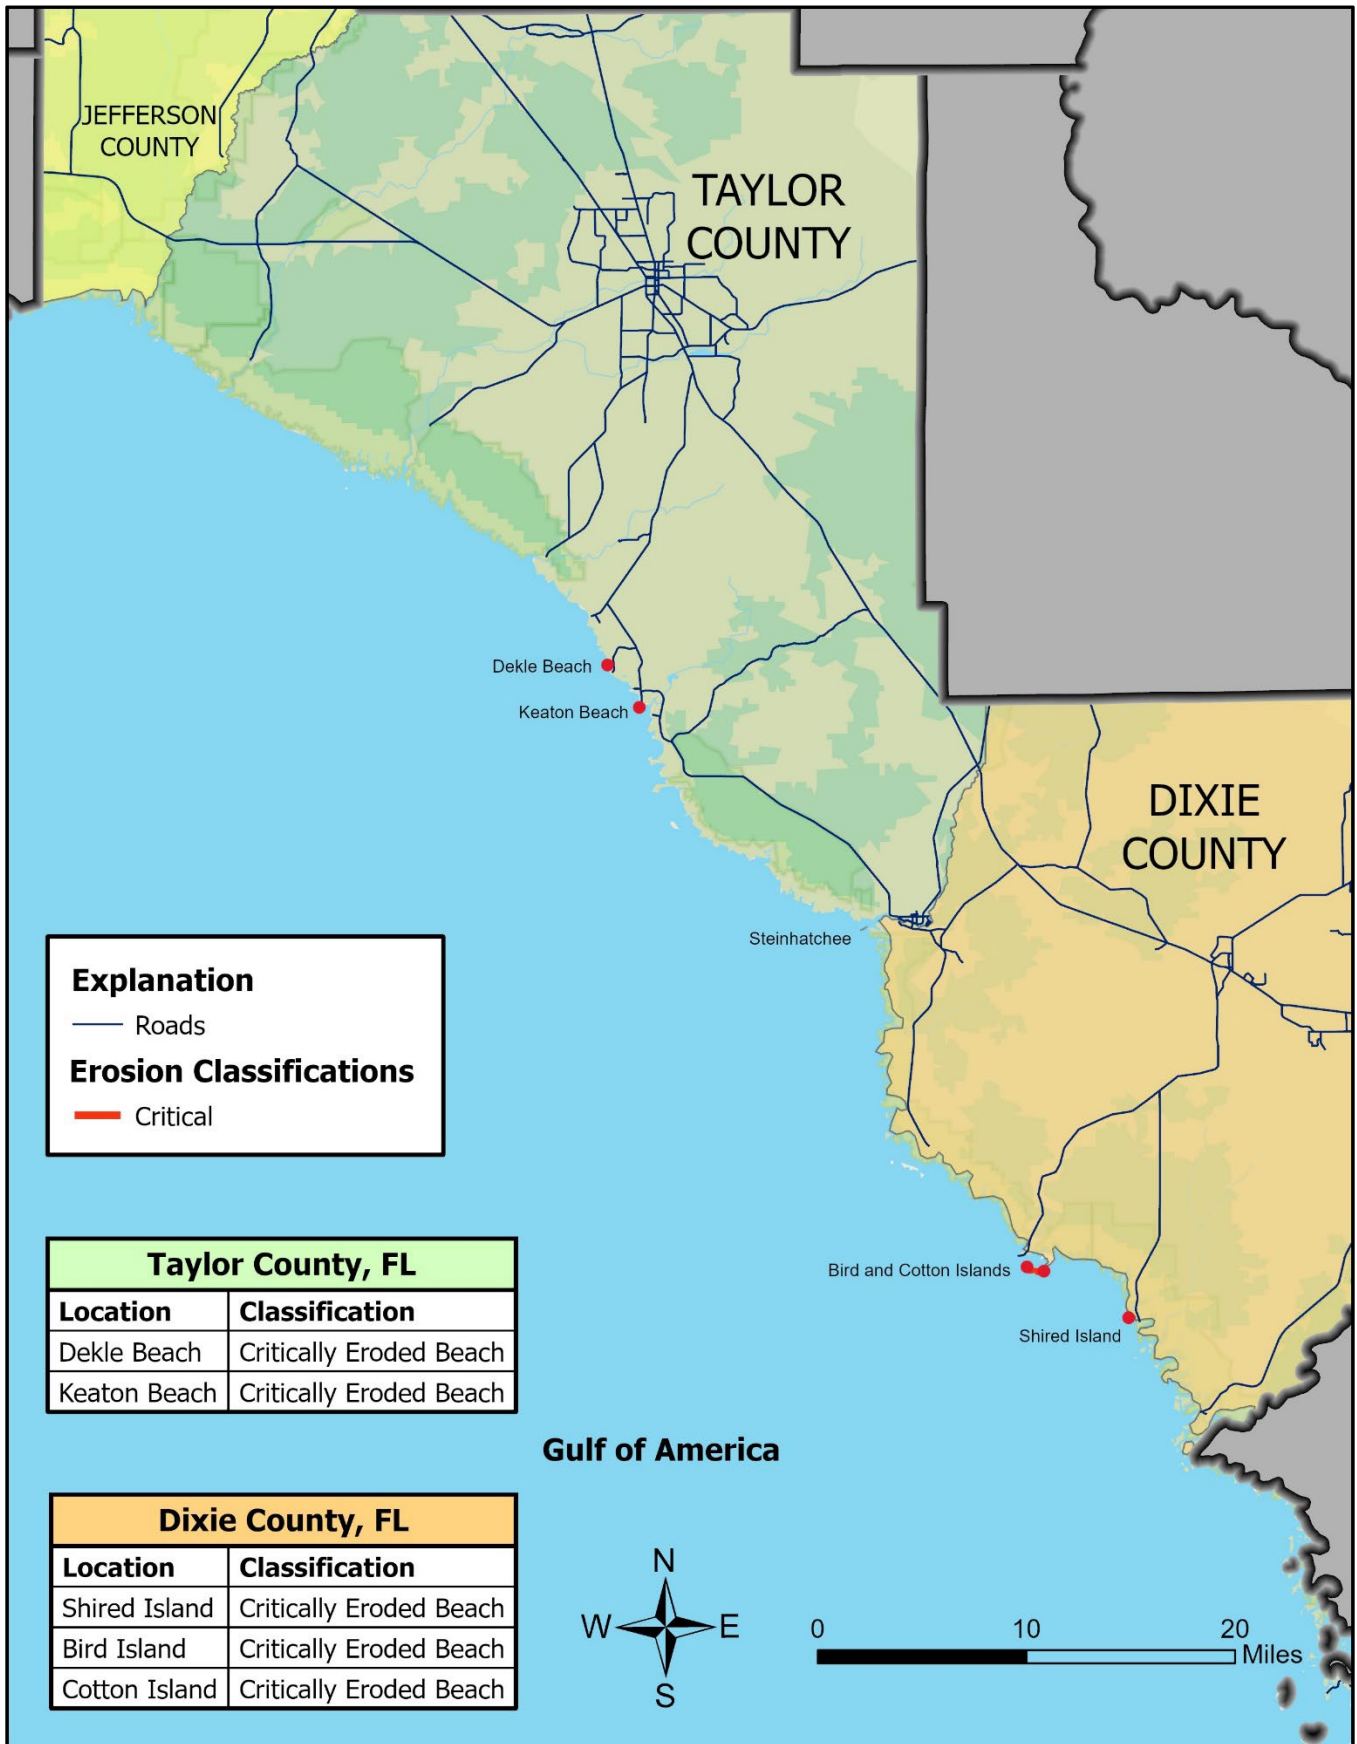
There are three critically eroded areas in Dixie County identified at this time that total 1.0 mile. The three separate islands are: Shired Island (0.6 mile), Bird Island (0.2 mile) and Cotton Island (0.2 mile). The erosion of these islands threatens ancient pre-Columbian shell middens and burial sites dating as far back as the late archaic period (2250 B.C.E. – 1500 B.C.E.). Severe erosion following Hurricanes Idalia in 2023 and Helene in 2024 substantially destroyed existing cultural resources as well as a park in Dixie County on Shired Island.

Figure 23. Critically eroded shoreline within Dixie and Taylor Counties.
