## **Critically Eroded Beaches in Florida**

**Office of Resilience and Coastal Protection  
Florida Department of Environmental Protection  
June 2026**

## June 2026

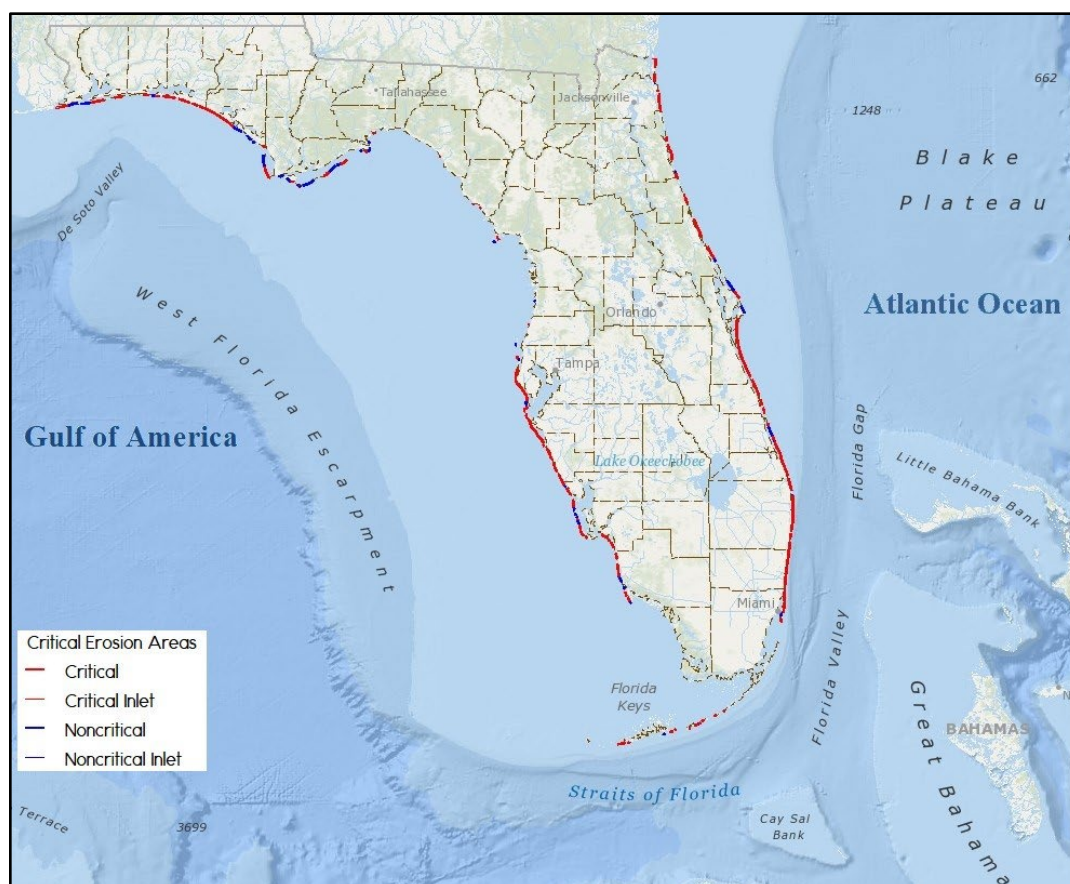
The 2026 report list includes 457.8 miles of critically eroded beach, 9.1 miles of critically eroded inlet shoreline, 88.9 miles of non-critically eroded beach and 3.2 miles of non-critically eroded inlet shoreline statewide, as shown in Figure 1.

**Figure 1.** Statewide areas of critically and non-critically eroded shoreline [Graphic from [ROSSI](#) database]. View an [interactive map](#) with aerial imagery showing R monuments and the critical erosion areas.

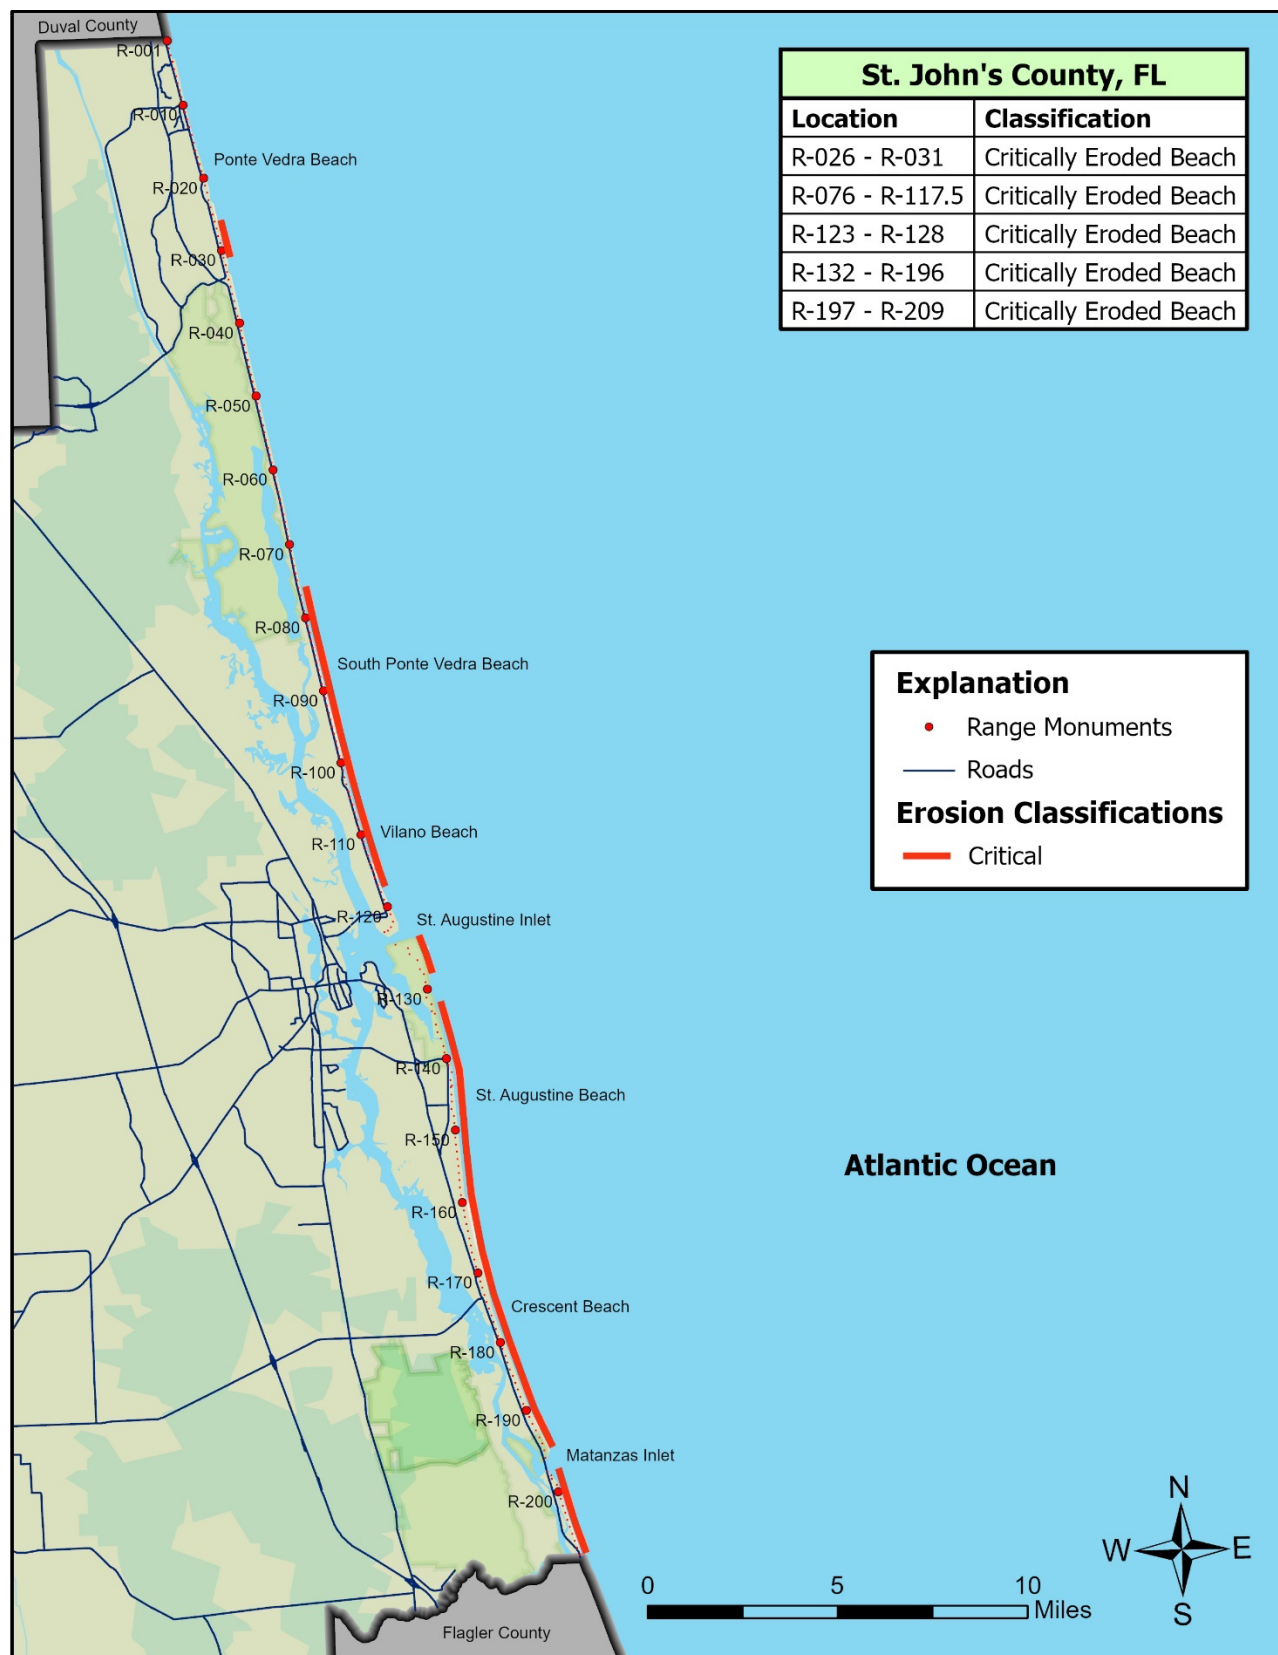
The southern 2.5 miles of St. Johns County beaches (R197 – R209/county line) located between Matanzas Inlet and the Flagler County line, are also critically eroded. The northern portion threatens State Road A1A and private development. Although the State Road A1A roadbed has been abandoned along the southern portion, wildlife habitat within the Matanzas River lagoon remains threatened. This area has been nourished from Atlantic Intracoastal Waterway dredge disposal and the river restoration at Summer Haven.

**Figure 4.** Critically eroded shoreline within St. Johns County.

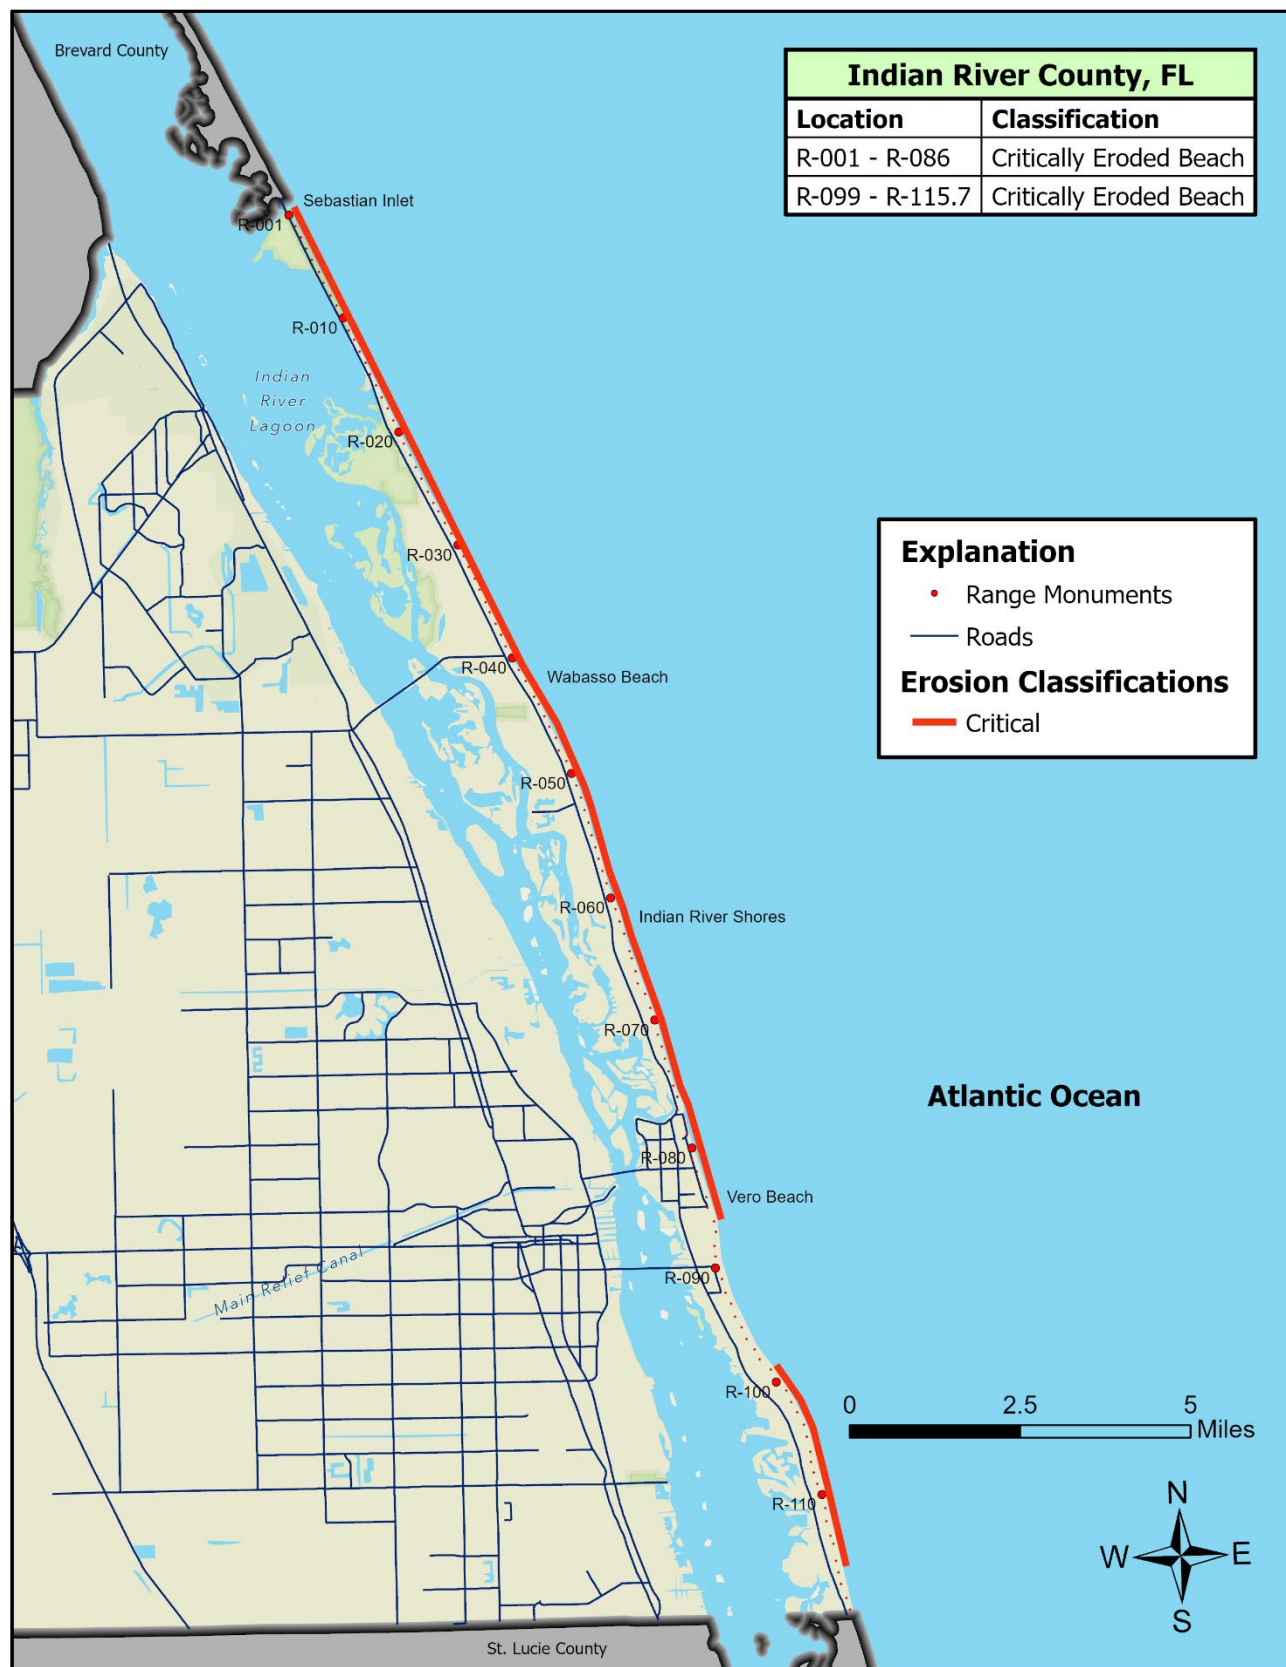
In southern Indian River County, a 3.1-mile segment in Sector 7 and Sector 8 (R99 – R115.7) is critically eroded, threatening development interests. A beach and dune restoration project have been constructed along portions of this segment due to storm erosion.

**Figure 8.** Critically eroded shoreline within Indian River County.
