Critically Eroded Beaches in Florida
Office of Resilience and Coastal Protection
Florida Department of Environmental Protection
June 2022

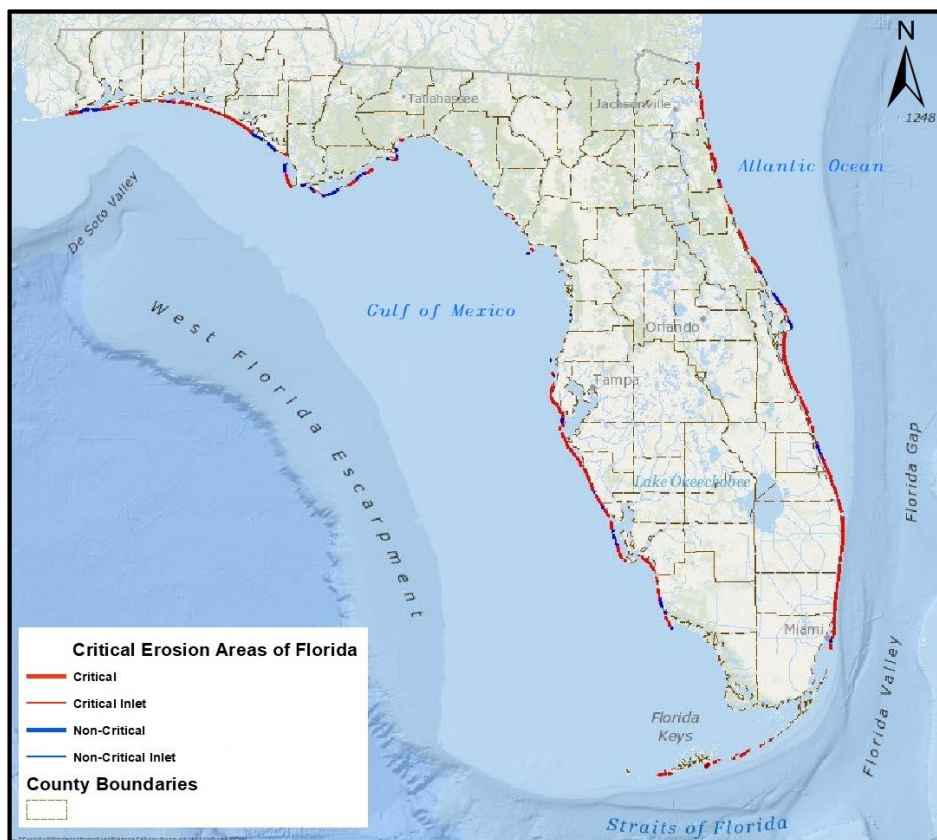
Figure 1. Statewide areas of critically and non-critically eroded shoreline [Graphic from [ROSSI database](#)]. View an [interactive map](#) with aerial imagery showing R monuments and the critical erosion areas.

In 2019, additional studies of shoreline conditions since Hurricane Irma concluded that small segments in Flagler County (1.6 miles), Collier County (0.6 mile) and Sarasota County (0.7 mile) were critical. Also, studies of shoreline changes in Franklin County since Hurricane Michael concluded changes in both non-critical and critical areas on St. Vincent Island. In 2020 and 2021, monitoring reports, studies and survey data indicated that critical erosion has expanded in a southerly direction on Casey Key in Sarasota County (0.6 mile) and new segments were added in Volusia County (1.2 mile) and Broward County (0.6 mile). Additional measurements were made in the Florida Keys with GIS maps to provide more precise distances resulting in greater lengths for the existing critically eroded areas (1.2 mile). No changes were made in the updated Critically Eroded Beaches Report of 2022. The 2022 list includes 426.3 miles of critically eroded beach, 9.1 miles of critically eroded inlet shoreline, 88.7 miles of non-critically eroded beach and 3.2 miles of non-critically eroded inlet shoreline statewide, as shown in *Figure 1*.

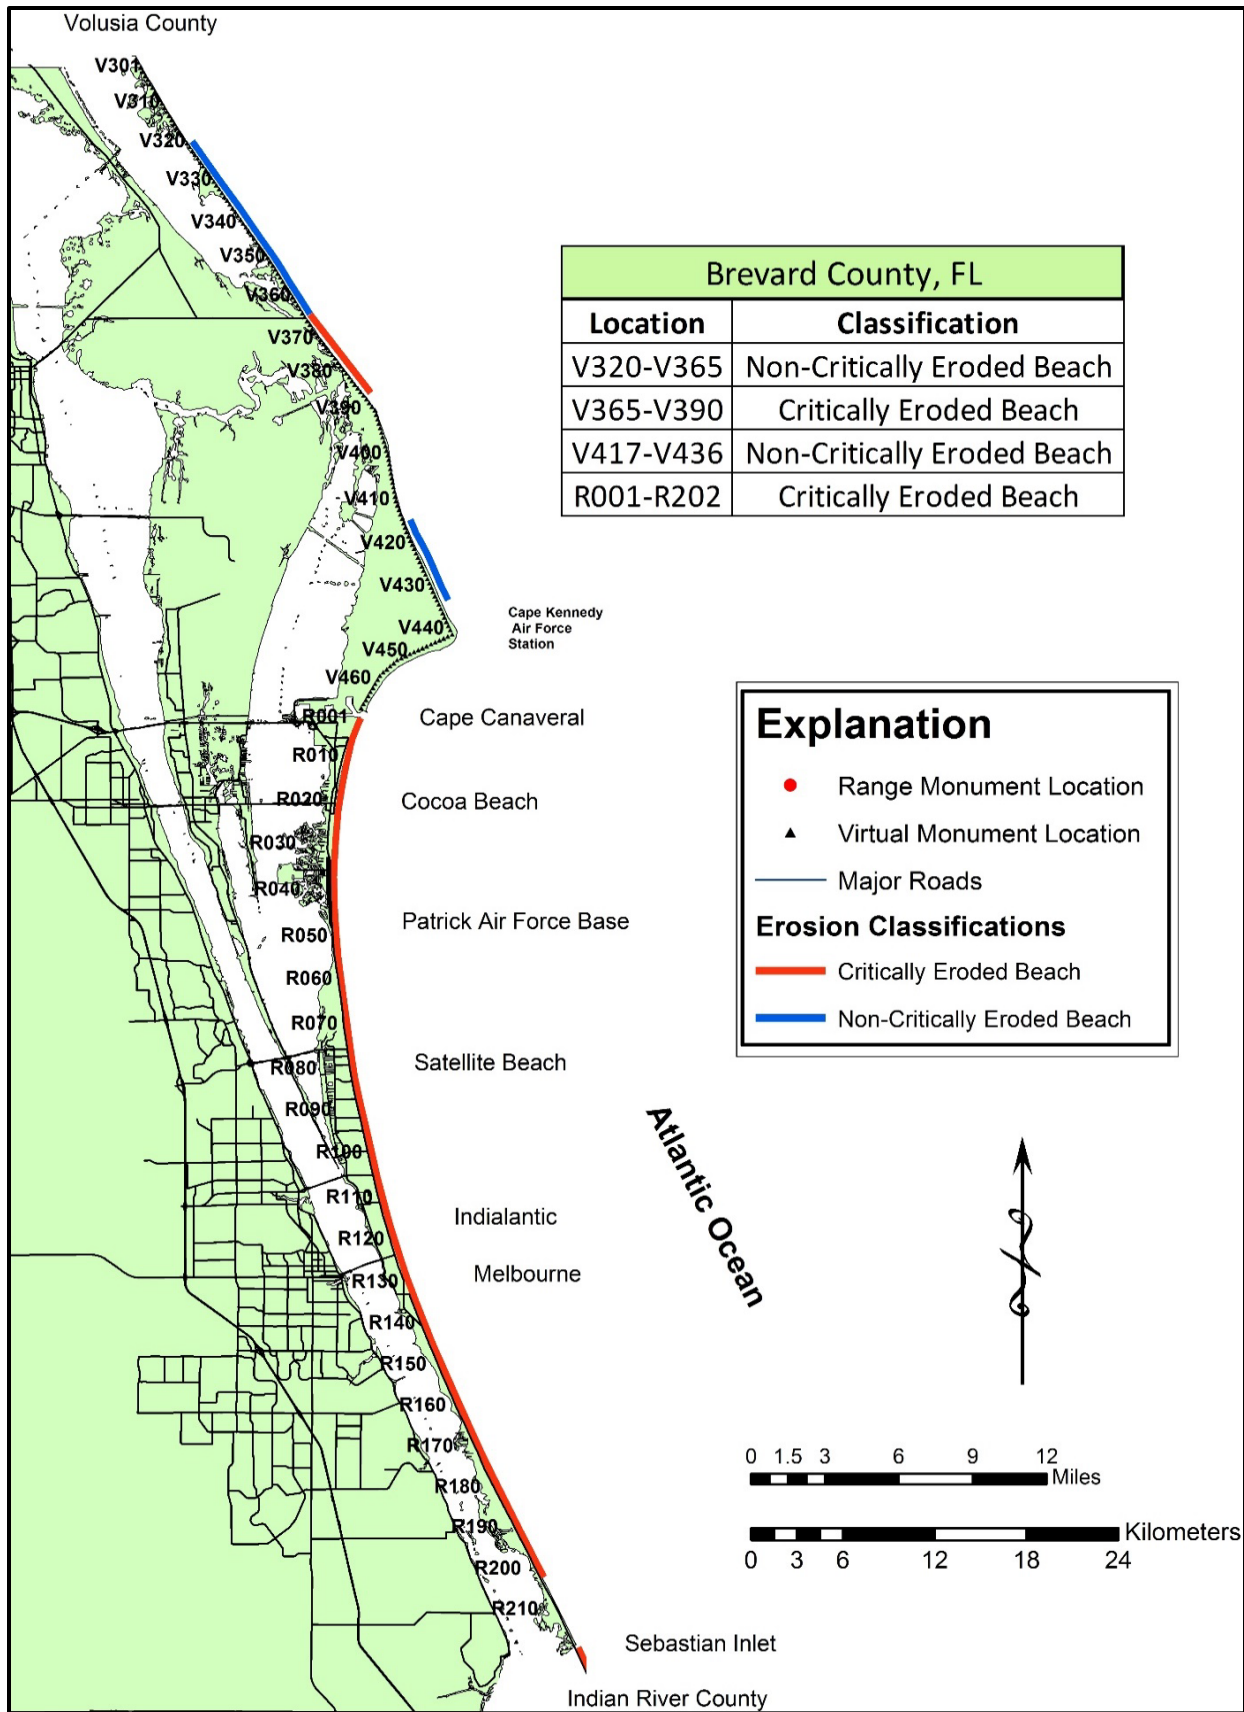
Figure 7. Critically eroded shoreline within Brevard County.

From Canaveral Inlet extending 36.5 miles to the south is a long coastal segment (R1 – R202) designated as critically eroded. With the impact of Hurricanes Frances and Jeanne in 2004, the southerly 11.5 miles of this segment became critically eroded. Threatened are development, recreational interests and wildlife habitats. Beach restoration projects have been conducted in Canaveral, Cocoa Beach, Patrick Air Force Base, Indialantic and Melbourne Beach.
