## **Critically Eroded Beaches in Florida**

**Office of Resilience and Coastal Protection  
Florida Department of Environmental Protection  
August 2025**

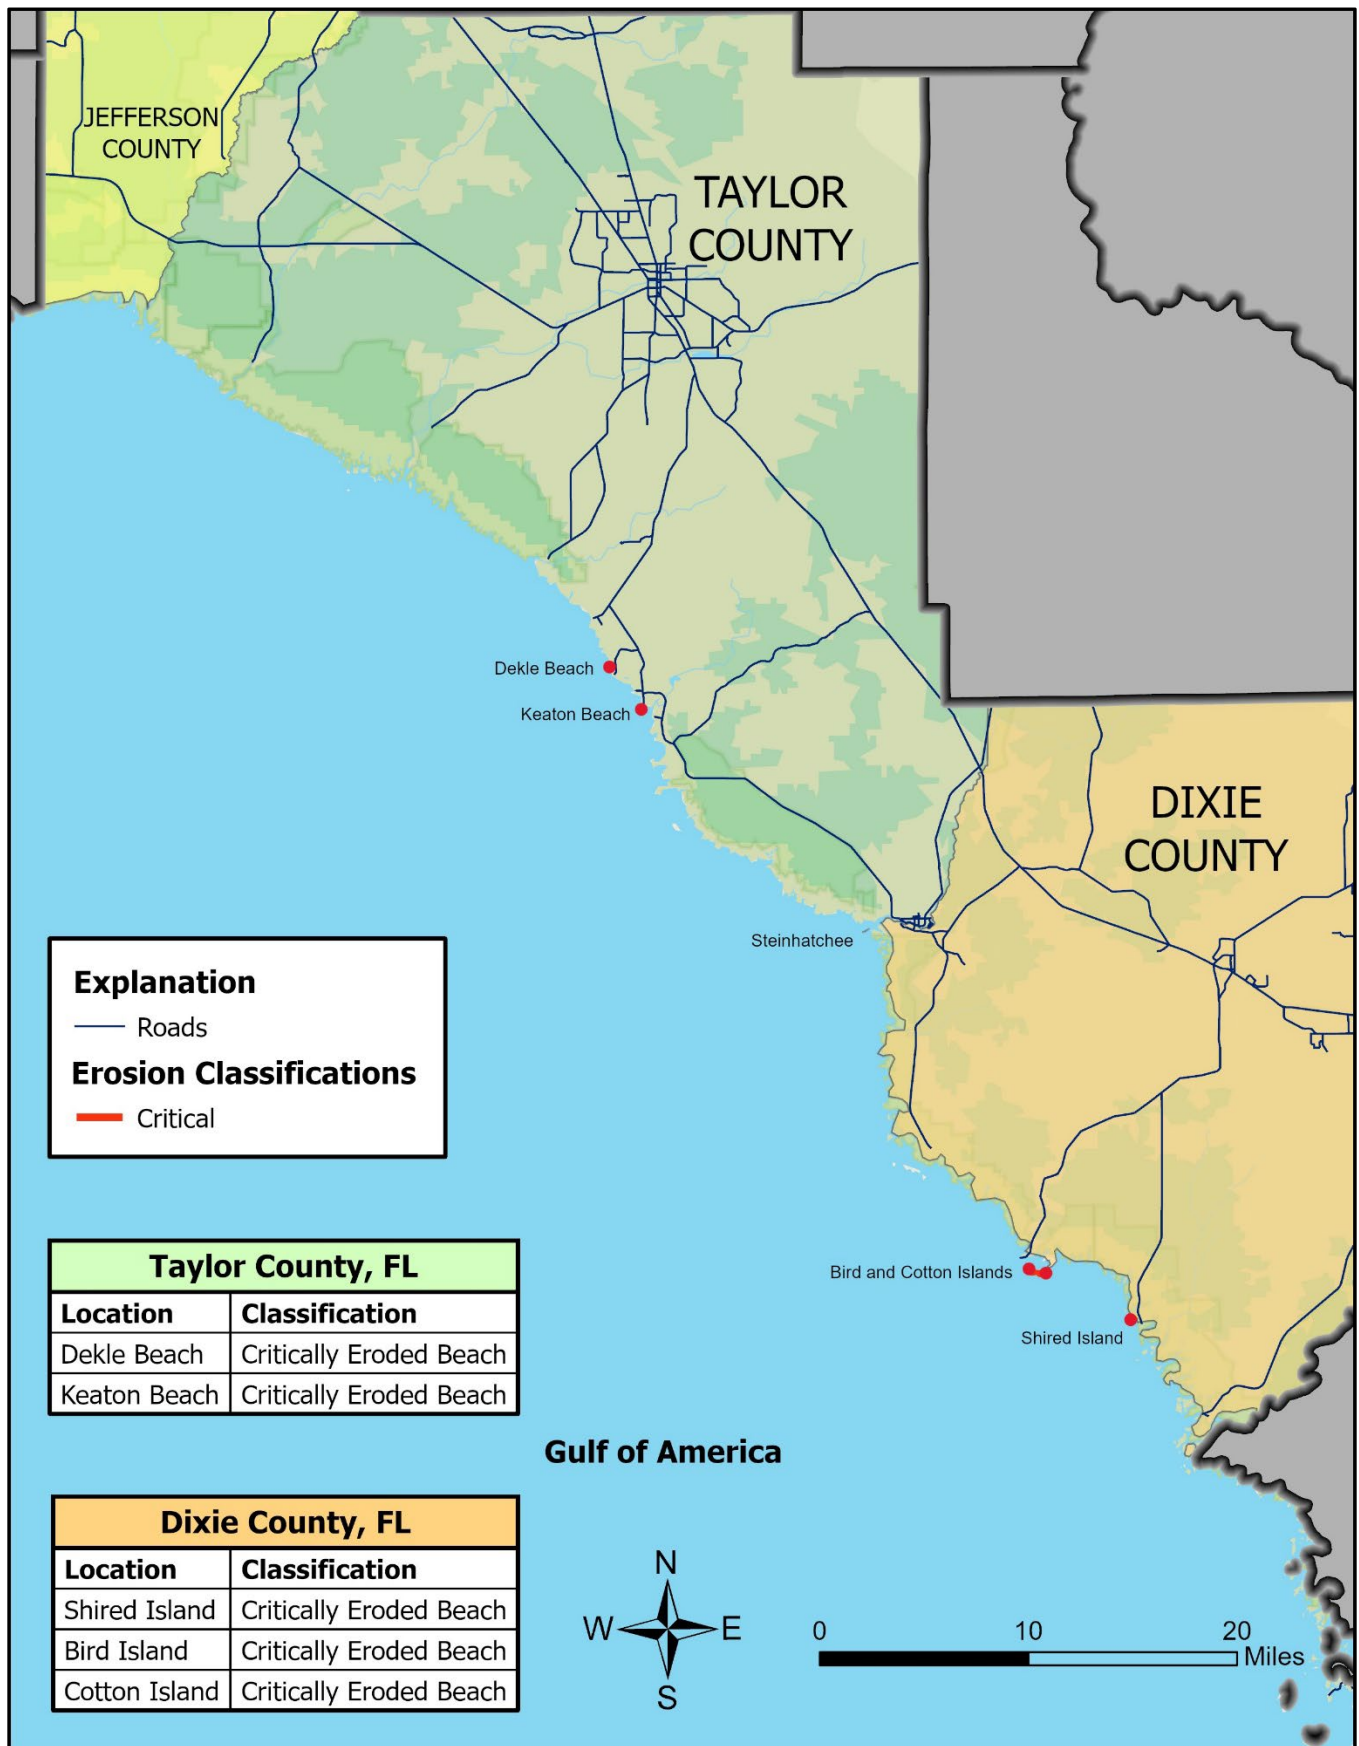
**Figure 23.** Critically eroded shoreline within Dixie and Taylor Counties.

There are three critically eroded areas in Dixie County identified at this time that total 1.0 mile. The three separate islands are: Shired Island (0.6 mile), Bird Island (0.2 mile) and Cotton Island (0.2 mile). The erosion of these islands threatens ancient pre-Columbian shell middens and burial sites dating as far back as the late archaic period (2250 B.C.E. – 1500 B.C.E.). Severe erosion following Hurricanes Idalia in 2023 and Helene in 2024 substantially destroyed existing cultural resources as well as a park in Dixie County on Shired Island.
