## **Critically Eroded Beaches in Florida**

**Office of Resilience and Coastal Protection  
Florida Department of Environmental Protection  
August 2025**

## August 2025

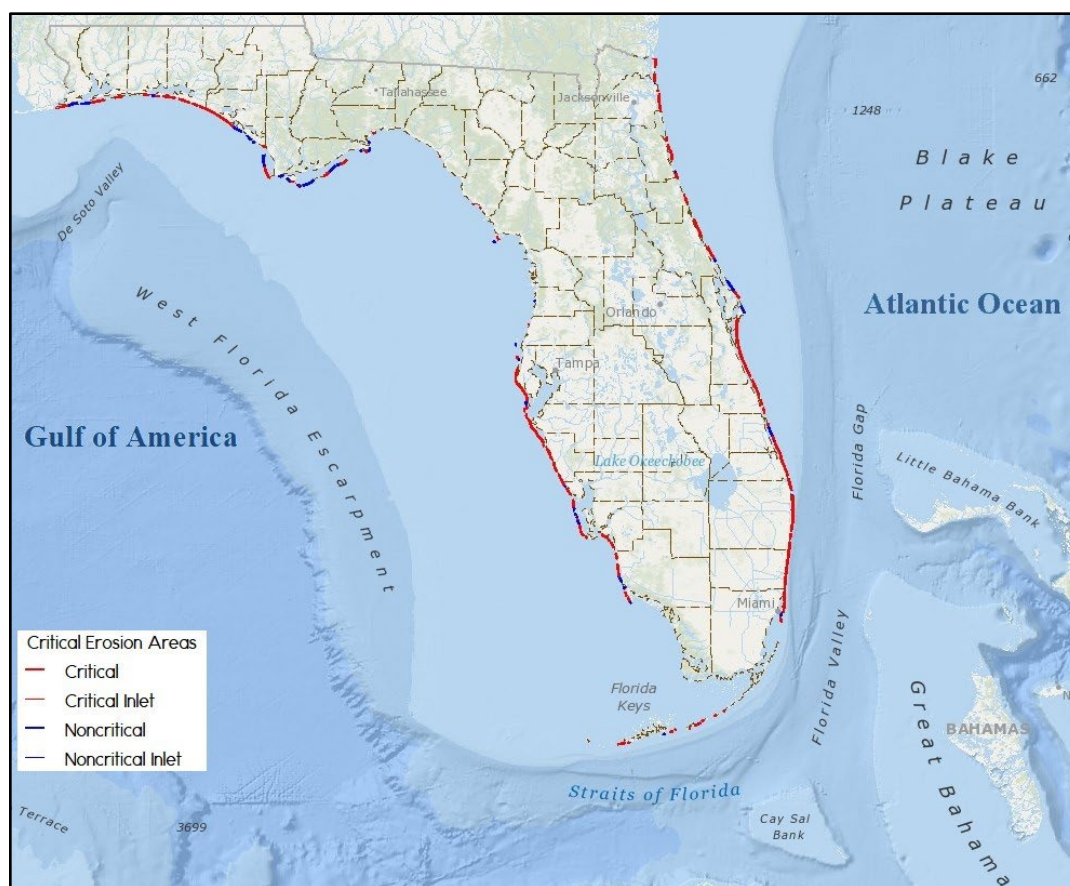
**Figure 1.** Statewide areas of critically and non-critically eroded shoreline [Graphic from [ROSSI](#) database]. View an [interactive map](#) with aerial imagery showing R monuments and the critical erosion areas.

No changes were made to the updated Critically Eroded Beaches Report of 2022. Due to erosion caused by Hurricanes Ian and Nicole (2022), additional critical erosion areas were added to the 2023 critical erosion report in St. Johns County (0.8 mile), Volusia County (5.0 miles) and Lee County (0.4 mile). Both Volusia County (0.9 mile) and St. Johns County (7.6 miles) had non-critical erosion segments added into the 2023 report. Due to eastward erosion progression along St. George Island (0.6 mile) in Franklin County and new information on critical wildlife habitat being threatened along Gomez Key (0.2 mile) in Levy County, two erosion segments have been added into the 2024 report. One segment (0.2 mile) in Pasco County was delisted in 2024 at Hudson Beach due to coastal armoring of the beach. Due to new information in 2025 on critical wildlife habitat being lost and threatened, 7.6 miles along the Crescent Beach shoreline in St. Johns County has now been changed from non-critical to critically eroded. An additional measurement was made in St. Johns County with GIS maps to provide a more precise distance that resulted in one segment (0.1 mile) being added at the southern county line. Two segments (0.7 mile and 1.5 miles) in Flagler County have been added as critically eroded. A segment (3.6 miles) has been added as critically eroded in Indian River County. A segment (0.8 mile) has been added as critically eroded in Miami-Dade County along Virginia Key. In Collier County a segment (1.6 miles) has been listed as critically eroded and in Lee County a segment (1.8 mile) is listed as critically eroded. A segment (0.1 mile) at Keaton Beach in Taylor County was added and a segment (0.2 mile) was added onto Shired Island in Dixie County. The 2025 list includes 451.1 miles of critically eroded beach, 9.1 miles of critically eroded inlet shoreline, 88.9 miles of non-critically eroded beach and 3.2 miles of non-critically eroded inlet shoreline statewide, as shown in Figure 1.

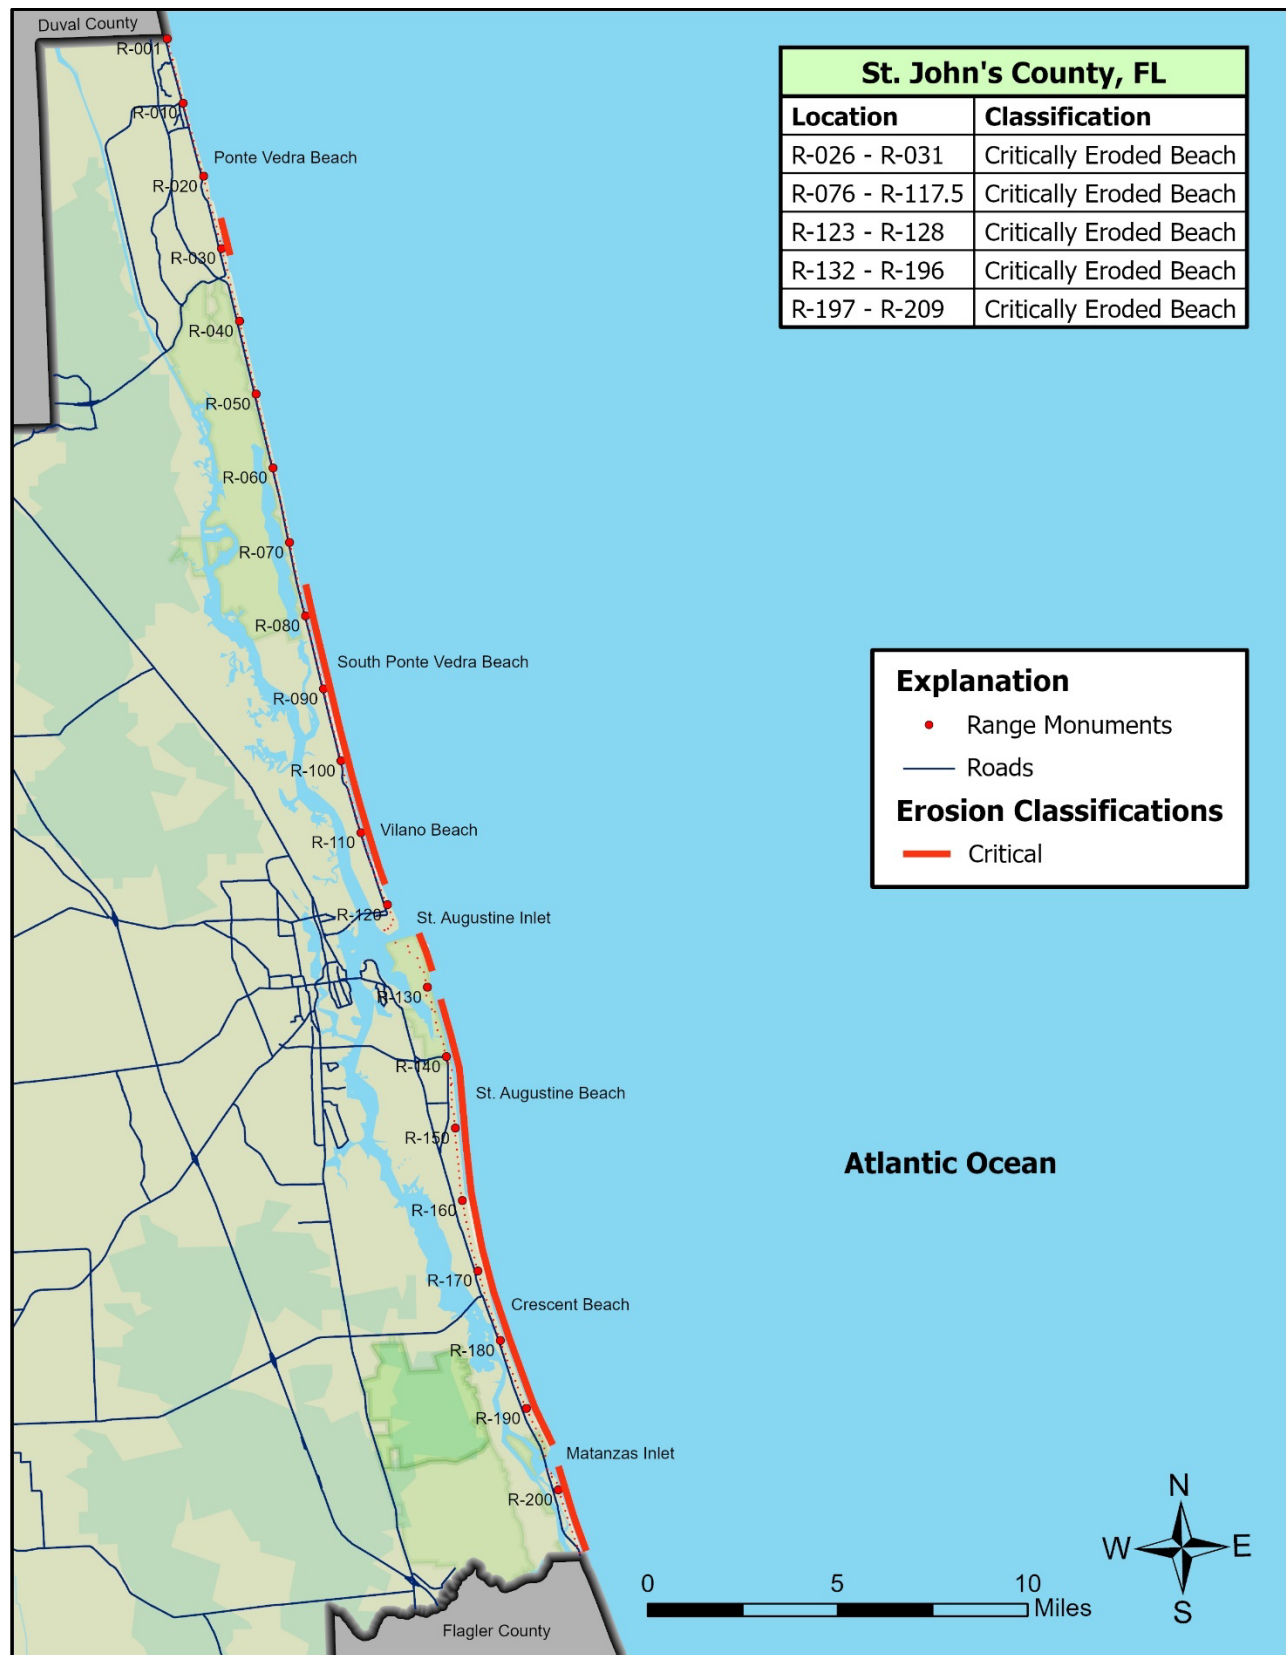
The southern 2.5 miles of St. Johns County beaches (R197 – R209/county line) located between Matanzas Inlet and the Flagler County line, are also critically eroded. The northern portion threatens State Road A1A and private development. Although the State Road A1A roadbed has been abandoned along the southern portion, wildlife habitat within the Matanzas River lagoon remains threatened. This area has been nourished from Atlantic Intracoastal Waterway dredge disposal and the river restoration at Summer Haven.

**Figure 4.** Critically eroded shoreline within St. Johns County.
