# Piney Point Updates May 2021

FLORIDA DEPARTMENT OF ENVIRONMENTAL PROTECTION

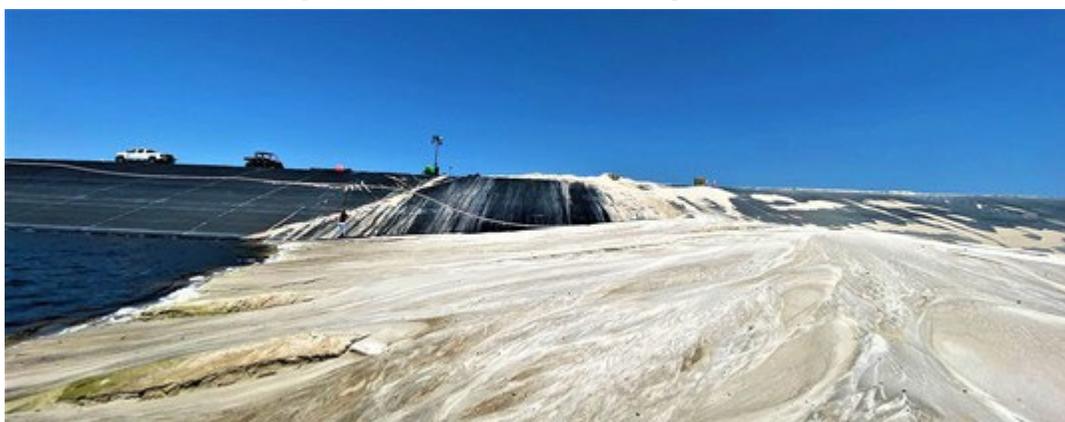
Sand placement in the NGS-South compartment concluded yesterday, which minimized the flow of concentrated seepage into the onsite lined stormwater system. It is estimated that approximately 16,400 cubic yards of sand have been added to the compartment since the operation began on May 11, 2021. The department will continue to monitor the success of this repair in the NGS-South, as well as the ongoing water treatment in OGS-North and LPWS, as short- and long-term water management strategies are identified.

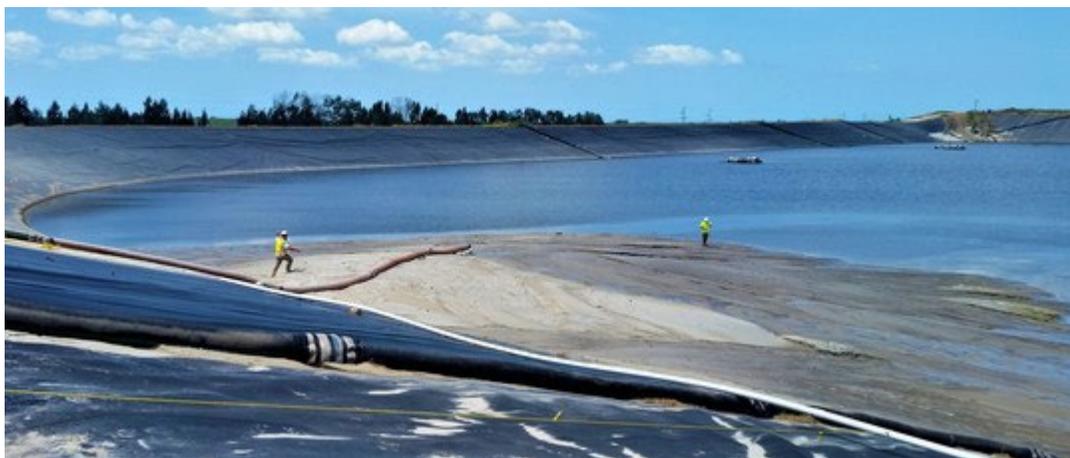
Sand placement in the NGS-South compartment is expected to conclude today. As a result of this effort, the flow of concentrated seepage into the onsite lined stormwater system has been minimized. It is estimated that more than 15,300 cubic yards of sand have been added to the compartment since the operation began on May 11, 2021.

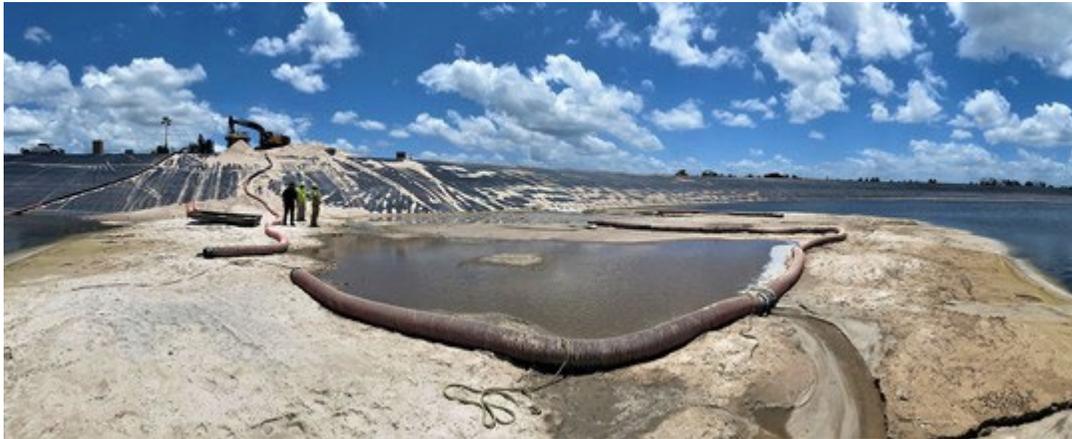
Sand placement in the NGS-South compartment is ongoing. Repairs to date continue to reduce the flow of the concentrated seepage into the onsite lined stormwater system. It is estimated that more than 11,700 cubic yards of sand have been added to the compartment since the operation began on May 11, 2021.

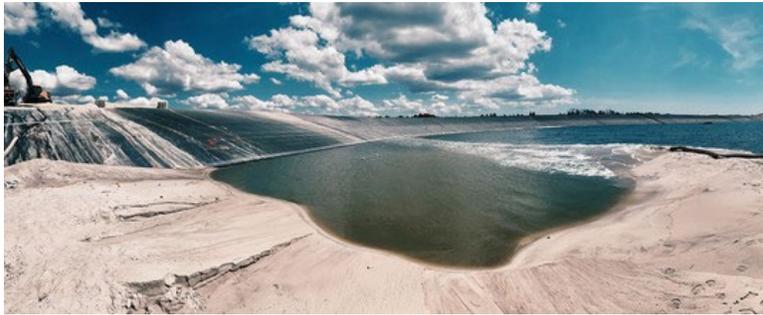
*Sand placement continues around the steel plate located in NGS-South.*

Sand placement continues in the NGS-South compartment to further stabilize the temporary repair and minimize the potential for additional seepage. As this project continues over the next several days, water levels are expected to fluctuate in the NGS-South compartment and in the lined on-site stormwater system.

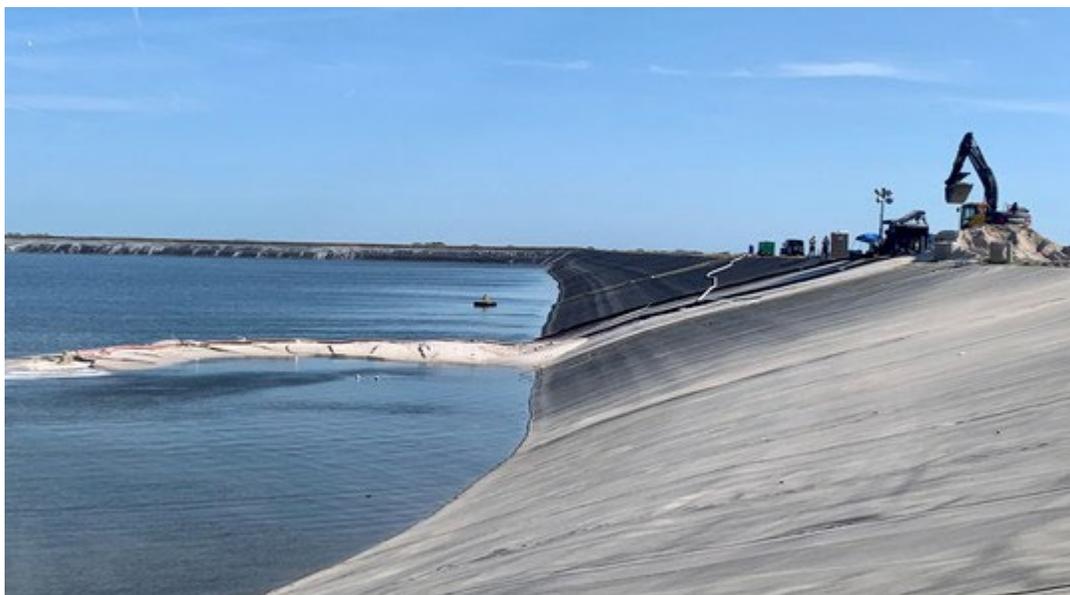
*Sand placement continues around the steel plate located in NGS-South.*

Sand placement continues and it is estimated that approximately 7,100 cubic yards of sand has been placed in the NGS-South compartment to further stabilize the temporary repair and minimize the potential for additional seepage. As this project continues, water levels are expected to fluctuate in the NGS-South compartment and in the lined on-site stormwater system.

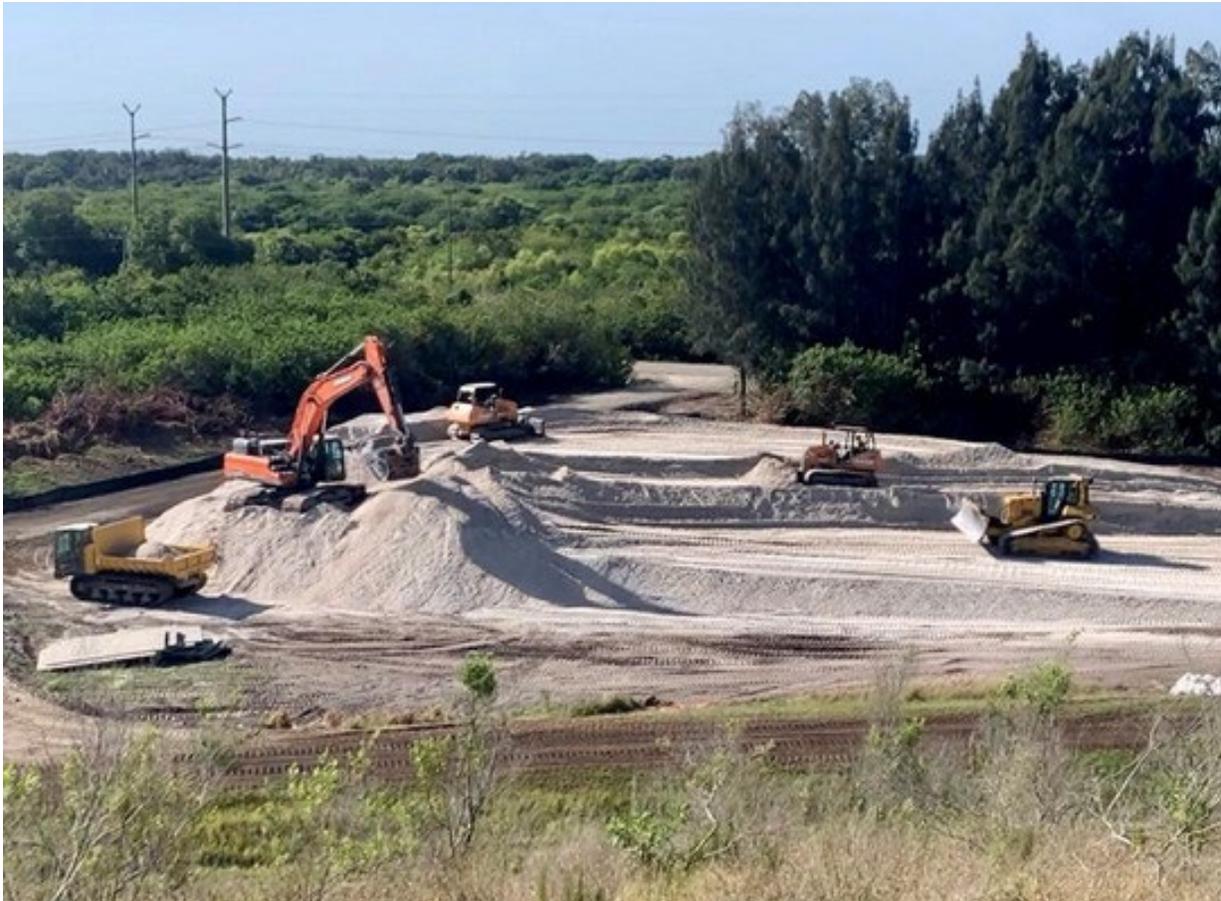
*Sand is stockpiled onsite and transported to the top of the gypsum stack where it is then slurried and pumped into the NGS-South compartment.*

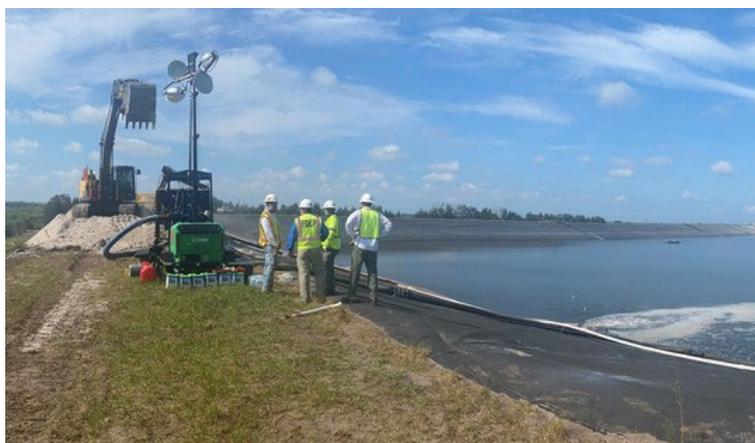
DEP began work today incorporating sand around the liner seam-separation inside the NGS-South compartment to reinforce the steel plate and to further reduce the potential for additional seepage. While the [steel plate](#), [stone aggregate](#) and [geo-composite material](#) continue to minimize the concentrated seepage that is being contained onsite, DEP expects additional progress and stabilization will be made with the introduction of the sand placement.
