Rainbow Springs State Park

Public Meeting Draft Unit Management Plan

**STATE OF FLORIDA
DEPARTMENT OF ENVIRONMENTAL PROTECTION
Division of Recreation and Parks
September 2021**

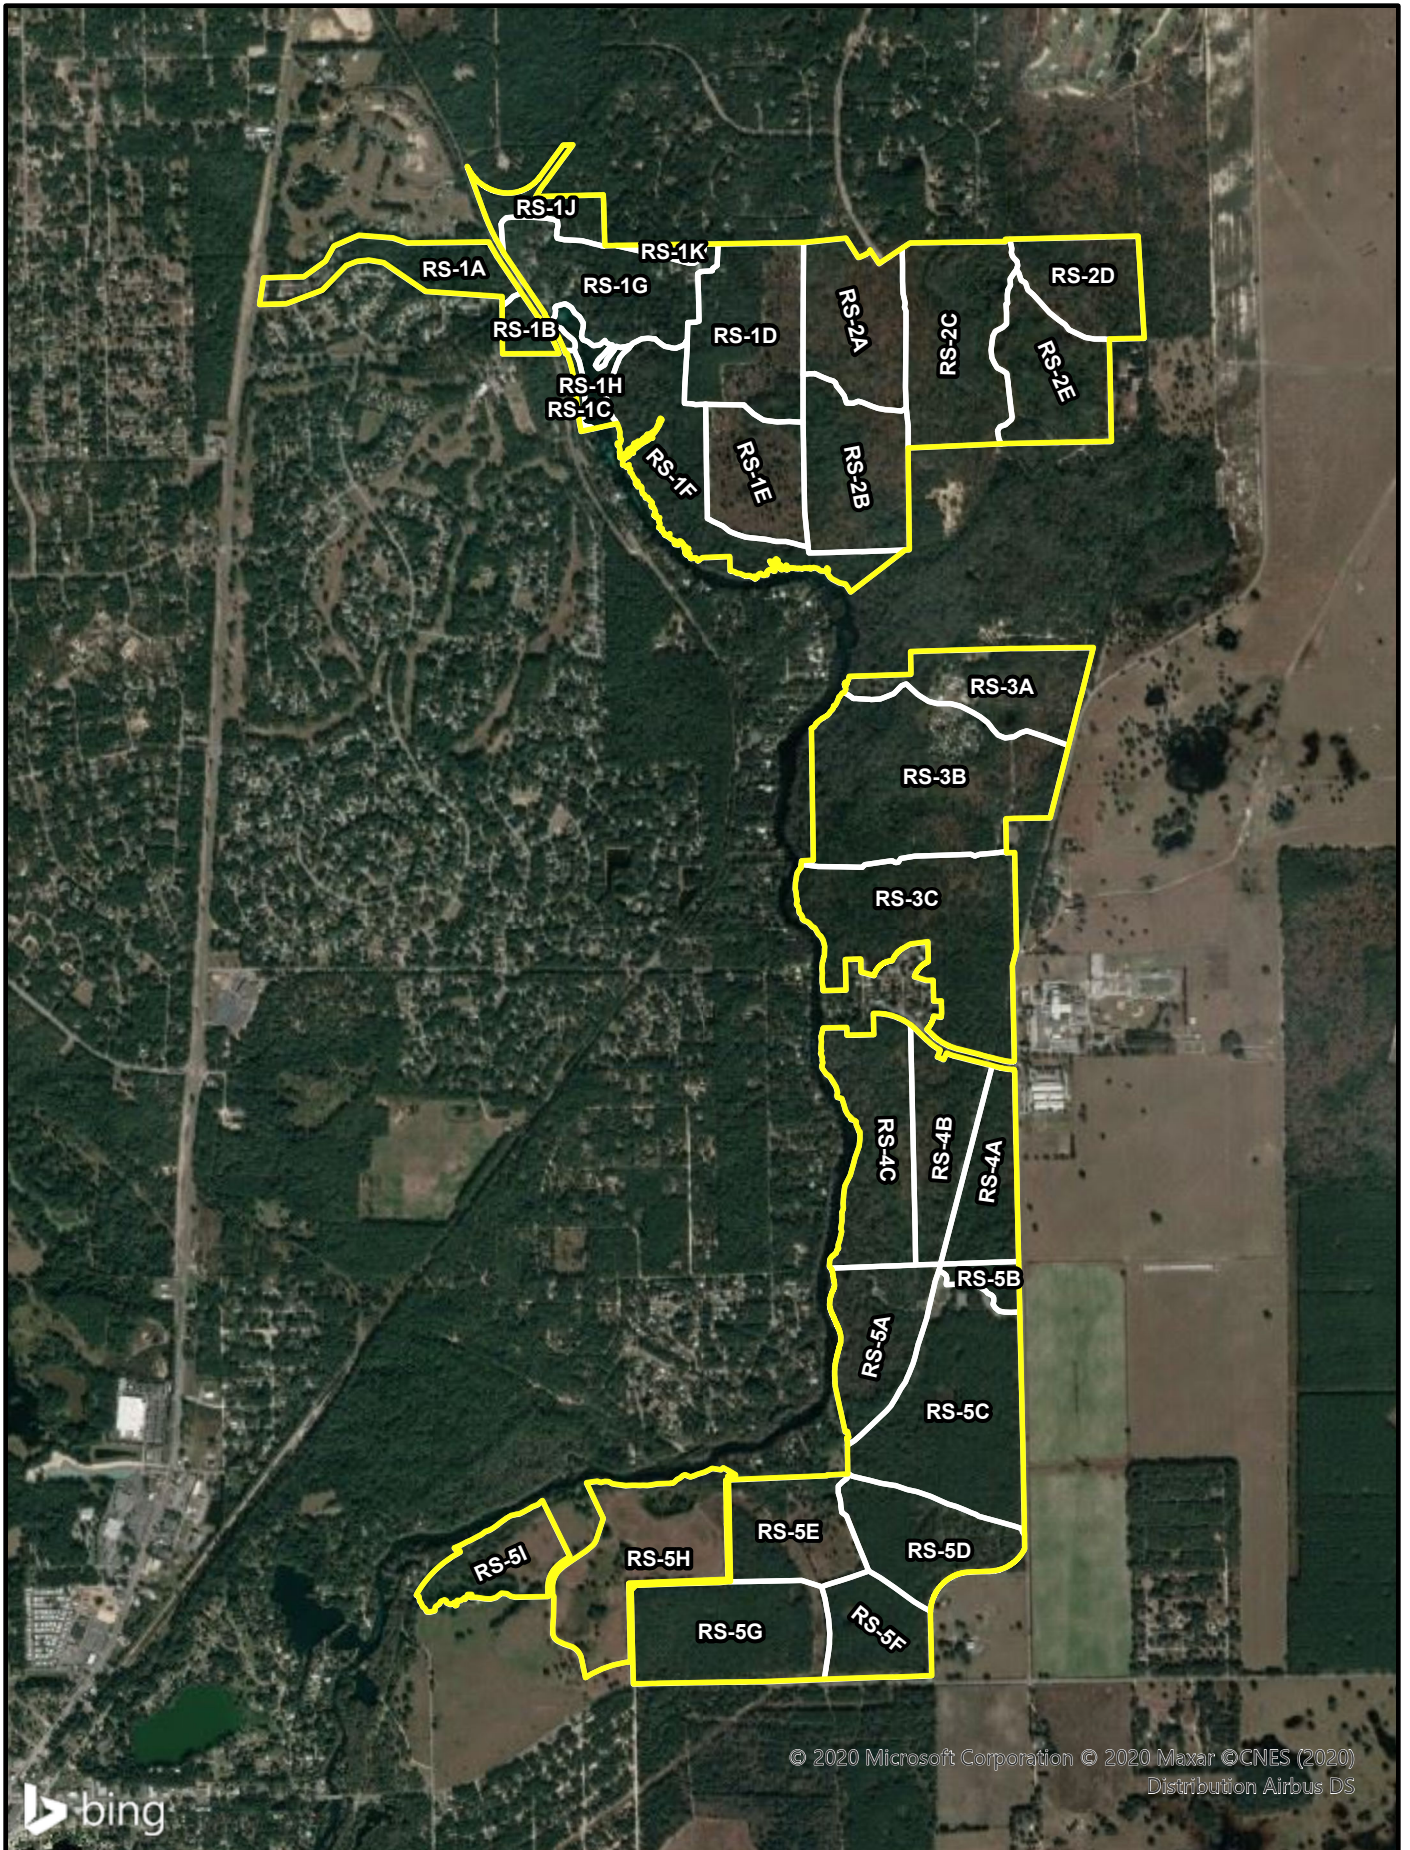
**MANAGEMENT ZONES
MAP**

The entire park is divided into management zones that delineate areas on the ground that are used to coordinate management activities (see Management Zones Map). The shape and size of each zone may be based on natural community type, burn zone, and the location of existing roads and fire breaks. Table 1 reflects the management zones with the acres of each zone.

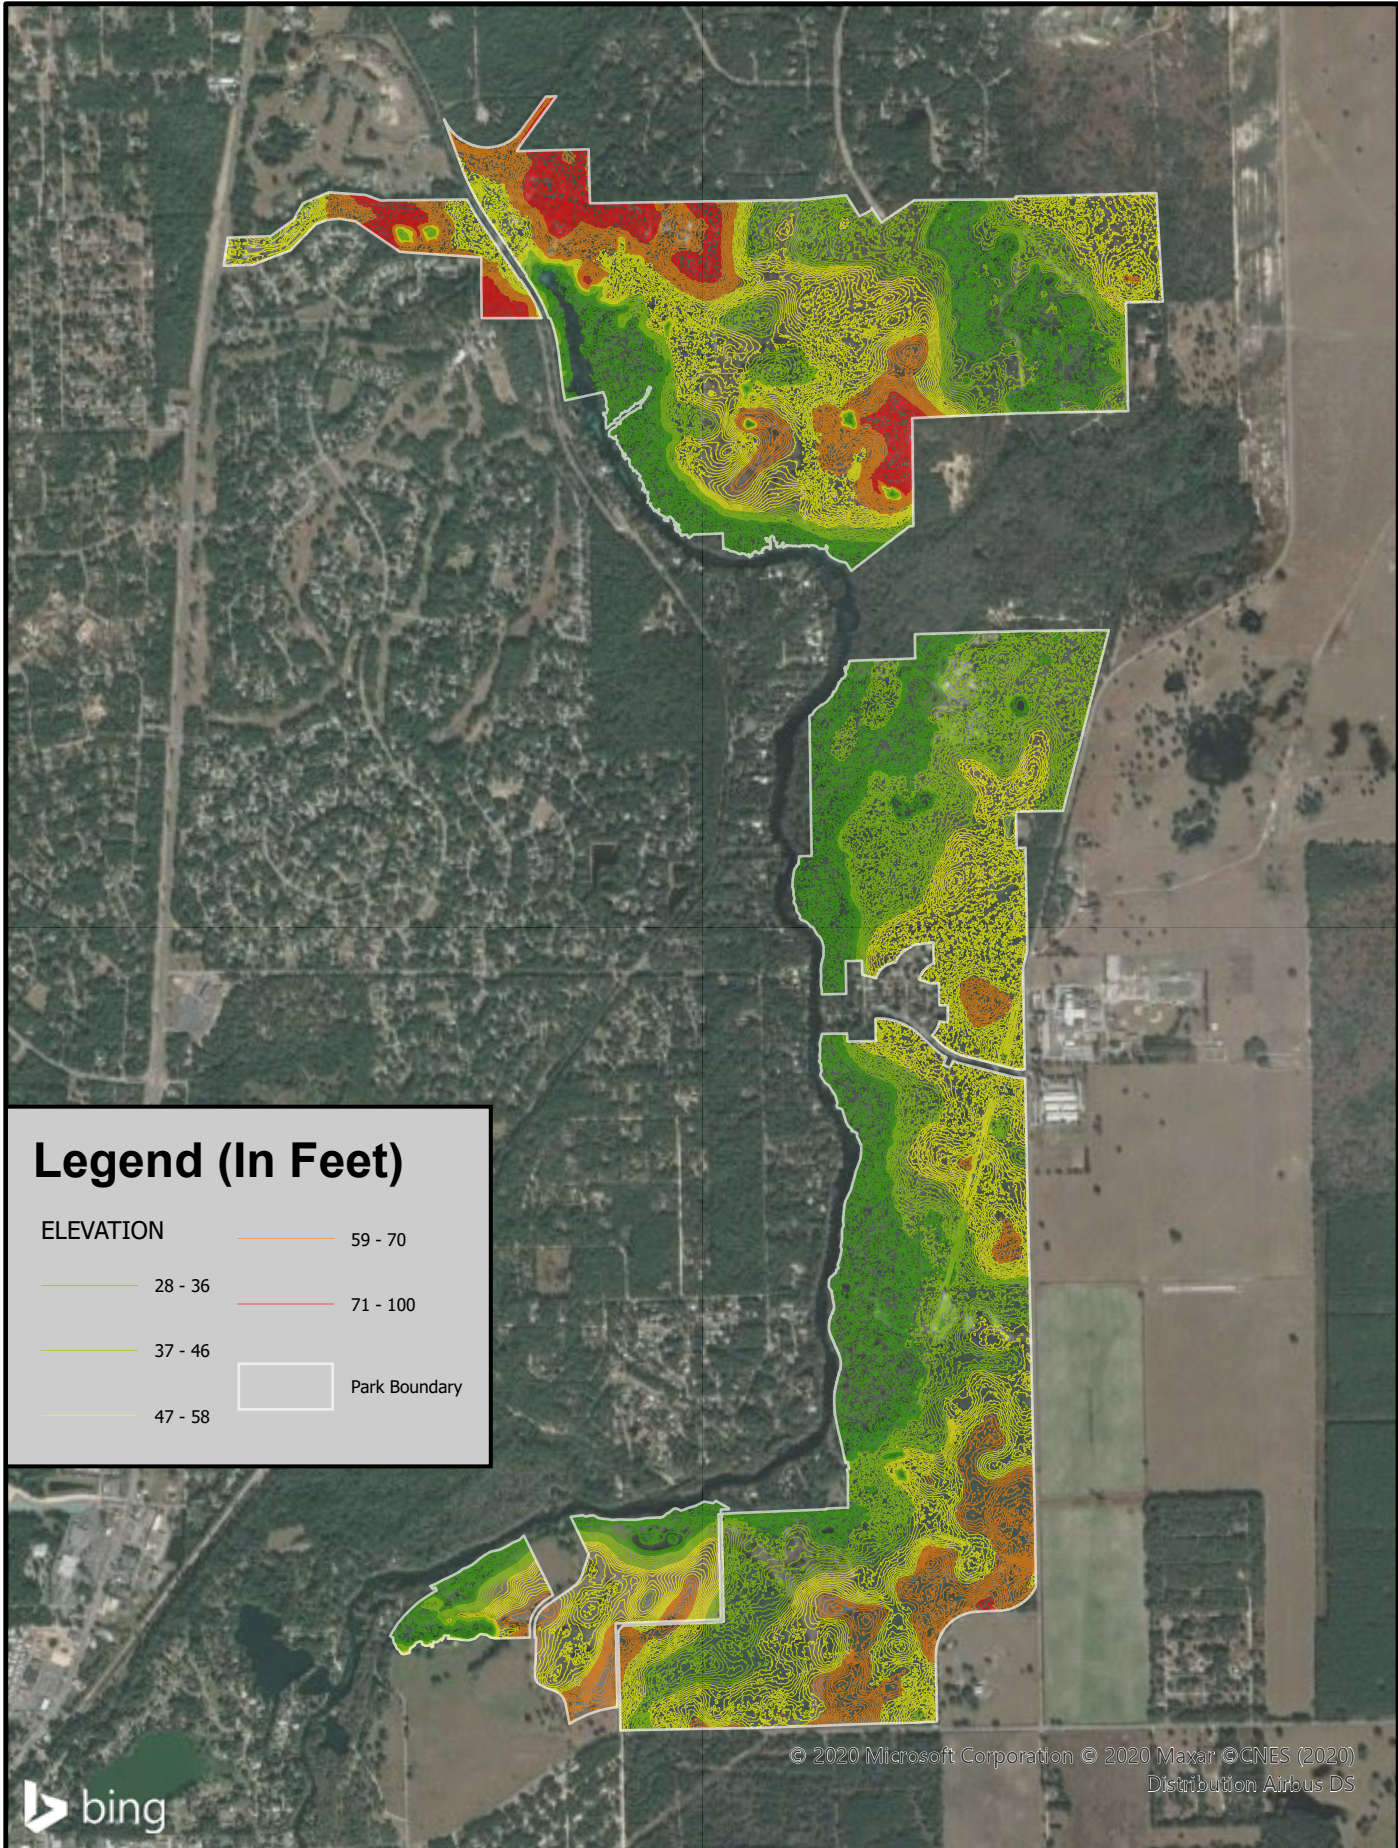
Legend (In Feet)

| ELEVATION | 59 - 70 |

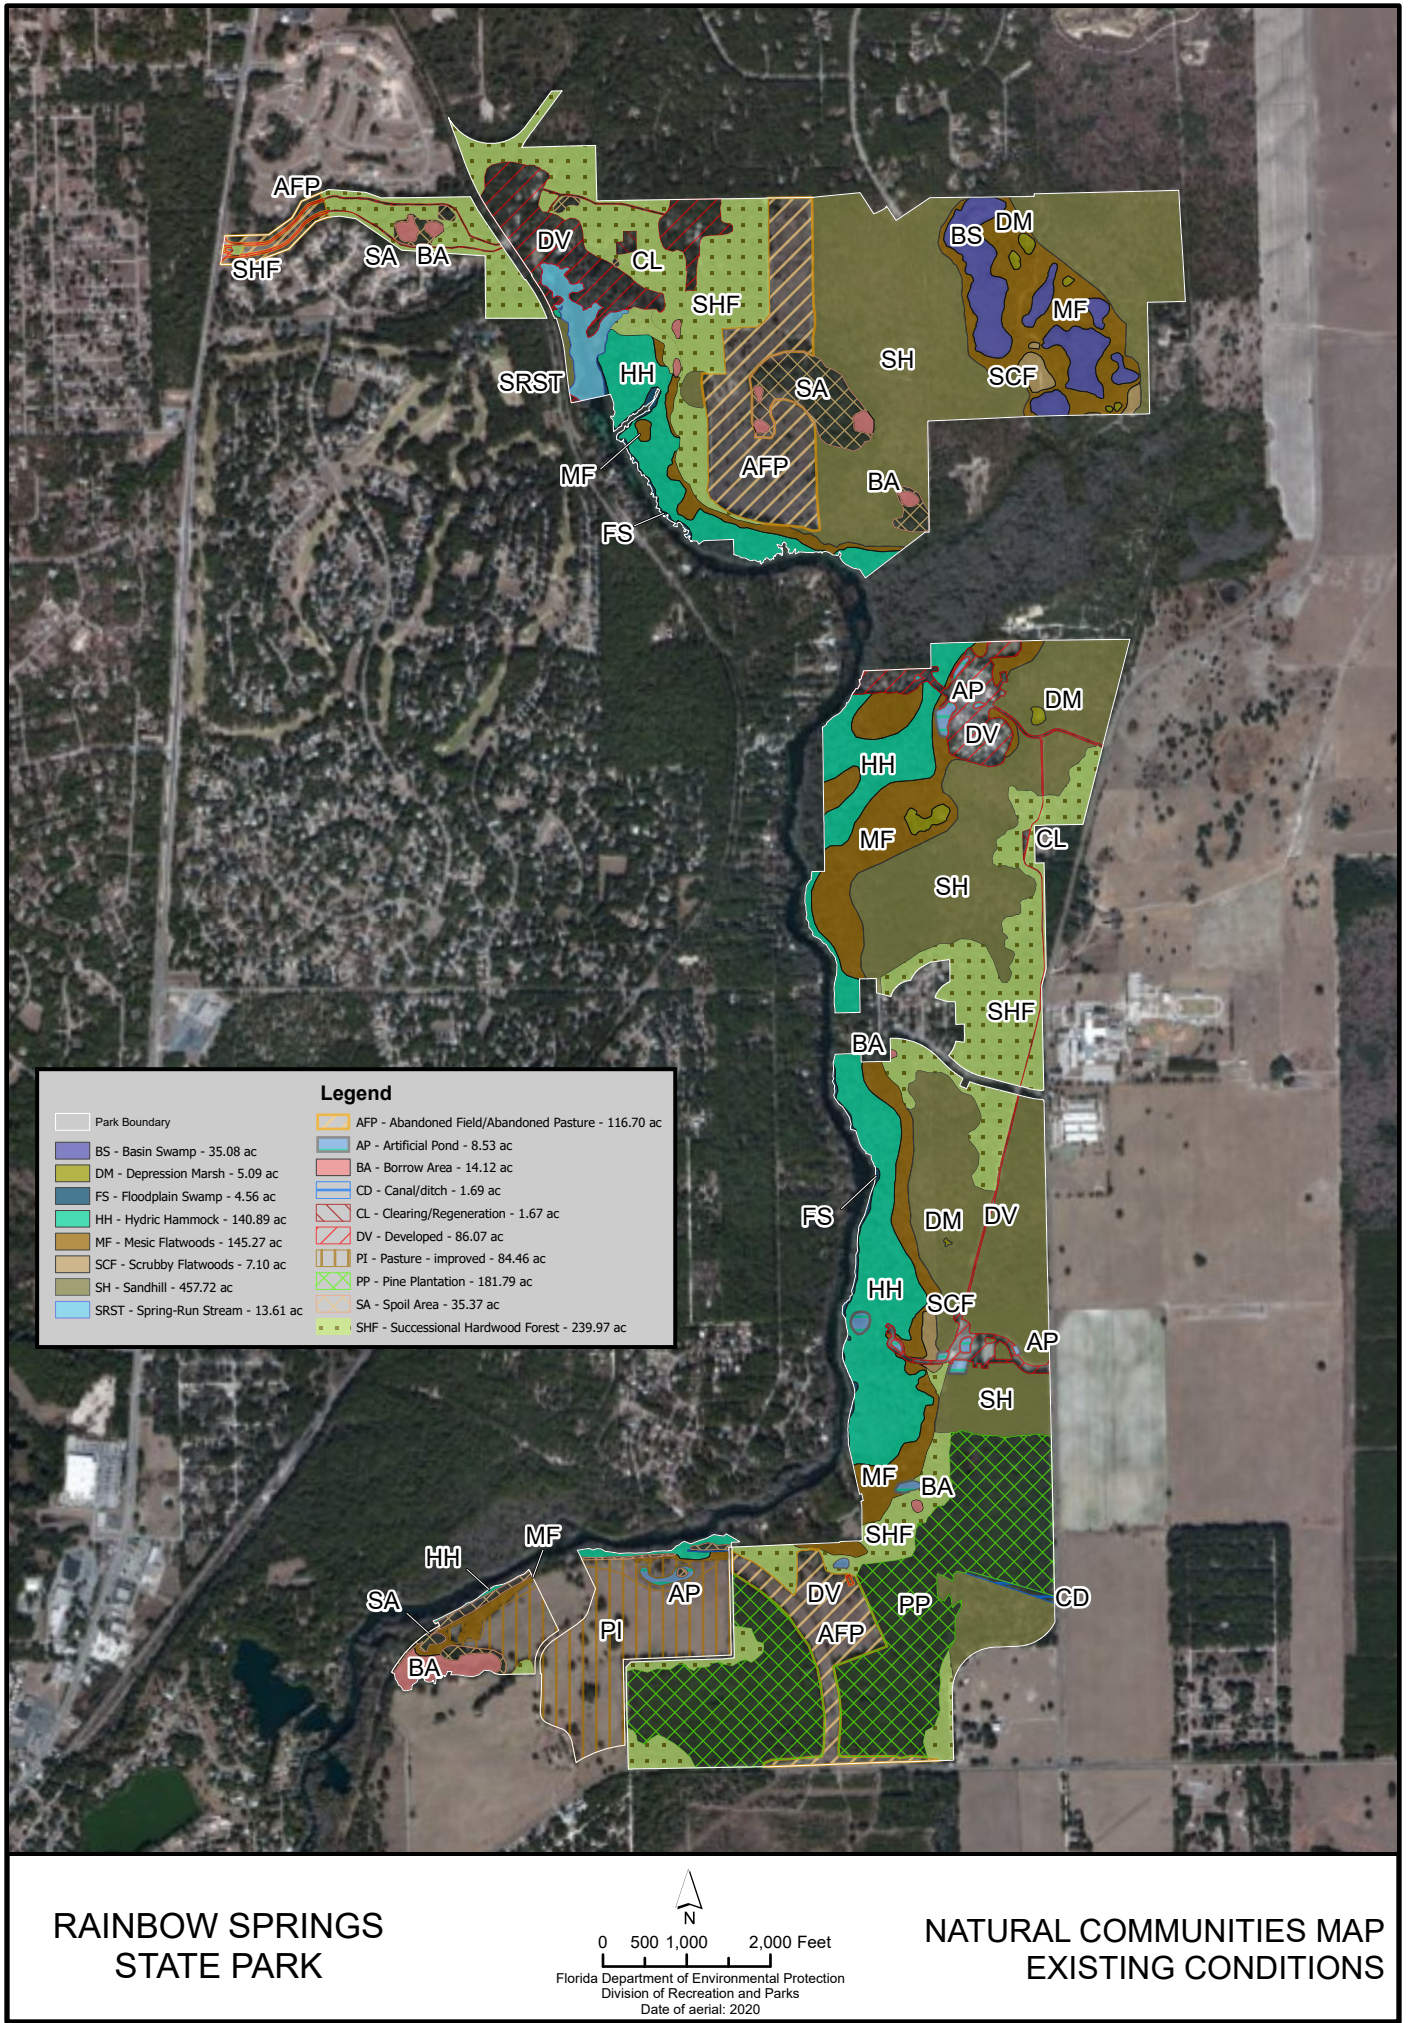
NATURAL COMMUNITIES MAP
EXISTING CONDITIONS

| Legend | |
| Park Boundary | AFP - Abandoned Field/Abandoned Pasture - 116.70 ac |
