*Strategic Beach Management Plan:*  
*Northeast Atlantic Coast Region*  
**Division of Water Resource Management**  
**Florida Department of Environmental Protection**  
**May 2018**

## ***Introduction - Northeast***

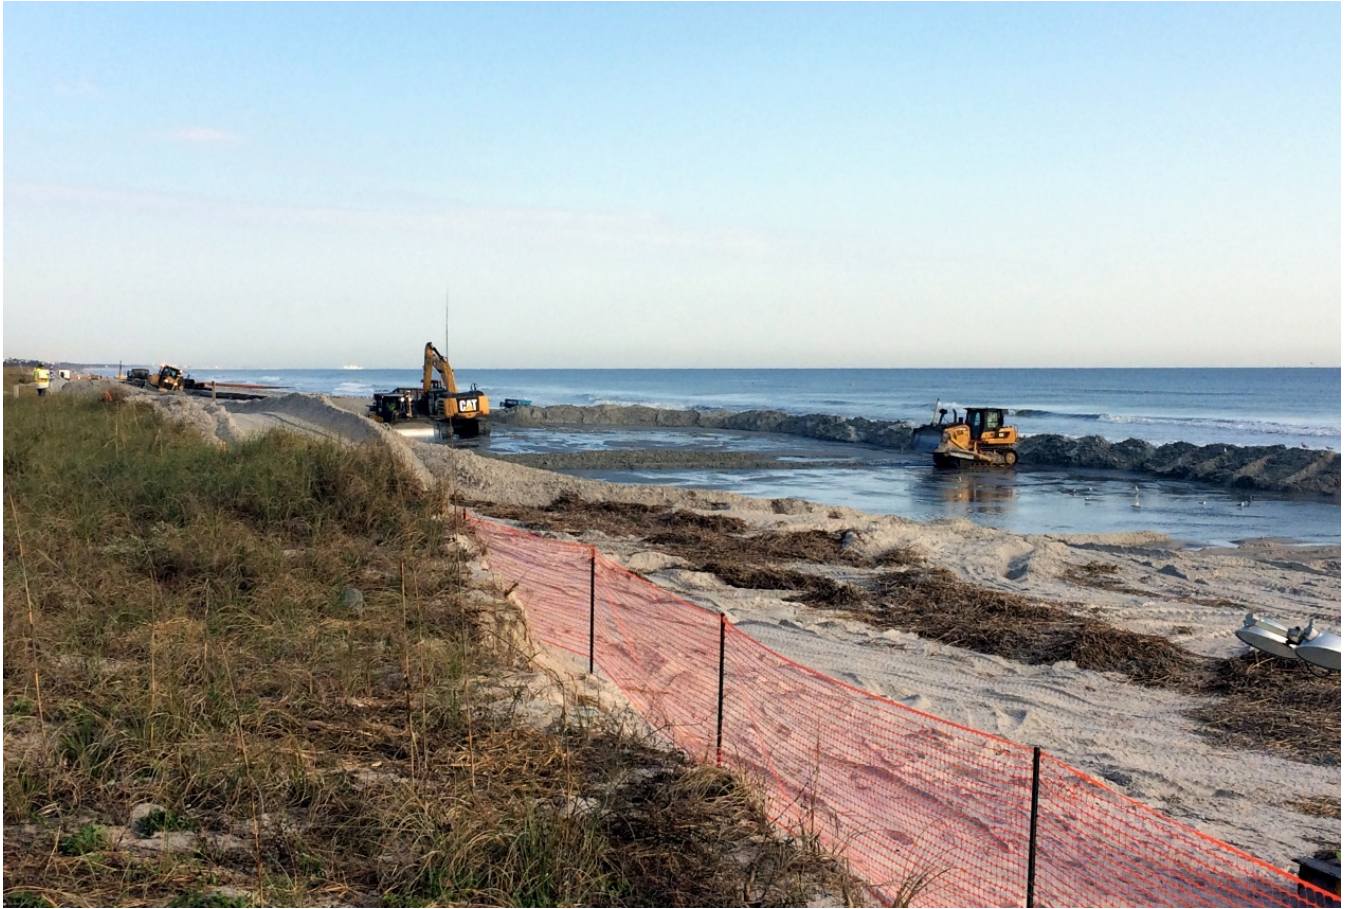
Duval County Shore Protection Project under construction in November 2016.  
Photo courtesy of Kevin Bodge, P.E.

This is a 10.1-mile segment of critically eroded beach from the southern jetty of the St. Johns River entrance southward to the Duval–St. Johns County line, and the project history for this segment of shoreline is described in Table 3. The federally authorized Duval County Shore Protection Project (South Jetty-R31-R80) was initiated in 1977 and completed in 1980, using sand from maintenance dredging of the river entrance and from an offshore borrow area. Nourishments occurred in 1985, 1986, 1987, 1991, and 1995. In 2003, nourishment began using sand dredged from the river entrance. This work stopped after placement of about 120,000 cy, when it was determined the material contained excessive amounts of shell and clay, and was therefore not suitable for placement on the beach. The project was reinitiated and completed in 2005 using material from an offshore borrow area. Work included repair of 8,500 feet of dunes located between R-43 and R-80. In the 2011 nourishment, 689,015 cy of material was placed along Duval County’s Atlantic shoreline. The project design consists of a beach berm at elevation +8 ft NAVD to protect the existing dune and upland development. The project is authorized until 2028. The next nourishment was planned for the fall of 2016 to place approximately 776,000 cy of material along most of Atlantic Beach, all of Neptune Beach, and all of Jacksonville Beach. There were construction delays due to Hurricane Matthew, and additional post-storm work was completed in May 2017 with placement of approximately 222,088 cy. An additional approximately 193,000 cy of material was used for dune restoration. Due to Hurricane Irma, the next beach nourishment construction event is scheduled for the winter of 2018/2019. Beach placement of material in the amount of approximately 809,300 cy for the beach berm and 69,200 cy for the dune from an offshore borrow area.
