**LAKE SEMINOLE
2011 STATE OF THE LAKE REPORT
FOR THE LAKE SEMINOLE WATERSHED
REASONABLE ASSURANCE PLAN**

July 2011

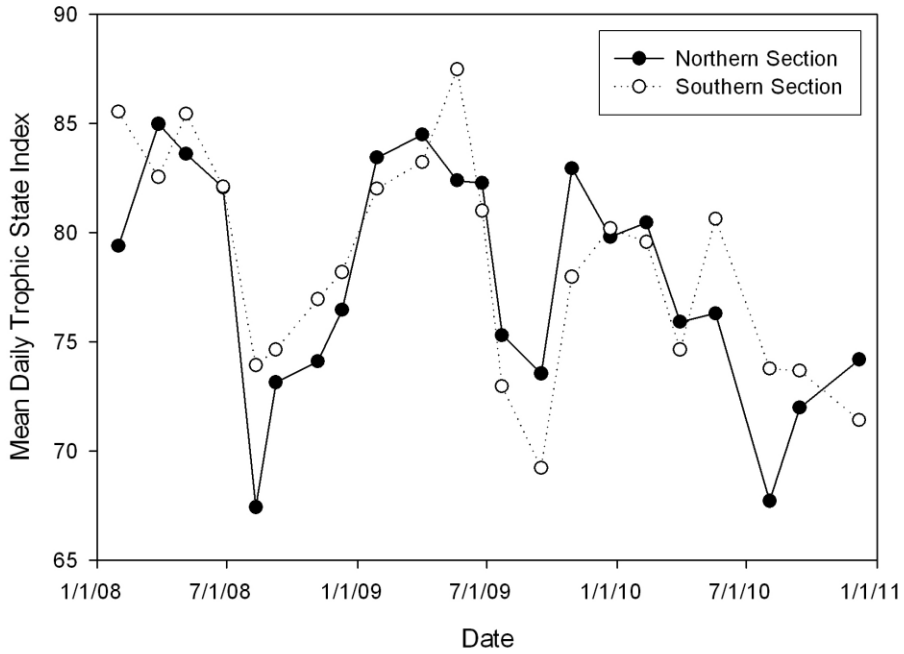
Figure 1 – Lake Seminole Mean Daily TSI

Since 2008, Lake Seminole has demonstrated a clear decline in TSI (Figure 1). There is also been a significant decrease in mean annual Chlorophyll-a (Figure 2). Both trends are very apparent when looking at longer term data and are also supported by increasing secchi depths observed in 2010 compared to previous years.

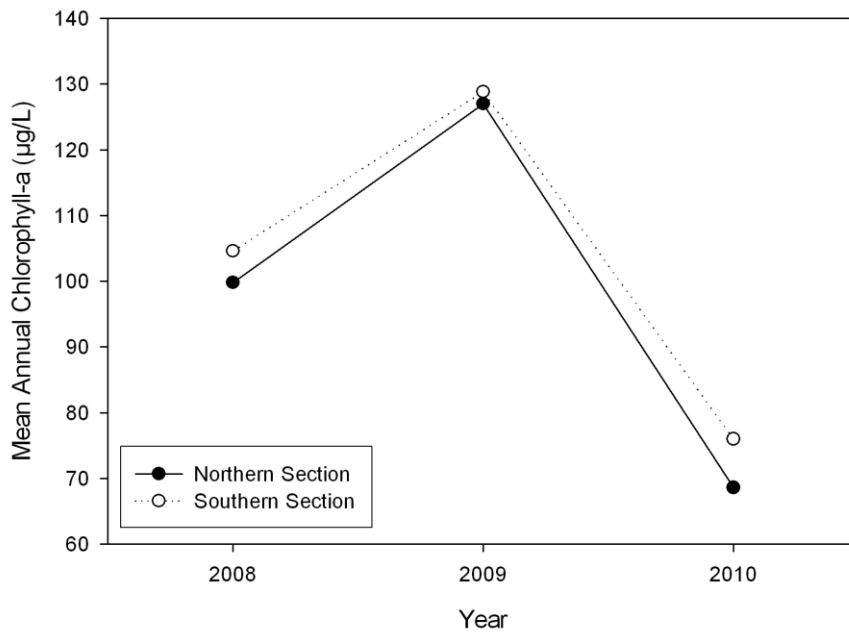
Figure 2 – Lake Seminole Mean Annual Chlorophyll-a
