Hurricane Irma Post-Storm Beach Conditions and Coastal Impact in Florida

**Division of Water Resource Management
Florida Department of Environmental Protection**

April 2018

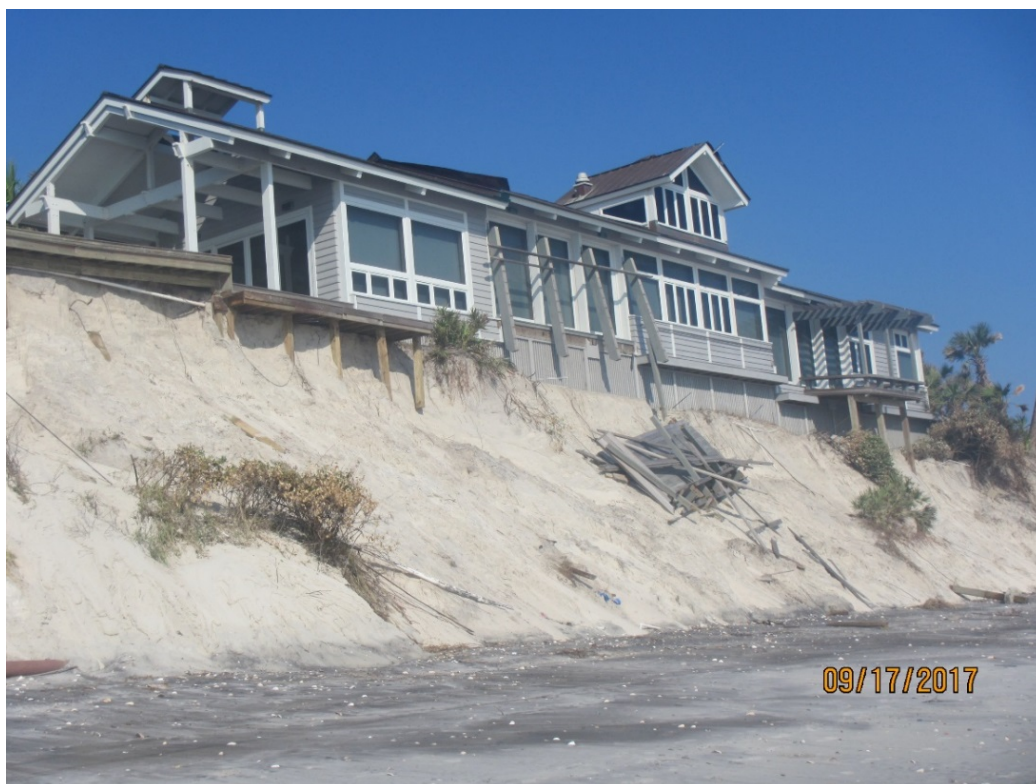
Irma's impact along the northern coast of St. John's County (R1-R118) north of St. Augustine Inlet was particularly severe, resulting in 115 buildings being left in imminent danger of incurring damage from another major storm (see Figure 9 and Figure 10). Example profiles of the major beach and dune erosion are shown in Figure 11 at R28 in Ponte Vedra and in Figure 12 at R94 in South Ponte Vedra adjacent to three destroyed single-family dwellings. South of St. Augustine Inlet, major beach and dune erosion (condition IV) was sustained along Anastasia Island State Park (R123-R140). Along the developed segment of Anastasia Island (R140-R193), including St. Augustine Beach, Crescent Beach and Matanzas Shores, the island sustained moderate to major beach and dune erosion (condition III to IV). Major beach and dune erosion is shown in Figure 13 at R142 in St. Augustine Beach adjacent the St. Augustine Beach

Figure 10. Major dune erosion threatening structure at R27.6, Ponte Vedra.

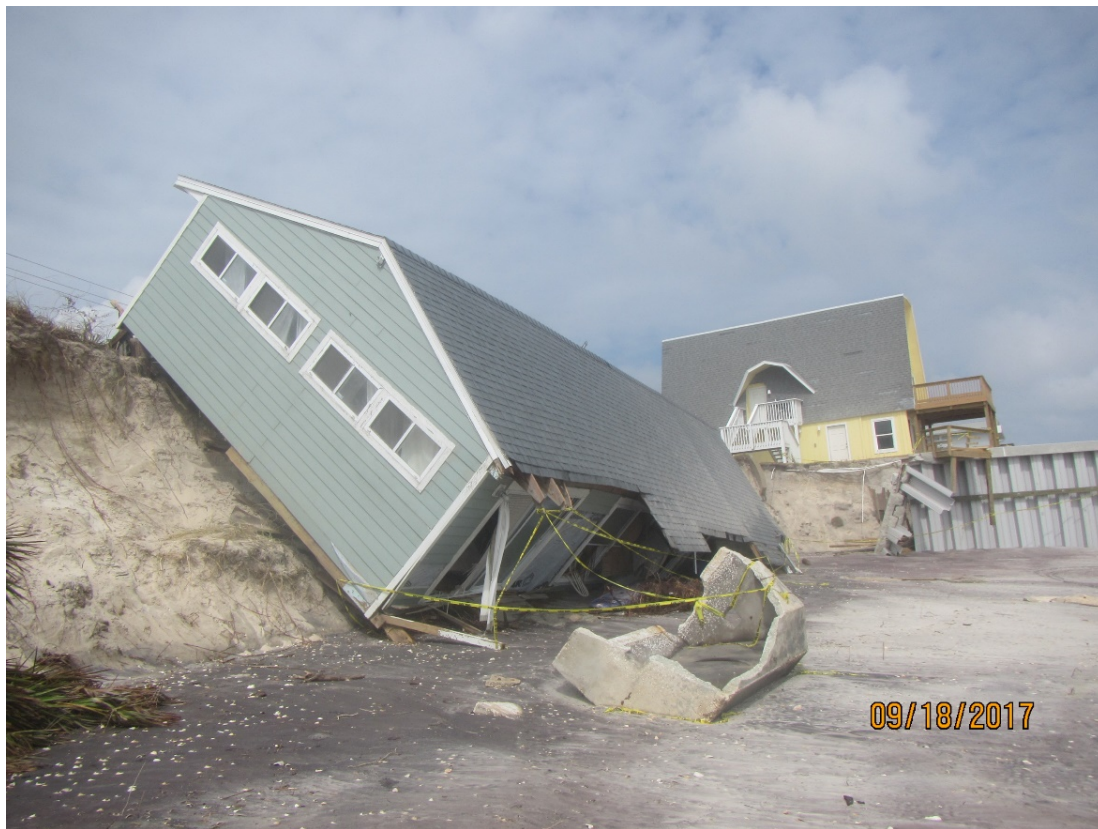
Figure 15. Single-family dwelling destroyed at R110, Vilano Beach.

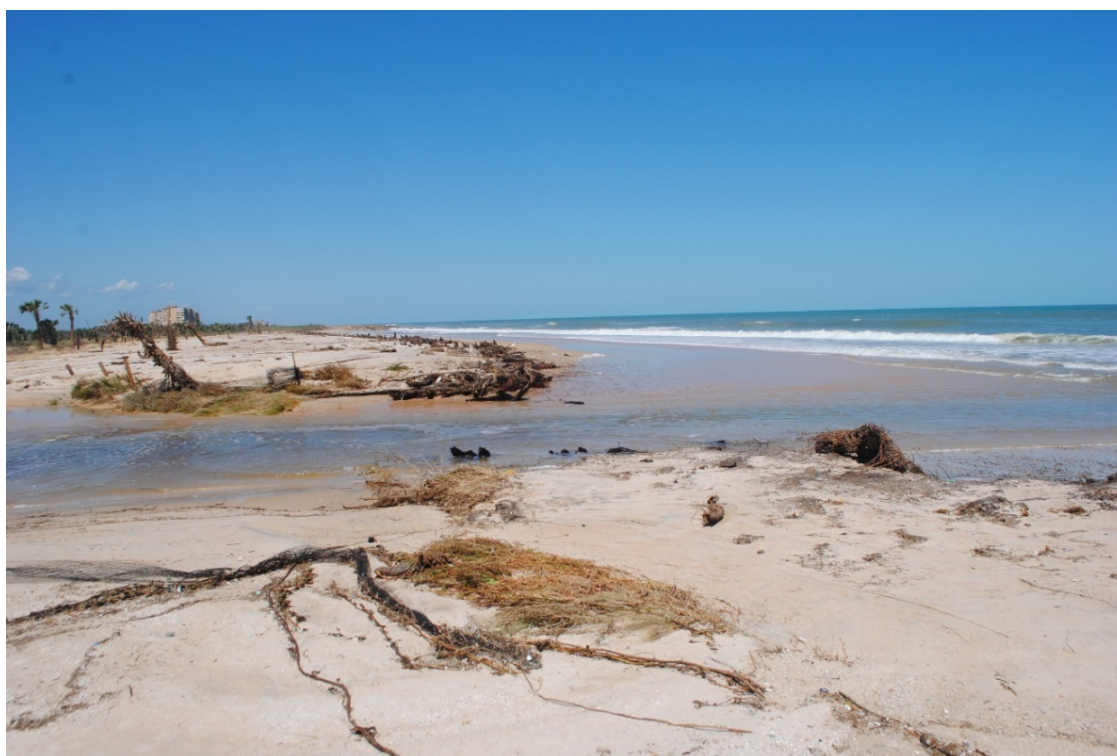
Figure 21. Dune breach by storm surge of Irma, Washington Oaks State Park, R14.5.

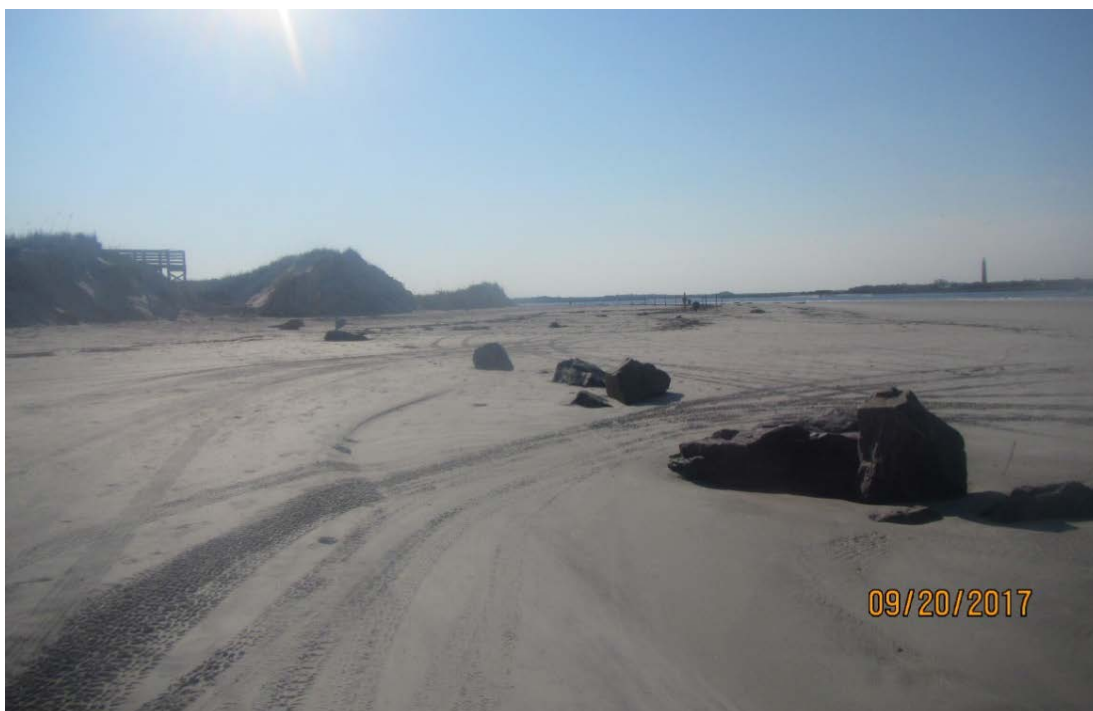
Figure 26. South jetty breach and overwash into Ponce de Leon Inlet (looking northwest), R149.

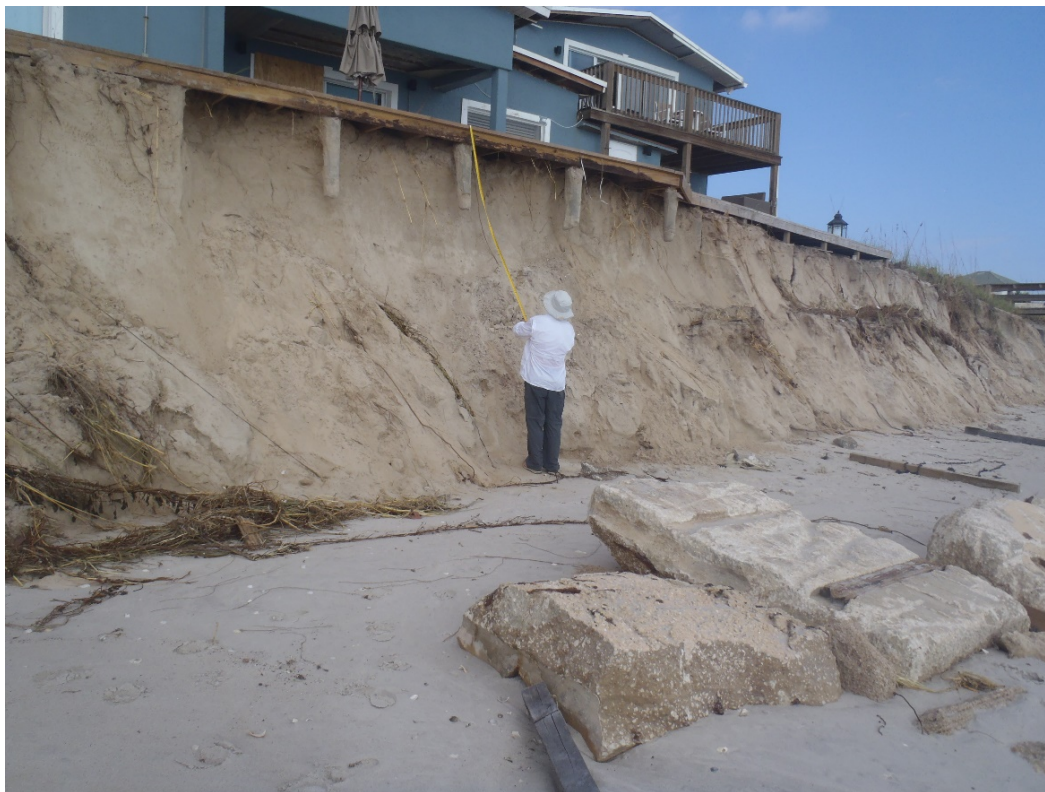
Figure 31. Major dune erosion at Shell Street, Indian Harbour Beach, R97.

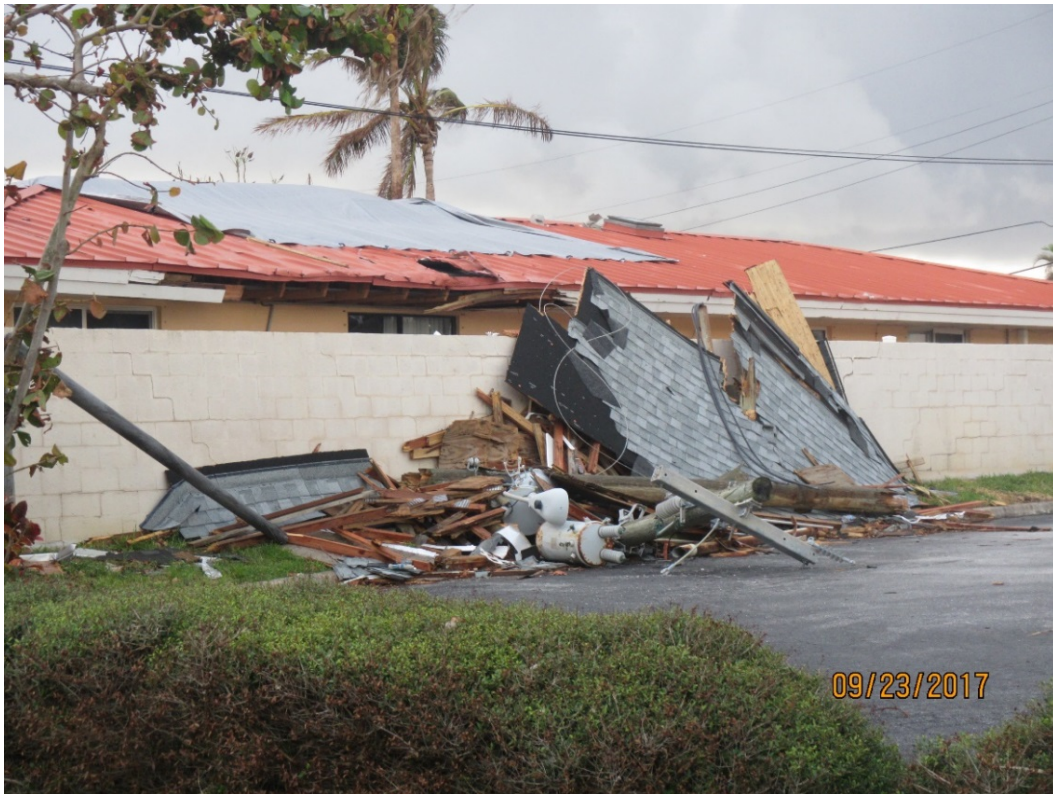
Figure 33. Condominium roof section blown across State Road A1A onto single-family dwelling by tornado at R122, Indialantic.

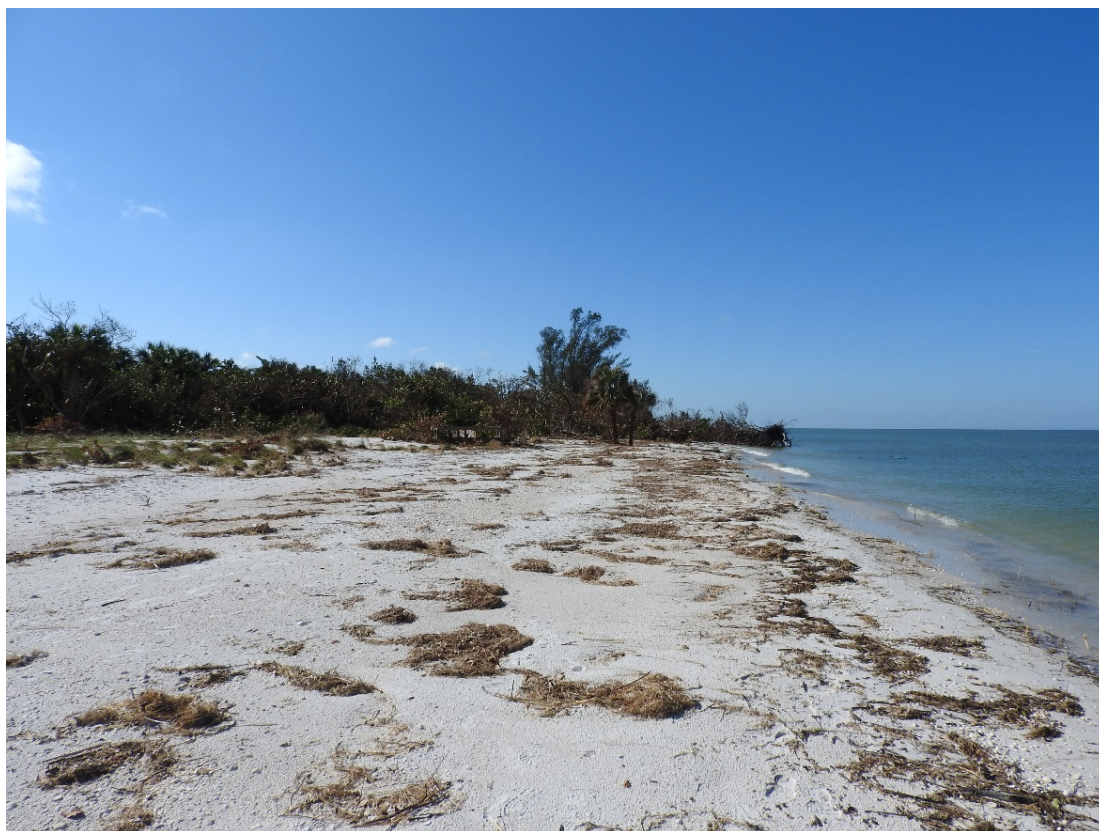
Figure 39. Major beach and dune erosion near R17 south of Wiggins Pass looking south.

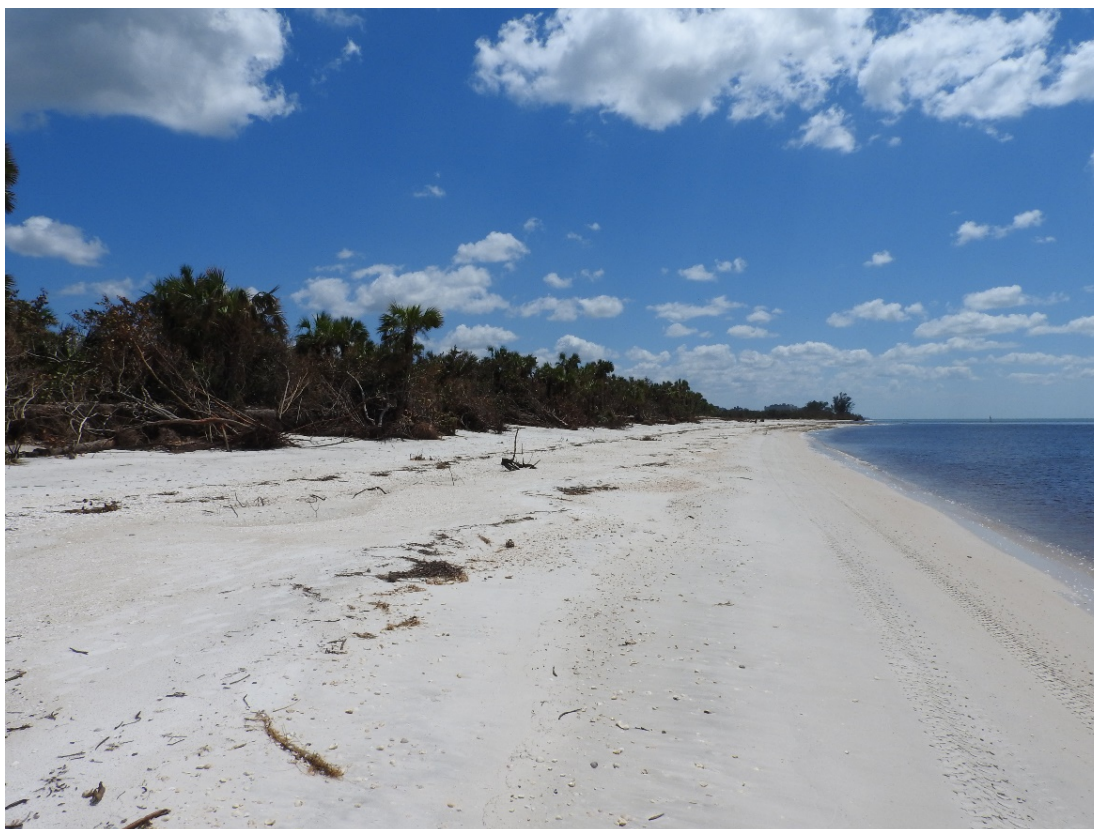
Figure 40. Major beach and dune erosion near R15 north of Wiggins Pass looking south.

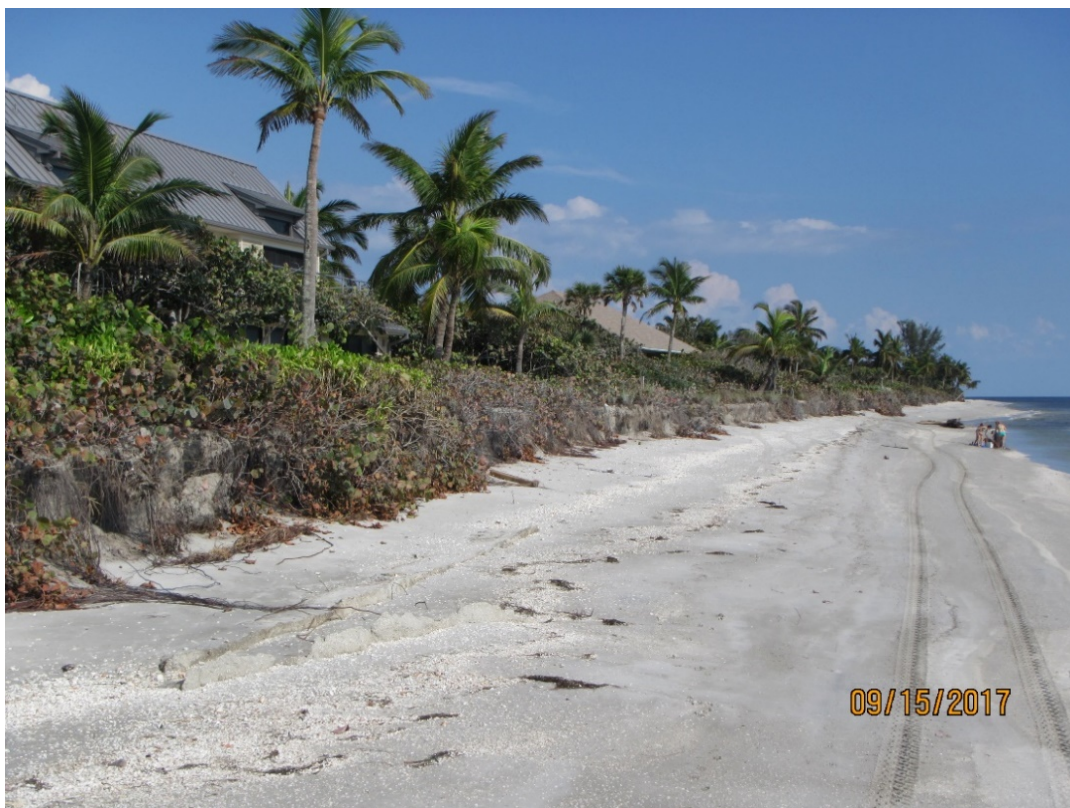
Figure 46. Erosion at the southern end of Sanibel Island near R131.

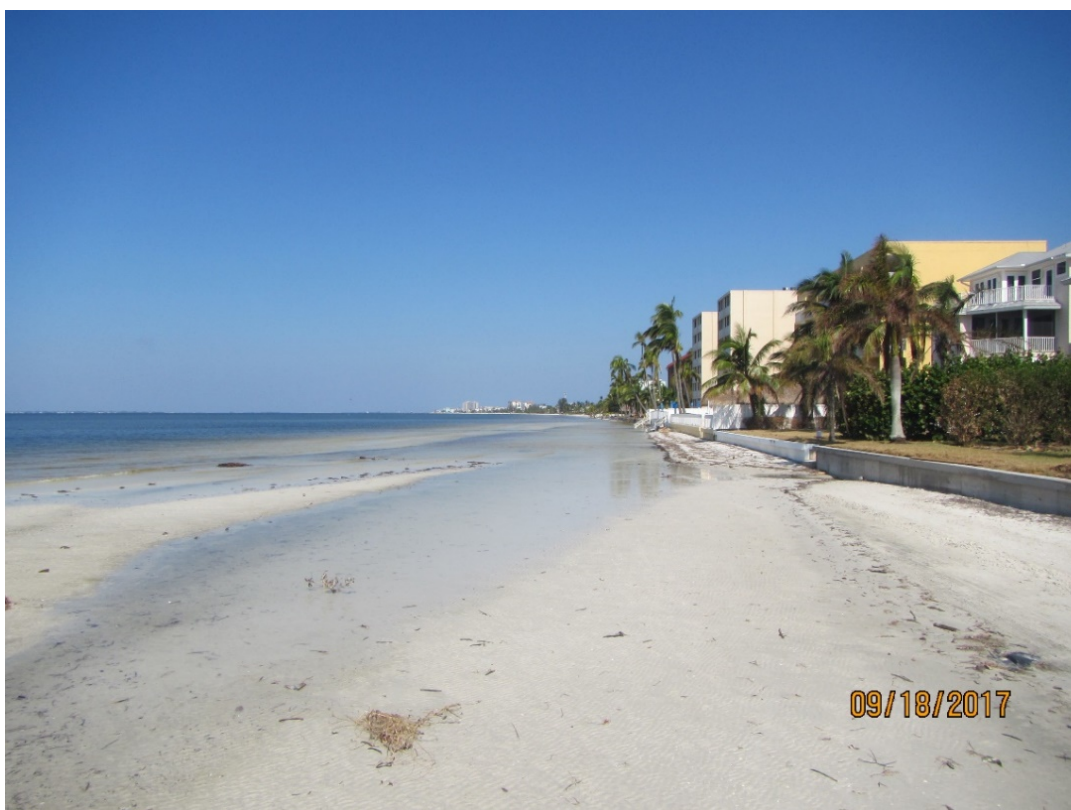
Figure 47. Erosion at Fort Myers Beach near R194.

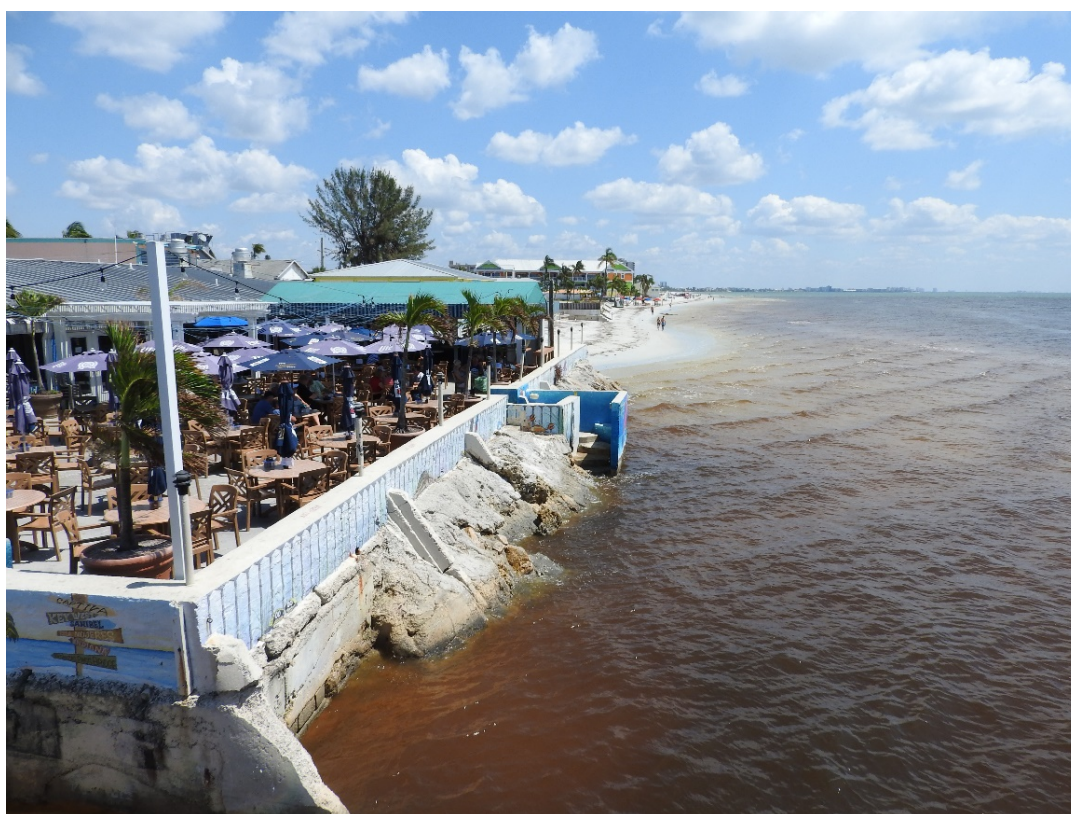
Figure 48. Erosion south of the Fort Myers Beach Pier near R180.

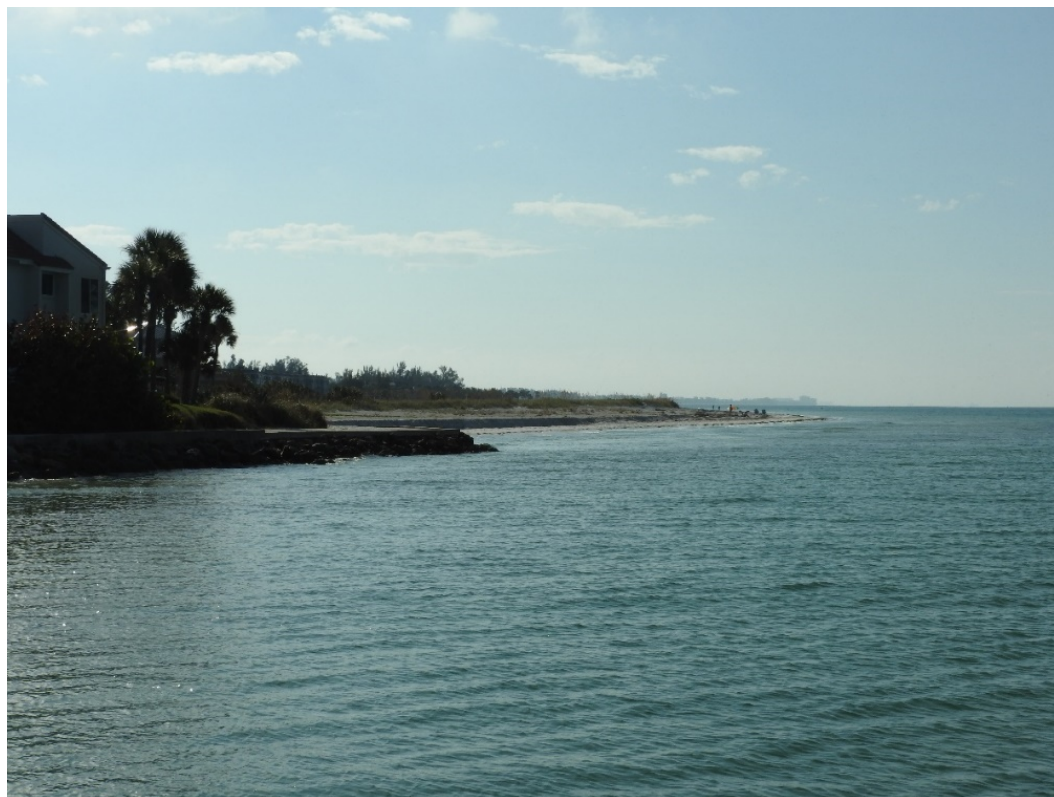
Figure 59. The northern end of Longboat Key had severe erosion between R43 and R45.

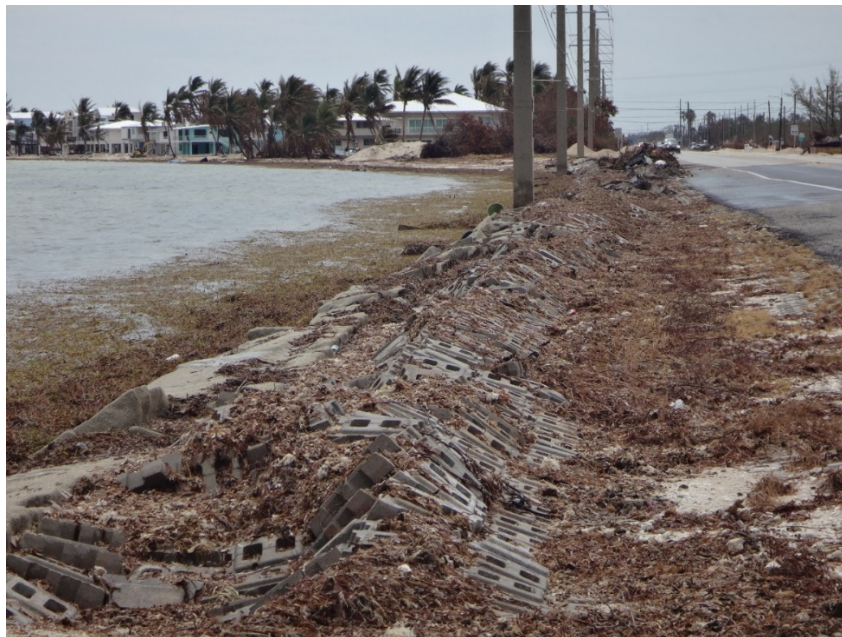
The 4.5-mile long Lower Matecumbe Key, including the community of Islamorada, has approximately 2.8 miles of sand beaches with a width varying between approximately 25 to 50 feet. Along western Lower Matecumbe Key is the 7,000-foot long Sea Oats Beach. The eastern 4,100 feet of Sea Oats Beach fronts on U.S. Highway 1, and 3,700 feet of this public beach segment is designated critically eroded. The western approximately 2,900 feet of Sea Oats Beach fronts private properties consisting of about 30 single-family homes along Sunset Drive. The general trend of net longshore transport along Sea Oats Beach is to the southwest (Clark, 1990), and the beach is anchored by a 350-foot long terminal groin at its western end. Hurricane Irma caused severe erosion along all of Sea Oats Beach, destroying what dune system existed before the storm. Within the right of way along U.S. Highway 1, the Florida Department of Transportation had constructed a dune system with a core of armoring consisting of a concrete block mattress and a concrete slab. These armoring structures were substantially destroyed (level IV damage), along with the dune system (Figure 62). The western end terminal groin sustained minor damage (level II damage). West of Sea Oats Beach and the Calusa Cove Marina is a sandy shoreline of predominantly mangrove. Intermittent sandy beach segments along 2,500 feet of this shoreline is called Anne's Beach. Erosion substantially removed the beach along this segment. All the elevated wooden walkways through the mangrove and along the pocket beaches were destroyed. Throughout Lower Matecumbe Key, widespread wind damage and flooding was sustained by development and infrastructure. Interior water marks observed in a residence at the west end of Sunset Drive appear to reach +9 feet.

Figure 62. *Sea Oats Beach fronting U.S. Highway 1, Lower Matecumbe Key.*

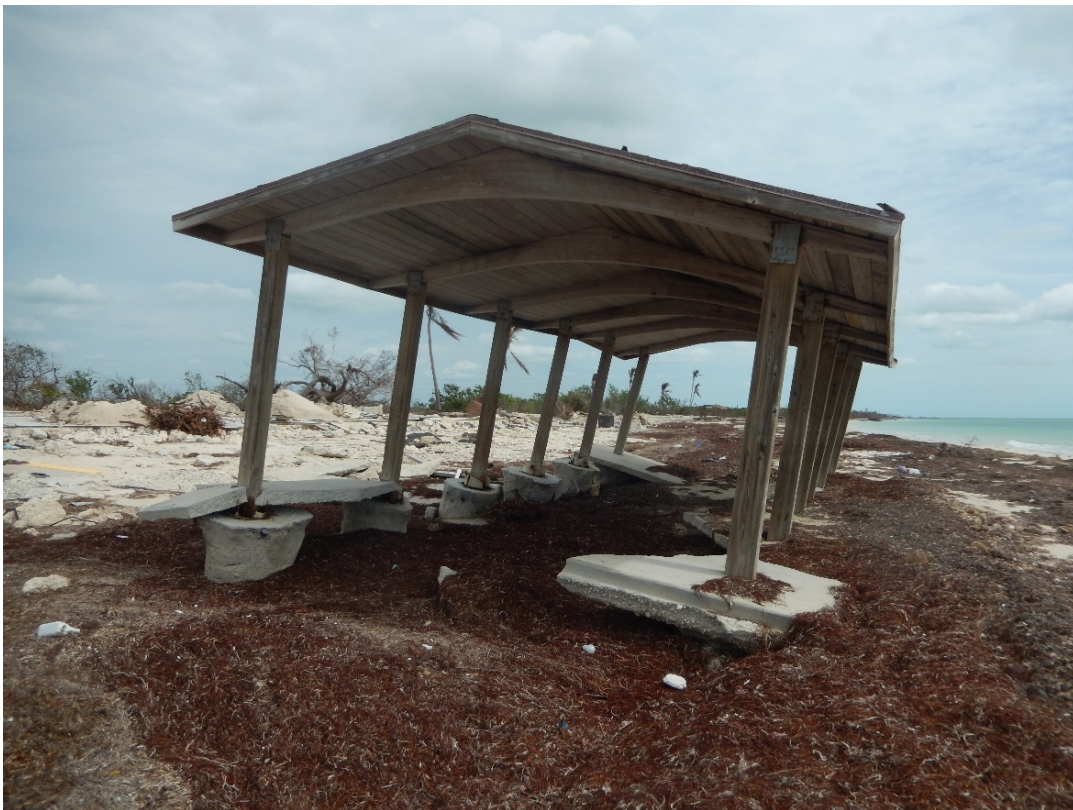
Figure 87. Middle beach pavilion and parking lot destroyed, Sandspur Beach.

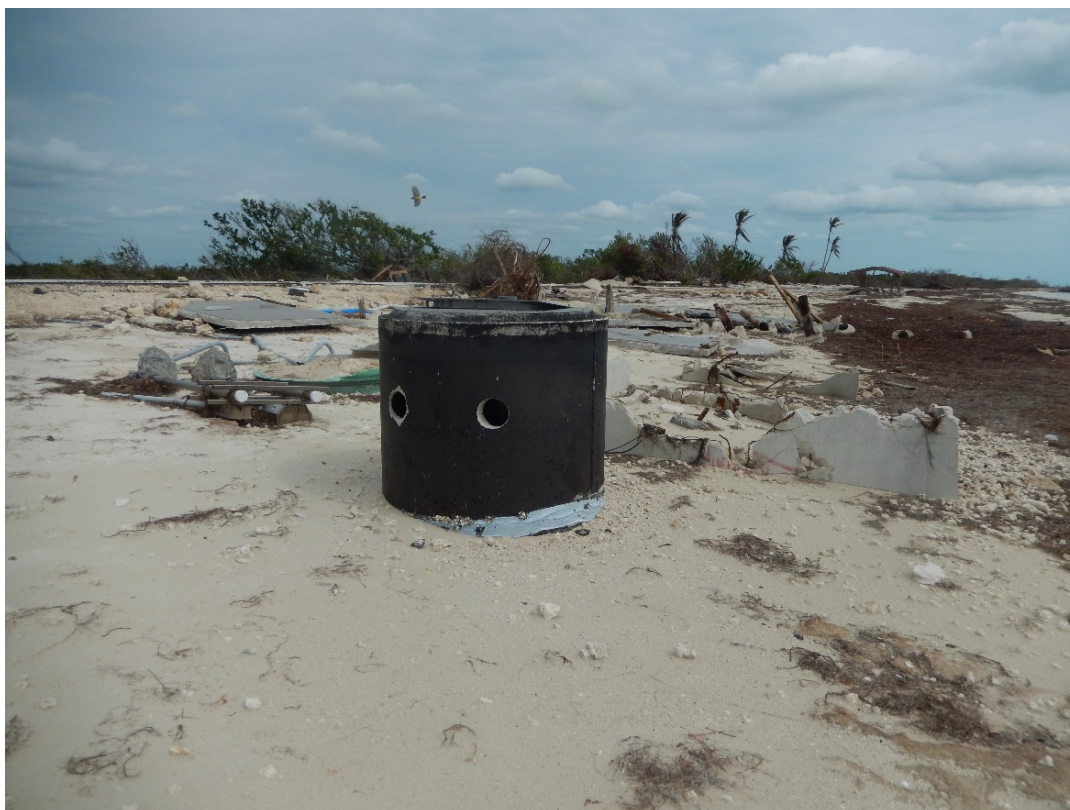
Figure 88. Bathhouse structure totally destroyed, Sandspur Beach.

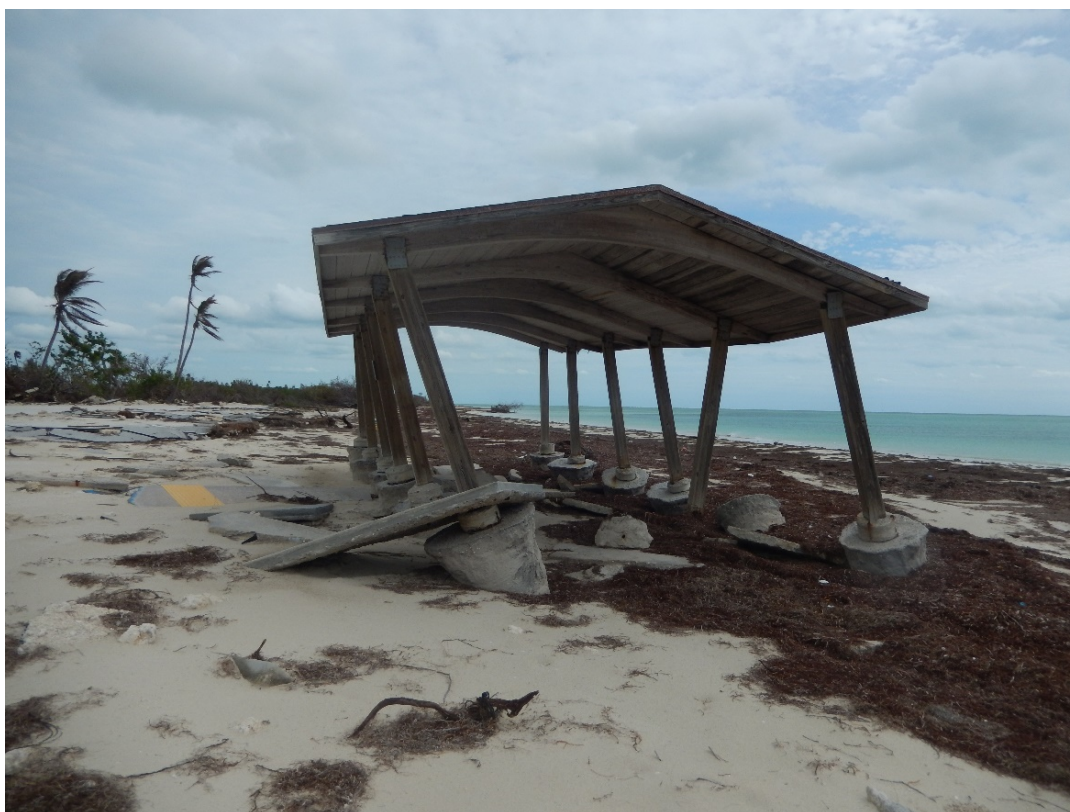
Figure 89. Eastern pavilion structure and parking lot destroyed, Sandspur Beach.

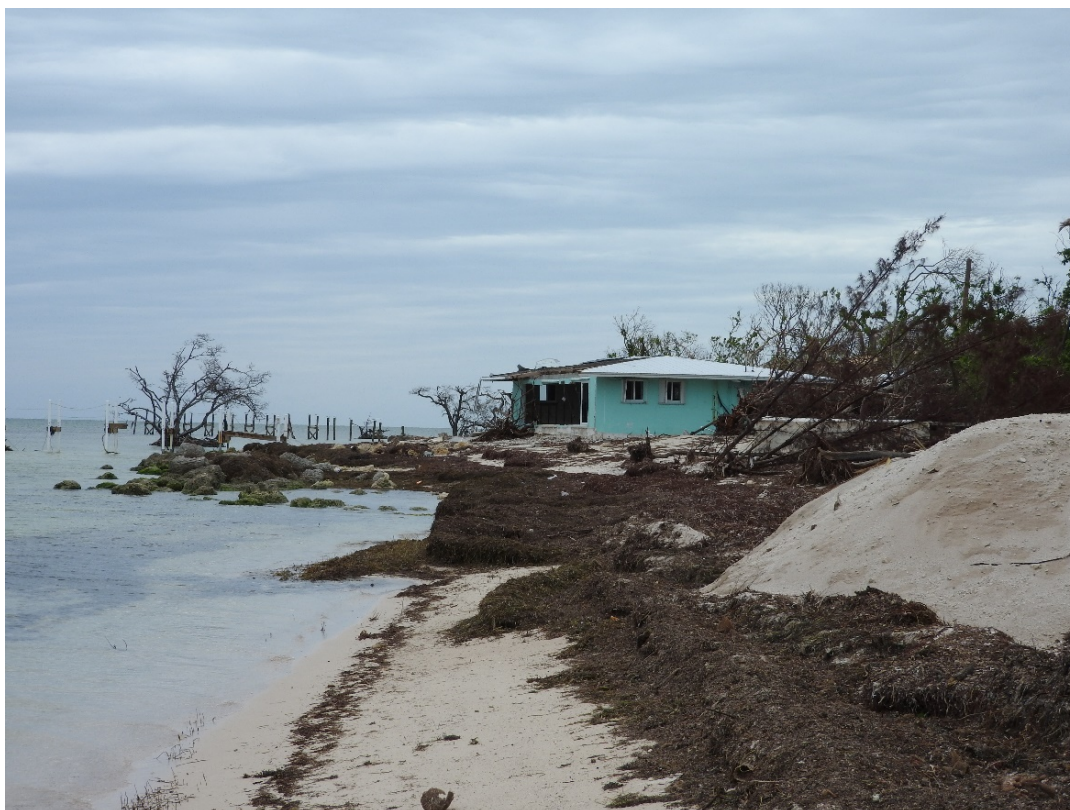
Major beach and dune erosion (condition IV) was sustained along Long Beach (Figure 90). The USGS measured a storm tide of +7.723 feet NAVD inside a dwelling on Long Beach. Damage to development was severe, as four single-family dwellings and six other major structures were destroyed, two single-family dwellings sustained major structural damage to their first floor, and another sustained major structural damage to its second floor (Figure 91, Figure 92 and Figure 93). Many other dwellings sustained understructure damage from the storm surge, and major roof damage due to wind loads. Approximately 400 feet of Long Beach Road was damaged.

Figure 92. Dwelling and dock destroyed, Long Beach, Big Pine Key.

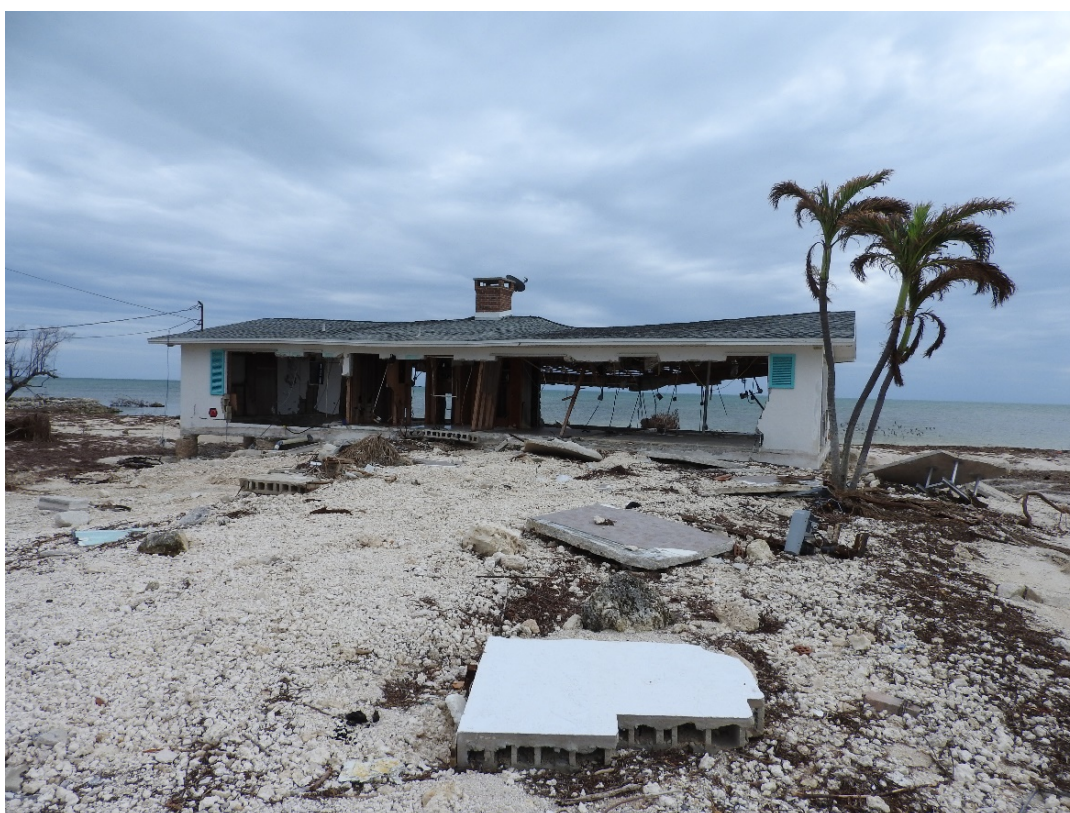
Figure 93. Single-family dwelling destroyed, Long Beach, Big Pine Key.

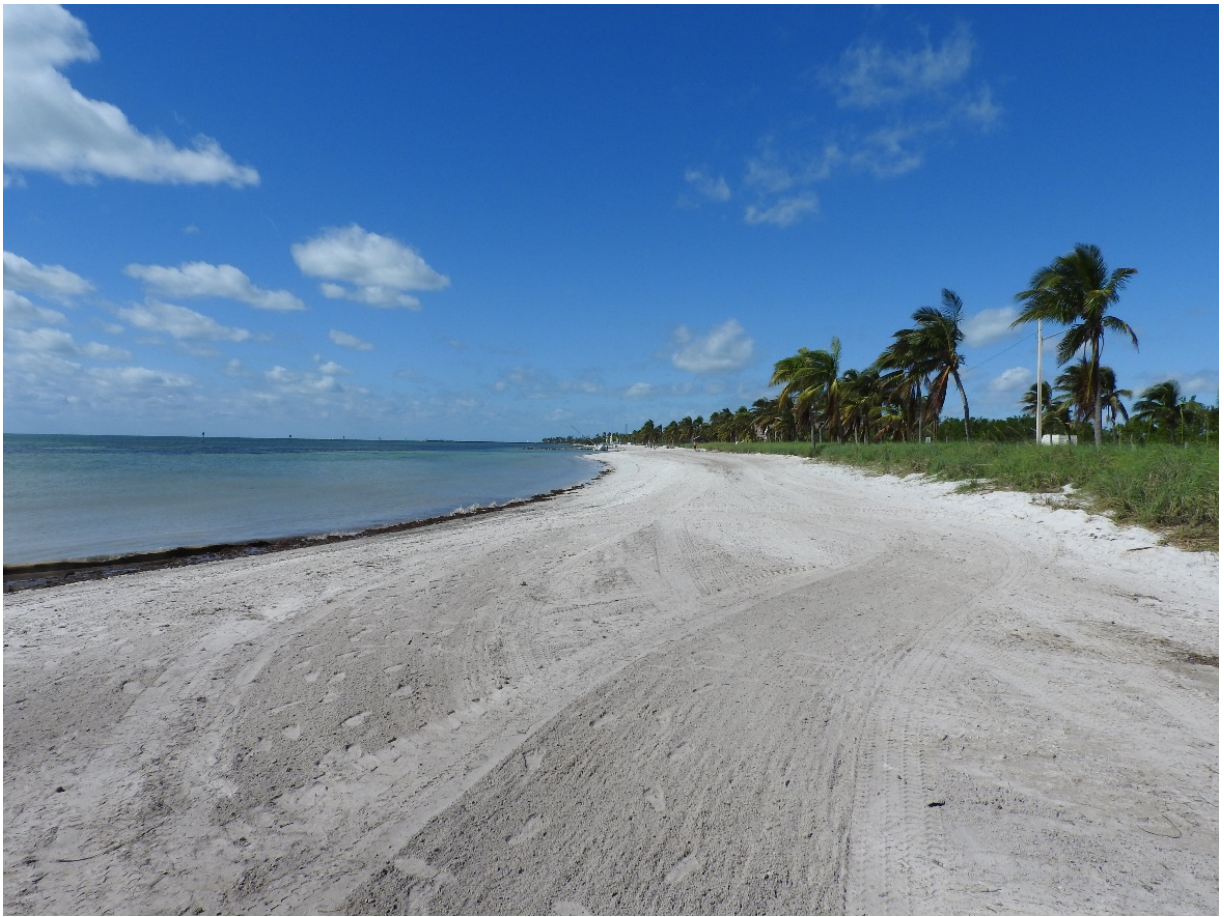
Figure 96. *George Smathers Beach, Key West.*

To the west is the 3,300-foot segment of shoreline named George Smathers Beach, which was originally restored in 1960 and included the construction of four boulder mound limerock groins (200 to 300 feet long) and beach restoration with 30,000 cubic yards of crushed limerock fine-grained sediment. George Smathers Beach was subject to erosion from several storms, and was first nourished with oolitic aragonite material from the Bahamas in 1989 and again with quartz sand trucked in from South Florida in 2000. Minor beach erosion (condition I) was sustained during Hurricane Irma (Figure 96). Surveys by the City of Key West measured a sand volume loss of -1,630 cubic yards (Atkins, 2017).

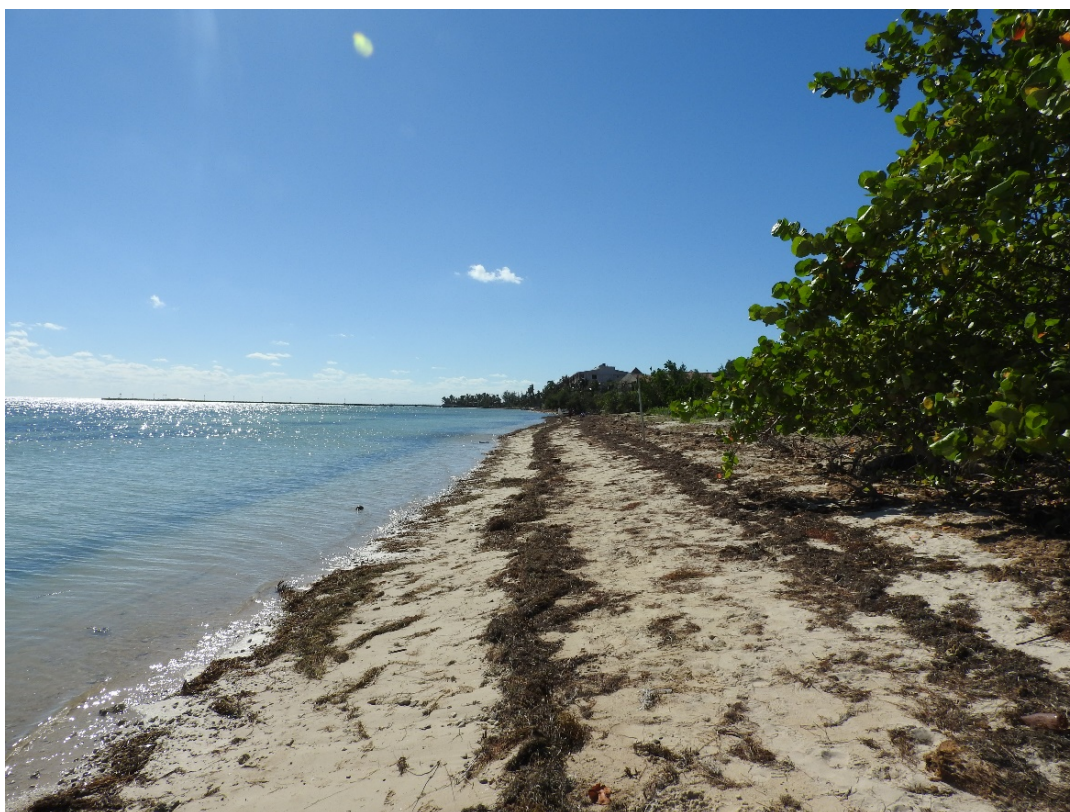
Figure 98. *Berg and Kitsos Beach, Key West.*

rock revetment, which sustained minor damage (level II damage). To the west is a city park along Berg and Kitsos Beach, which experienced minor beach and dune erosion (condition II) to one of the last segments of natural beach on Key West (Figure 98). West of Berg and Kitsos Beach are private properties with seawalls and little to no beach remaining. To the west of these private properties is a 660-foot city park called Rest Beach. A wide beach prior to the hurricane of 1944, Rest Beach was adversely affected by the White Street Pier construction in the mid-1960s. Rest Beach sustained minor beach and dune erosion (condition II) during Hurricane Irma (Figure 99). Sidewalks and beach access walkways were destroyed.

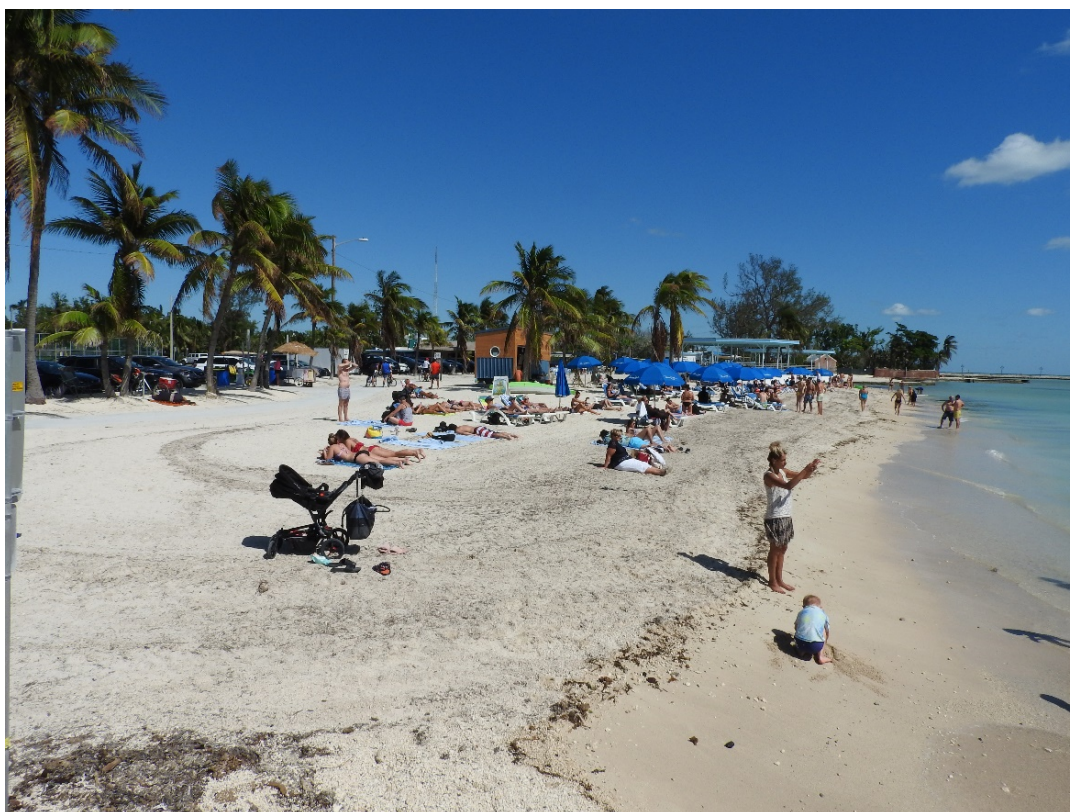
Figure 100. *Clarence Higgs Beach, Key West.*

West of Rest Beach and the White Street Pier is a 1,250-foot segment of Monroe County park known as the Clarence S. Higgs Memorial Beach. Although the gardens within West Martello Tower sustained wind damage, the seawall and revetment along the tower and the eastern segment of Higgs Beach sustained no discernable damage. The unarmored western segment of Higgs Beach experienced minor erosion and needs additional sand (Figure 100).

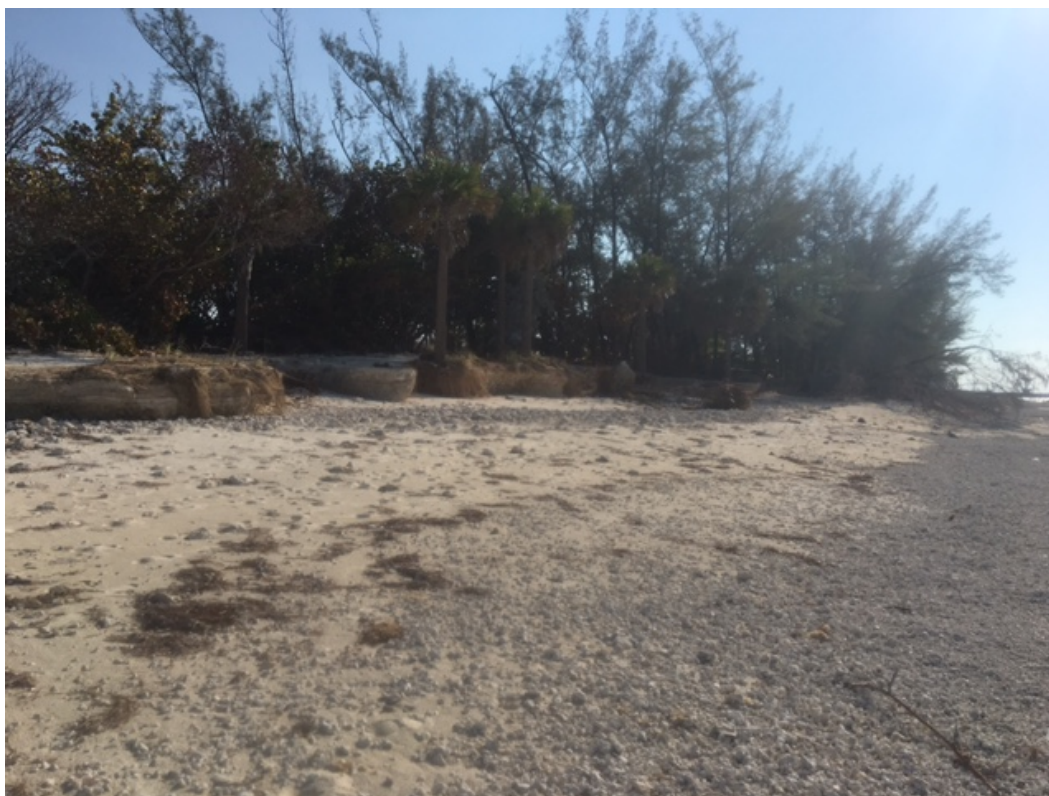
On the southwestern tip of Key West is an area that was built by dredge spoil from the ship channel dredging project of the 1950s. The fill site surrounds the 150-year old Fort Zachary Taylor and includes a 1,500-foot recreational beach within the Zachary Taylor State Park. This beach sustained minor beach and dune erosion (condition II) (Figure 101). In addition, two of the four nearshore boulder mound breakwaters appear to have sustained minor damage (level II damage) (Figure 102). On the northwestern shoreline of Key West at the northern end of Simonton Street is another street-end pocket beach that sustained minor beach erosion (condition I).

Figure 101. Minor beach and dune erosion, Fort Zachary Taylor State Park.
