*Hurricane Michael Post-Storm
Beach Conditions and Coastal Impact Report*

**Division of Water Resource Management
Florida Department of Environmental Protection**

January 2019

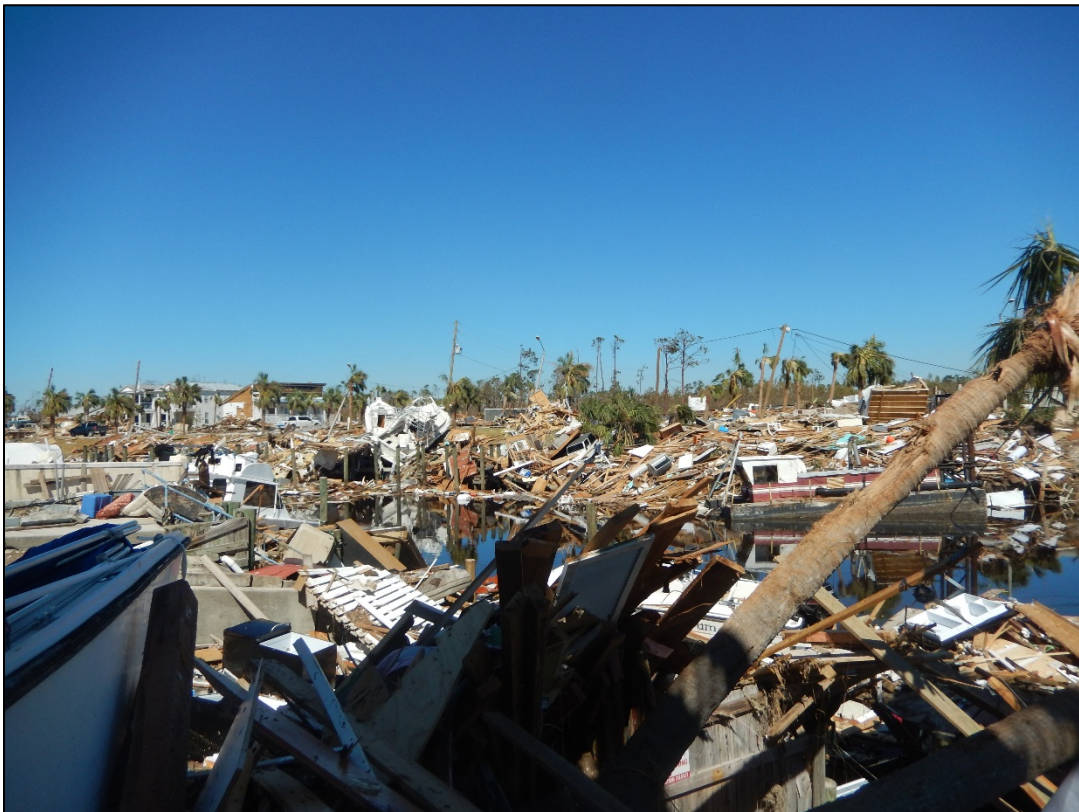
Figure 24. Mexico Beach Canal, R128.

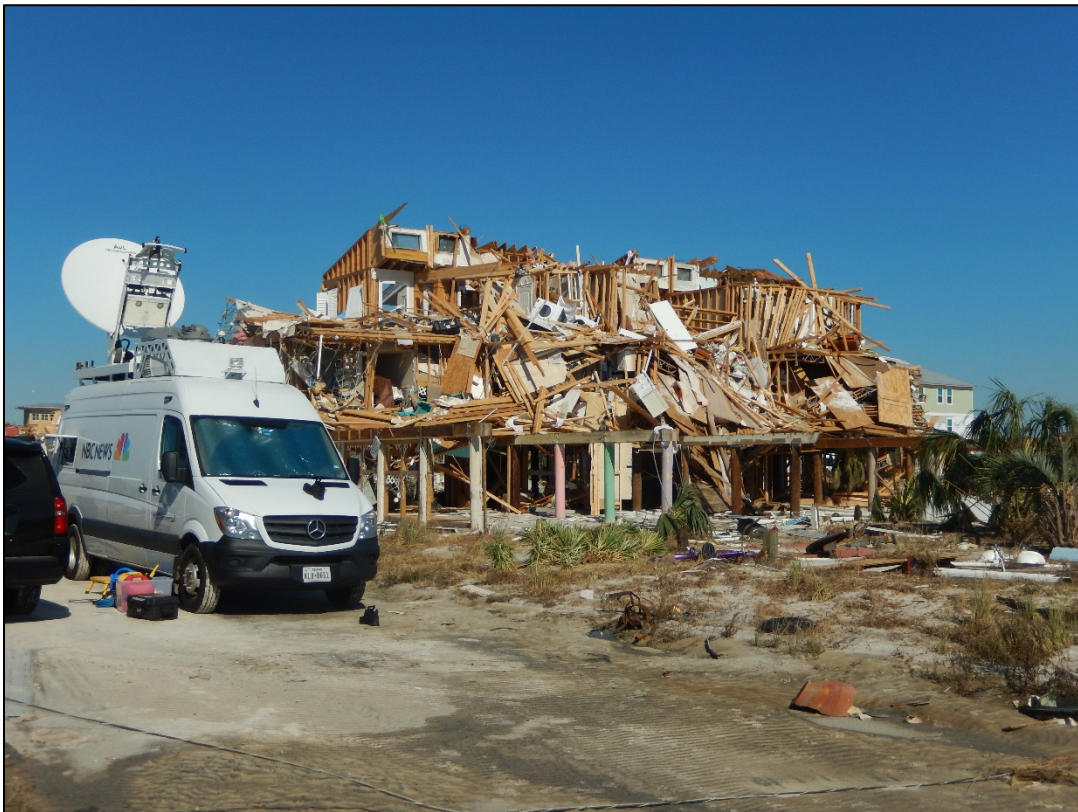
Figure 33. Pile-supported multifamily dwelling destroyed near R129, Mexico Beach.

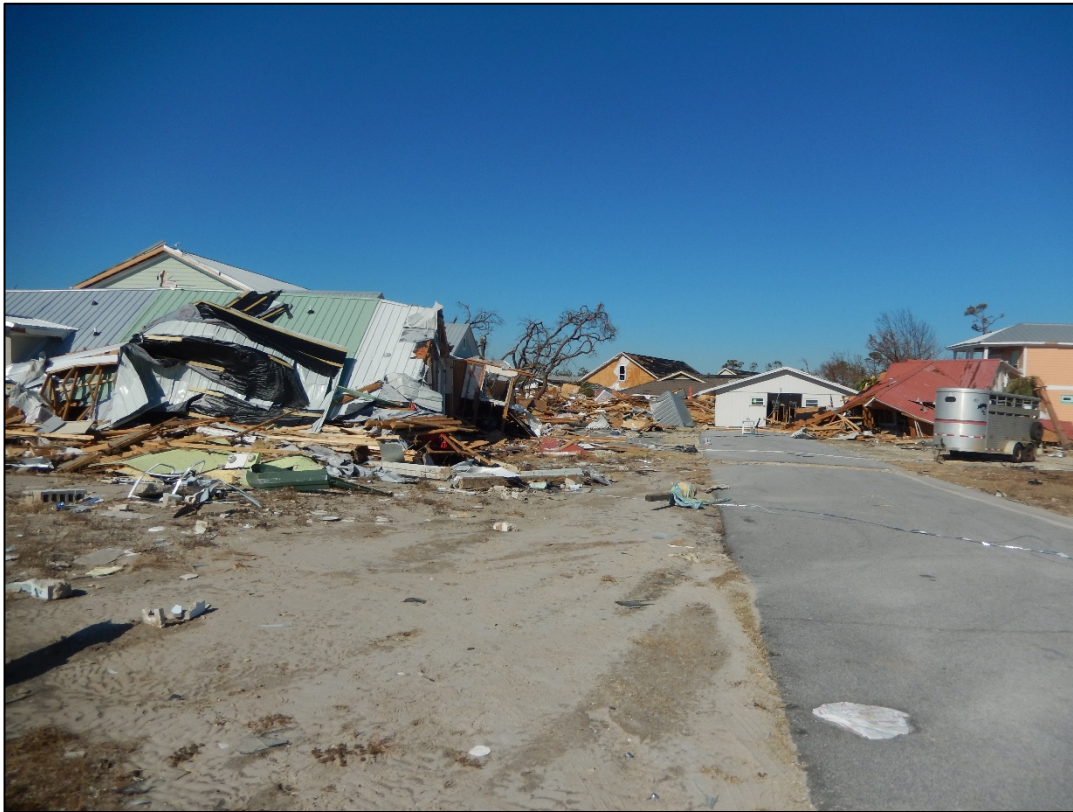
Figure 34. Buildings transported several hundred feet landward by the flood across U.S. 98 and deposited on 15th Street, R130, Mexico Beach.

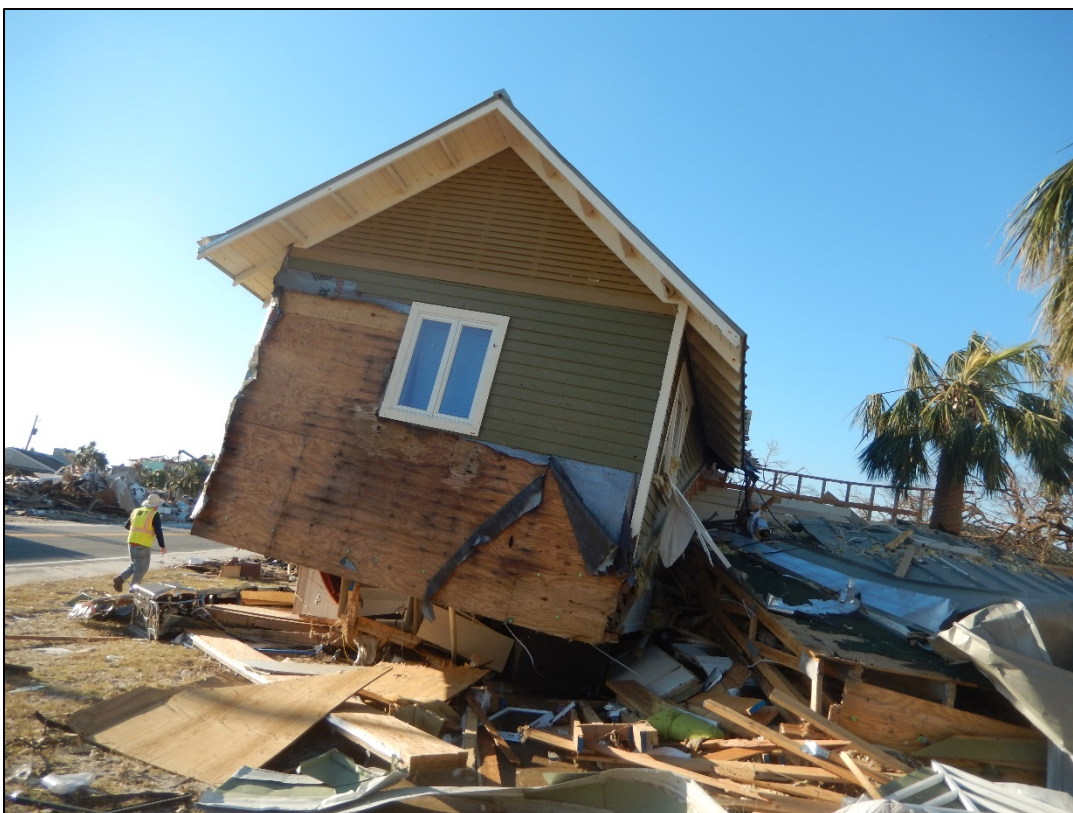
Figure 35. Beach dwelling transported across U.S. 98 by the storm surge, Mexico Beach.

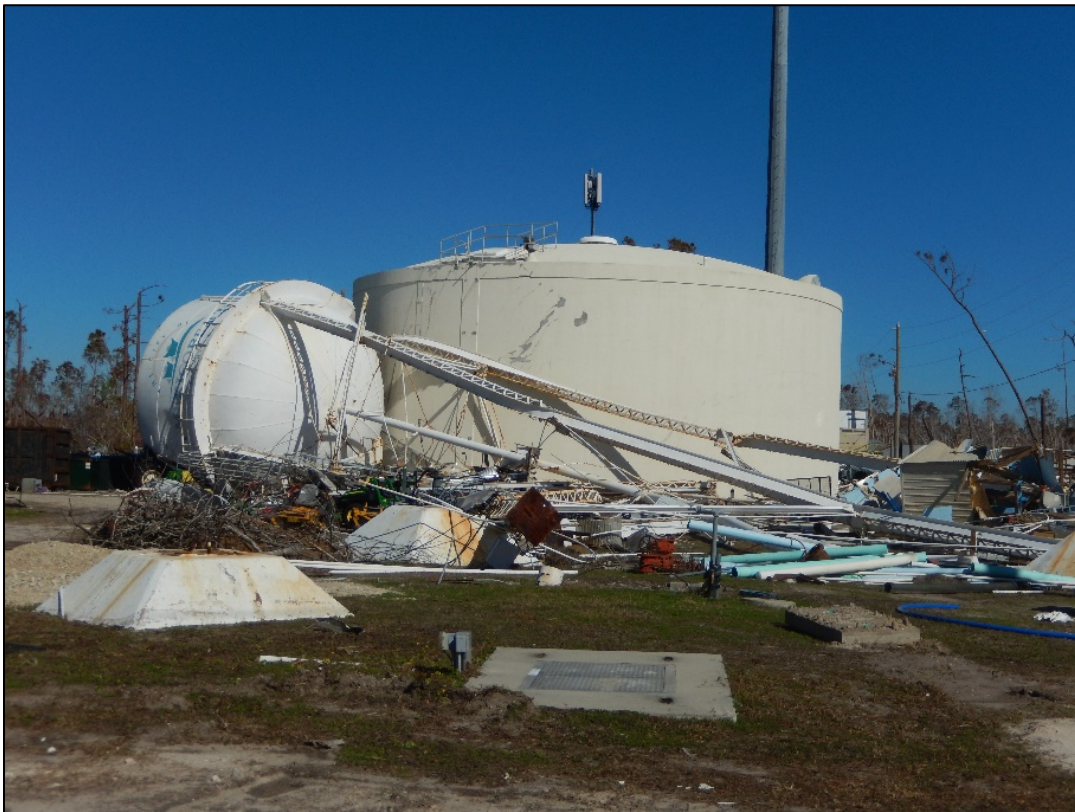
Figure 37. City water tower collapsed under high winds near R134, Mexico Beach.

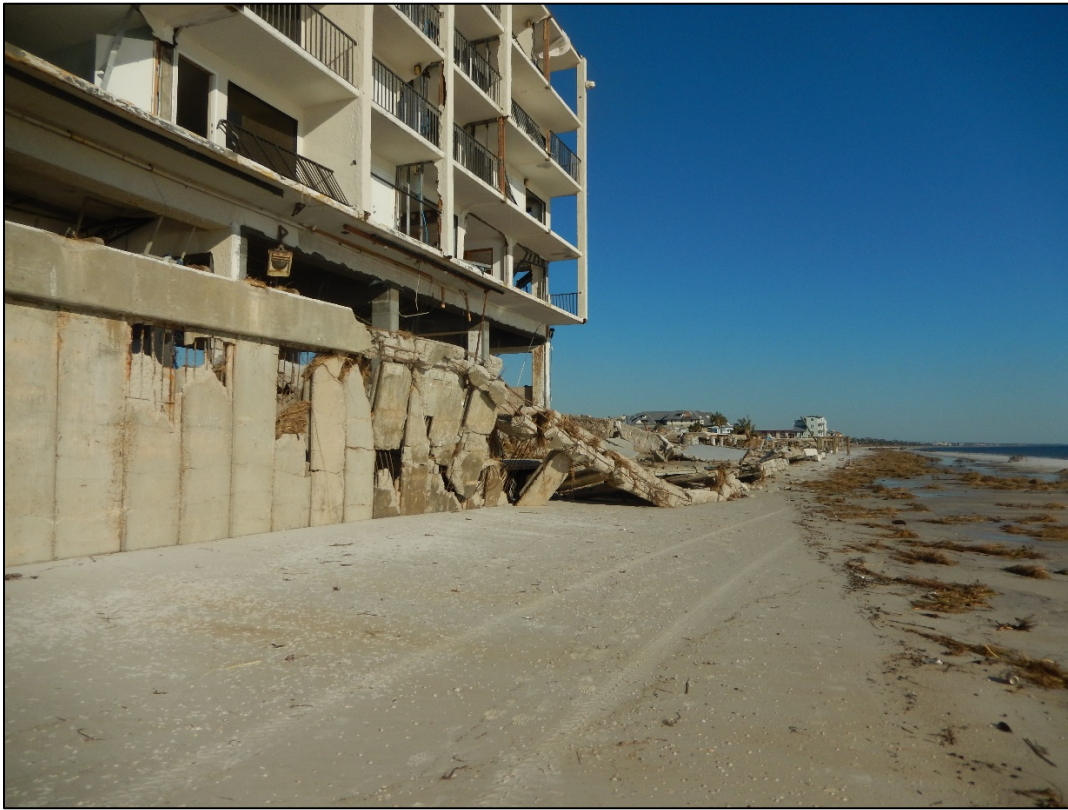
Figure 38. Over 700 feet of reinforced concrete seawall destroyed at R135, Mexico Beach.

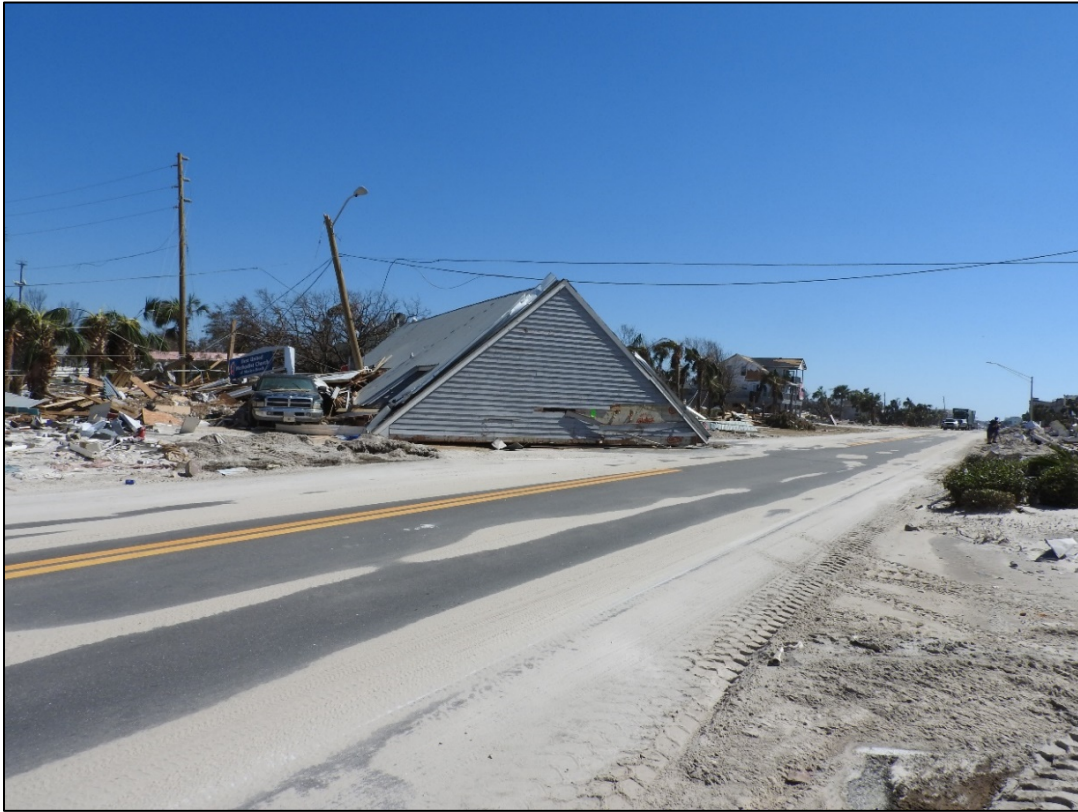
Figure 42. Roof of dwelling transported across U.S. 98 by the storm surge near R138, Mexico Beach.

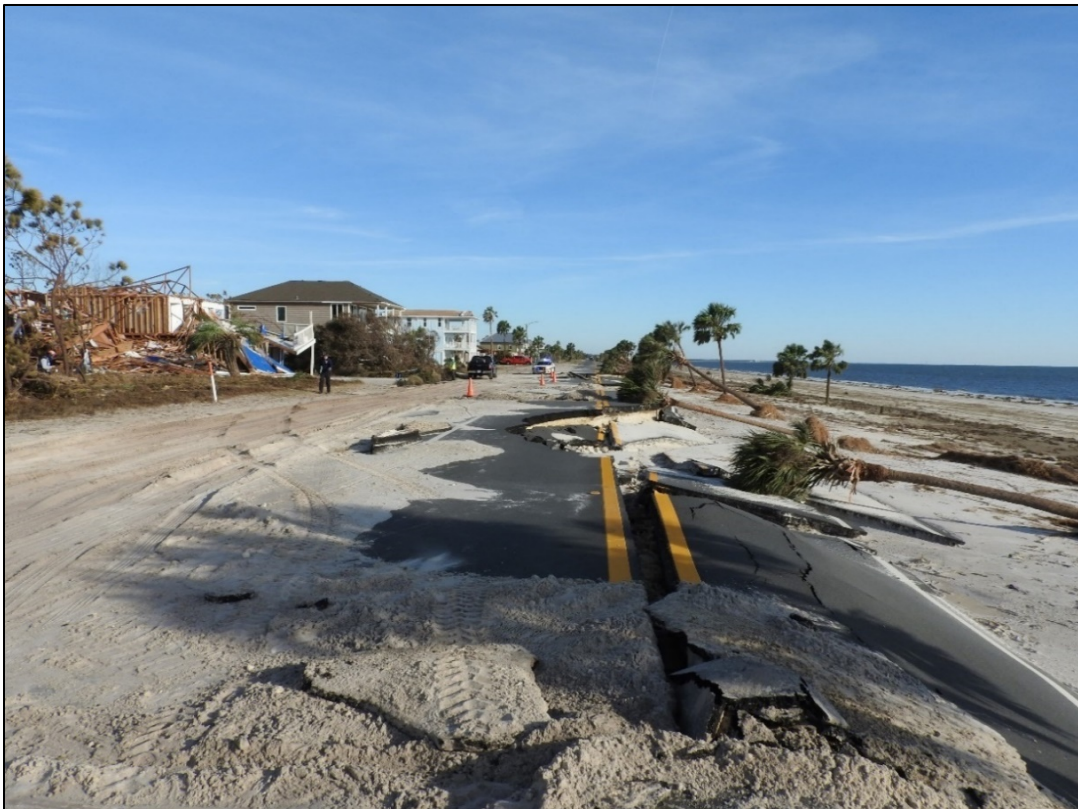
Figure 43. Segment of U.S. 98 destroyed near R139, Mexico Beach.

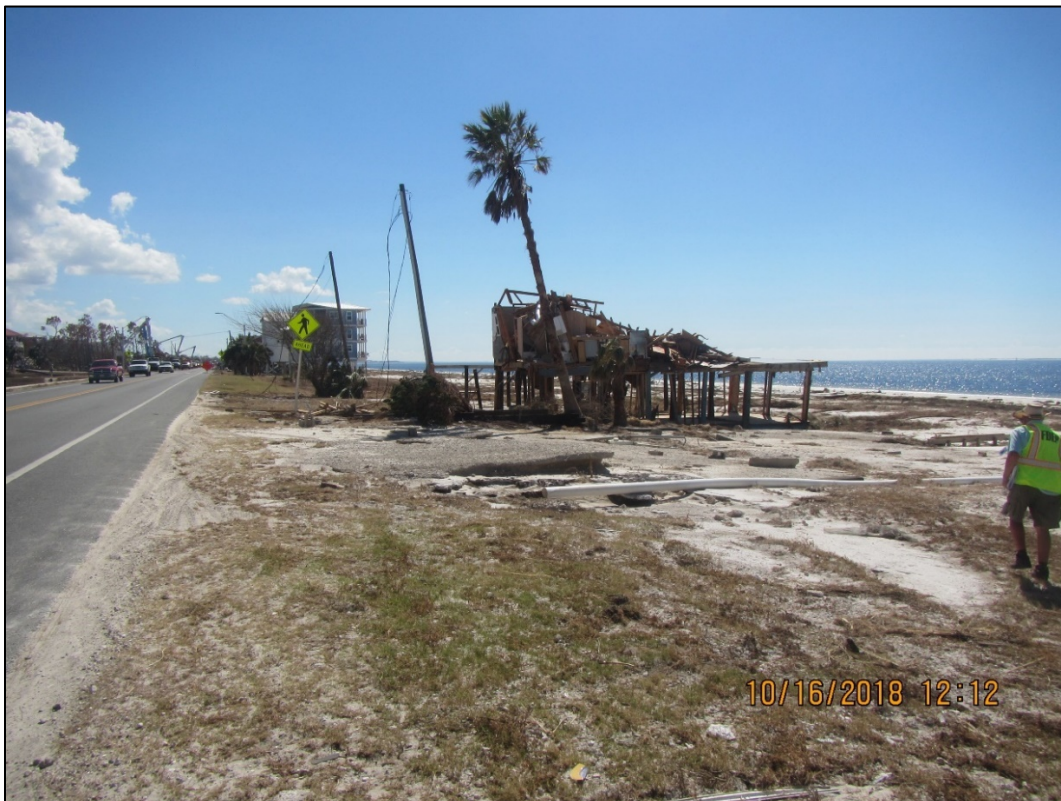
Figure 58. Dwellings destroyed along U.S. 98 near R3.5, Beacon Hill.

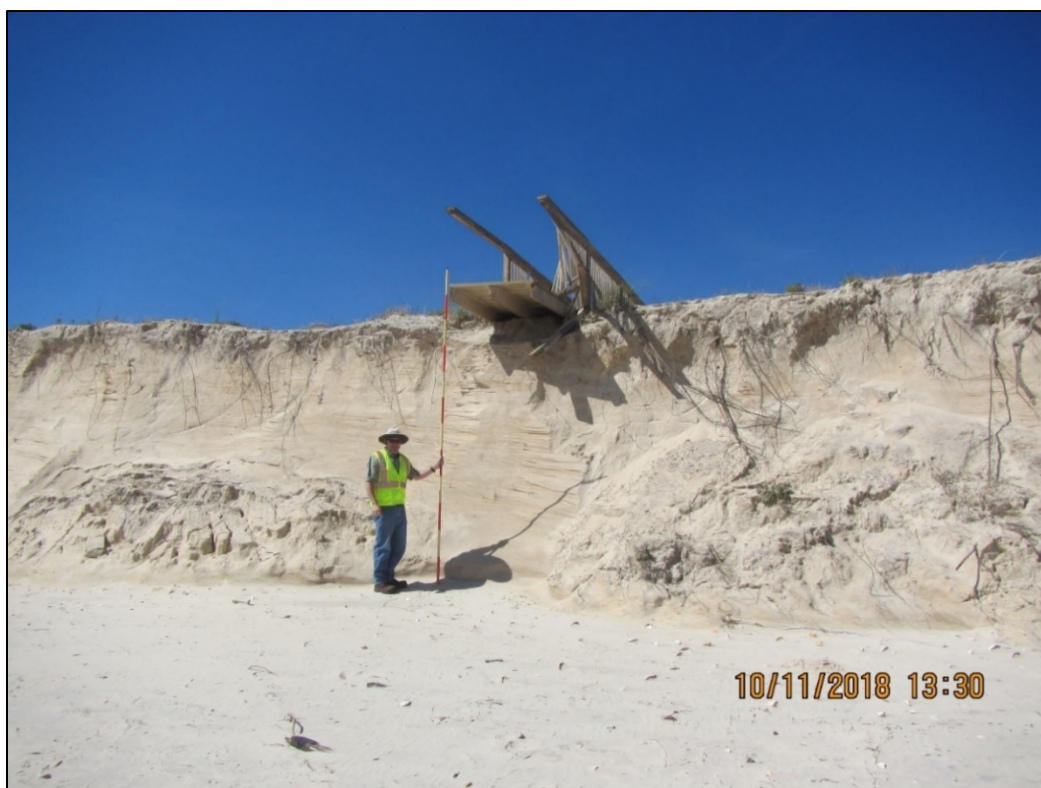
Along St. Vincent Island, Little St. George Island, and St. George Island, major beach and dune erosion (Condition IV) was sustained. Severe dune erosion was sustained at Bob Sikes Cut at R52 (**Figure 83**). Along St. George Island Plantation (R52-R73), the dunes retreated as much as 50 feet (**Figure 84**).

Figure 84. Major dune erosion at R72, St. George Island.

Some of the higher primary dunes now have vertical escarpments as high as 12 to 15 feet. To the east of the St. George Island Plantation, along the central stable beaches of St. George Island between R73 and R99 where low profile foredunes existed, the vegetation line retreated as much as 100 feet and greater, and the low foredunes were completely leveled. Between East Gorrie Drive and East Gulf Beach Drive, generally between R87 and R99, an intermittent inland lake existed after the storm due to both the storm surge and the rainfall (**Figure 85**). These interdunal depressions typically flood during major rain events. Between R99 and R104, behind a higher dune field than to the west, substantial flooding existed along East Gulf Beach Drive. Major dune erosion (Condition IV) was sustained along this area of residential development.

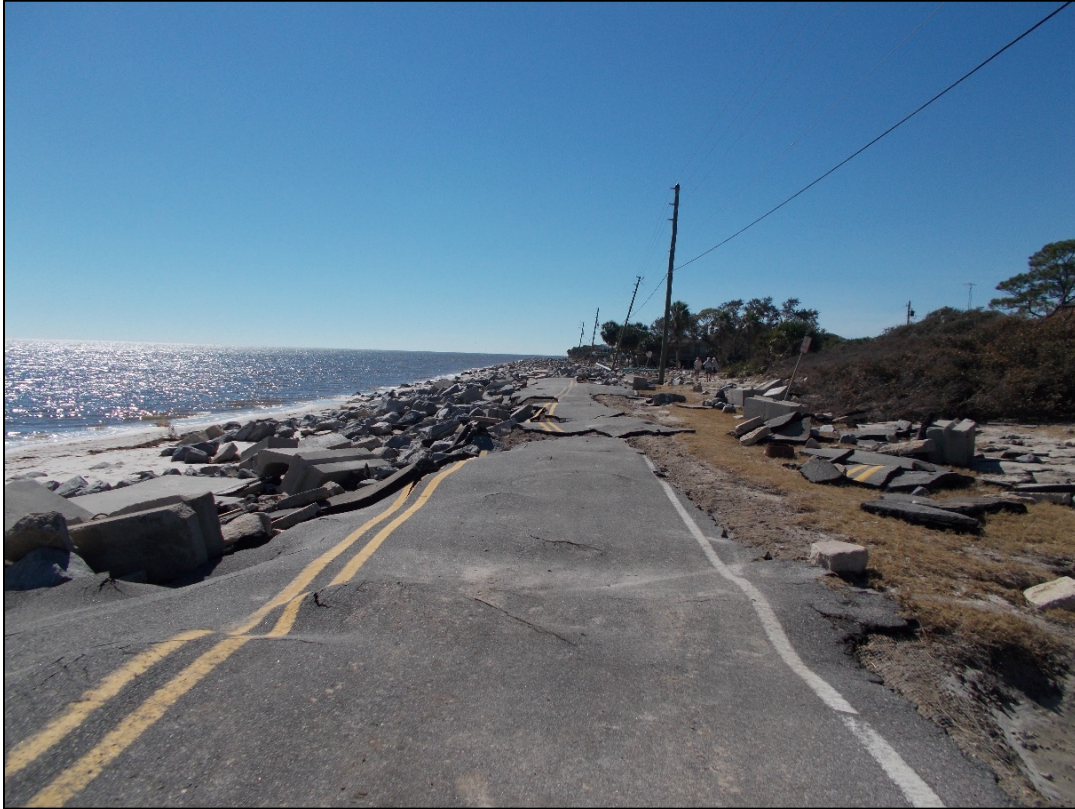
Figure 99. 3,000 feet of road and revetment destroyed between R211-R214, Southwest Cape.
