***Hurricane Michael Post-Storm
Beach Conditions and Coastal Impact Report***

**Division of Water Resource Management
Florida Department of Environmental Protection**

**January 2019
(Revised April 2019)**

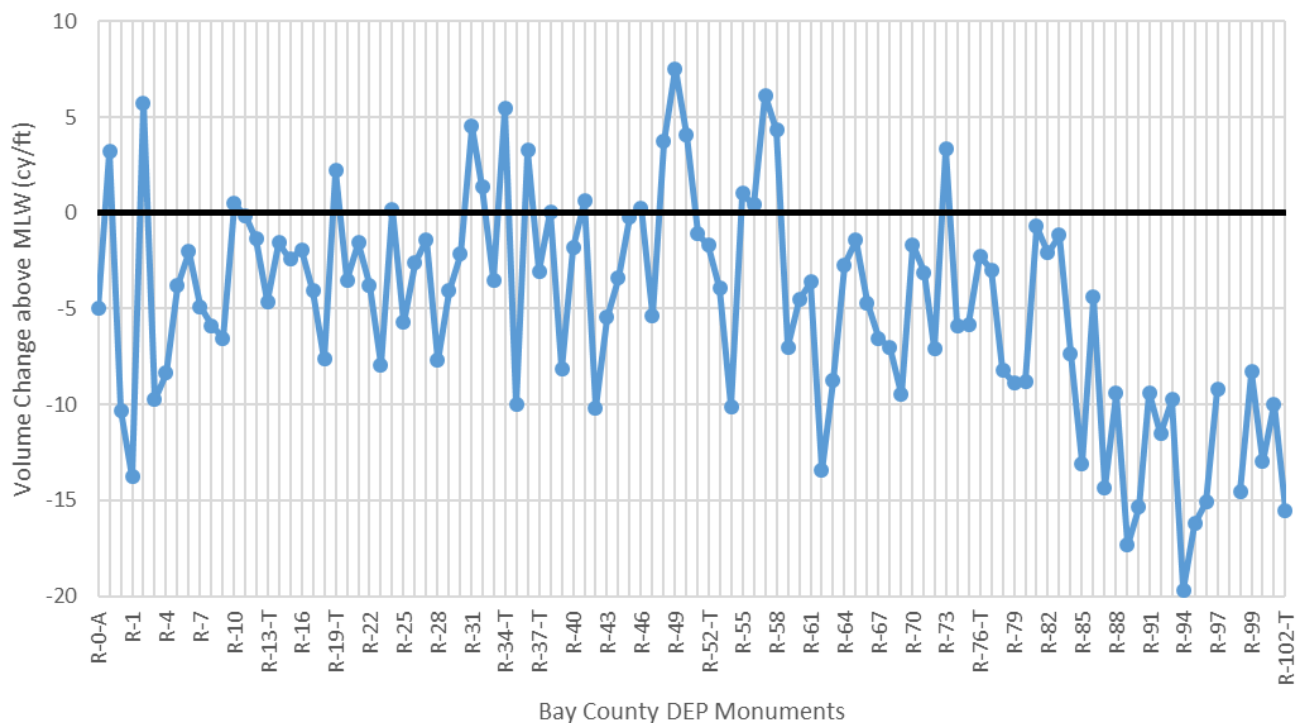
Figure 10 shows the net erosion plotted across western Bay County west of Tyndall Air Force Base, including St. Andrews State Park (R92-R102) where major beach and dune erosion was sustained.

Along the federal shore protection project (R0-R92), which was subject to storm tides of five to six feet, a total erosion volume of approximately -787,000 cubic yards above mean low water (MLW) was calculated. Much of the eroded volume remained above MLW in the form of overwash across the beach berm, and therefore a net erosion volume of approximately -369,000 cubic yards was calculated.

Figure 10. Net erosion along western Bay County (R0-R102) above Mean Low Water (MLW).

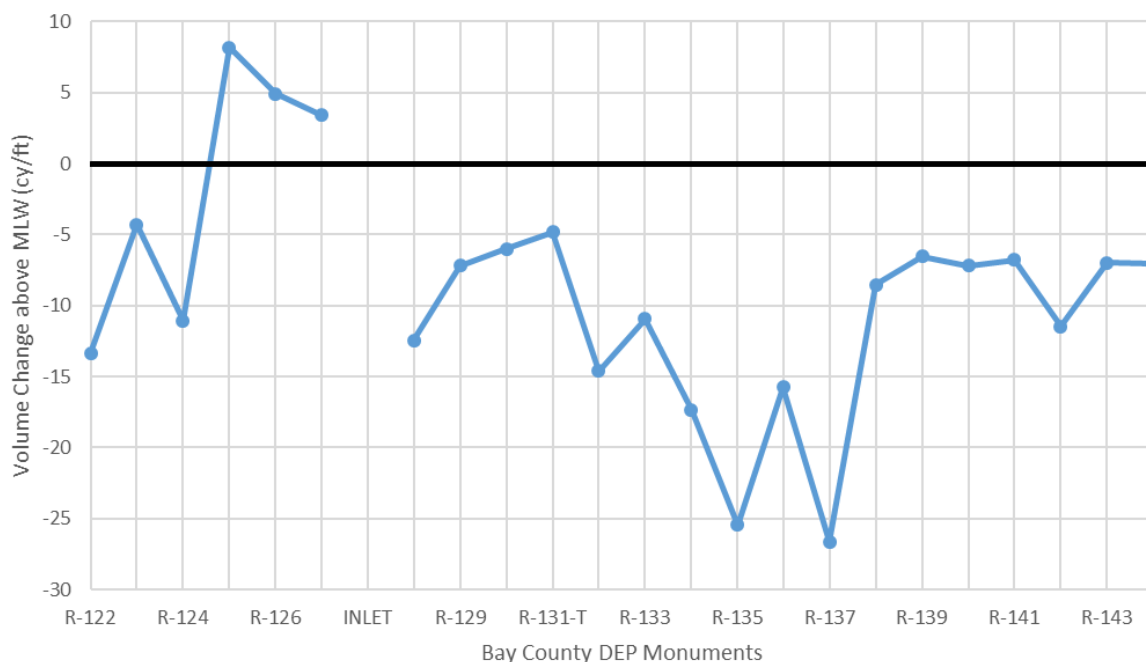
Michael's impact along the eastern coast of Bay County east of St. Andrews Inlet was particularly severe. From St. Andrews State Park through Mexico Beach, including Shell Island and Crooked Island, major beach and dune erosion (Condition IV) was sustained. Along Shell Island and Crooked Island, major washover fans were developed due to the storm surge that flooded these barrier islands and leveled dunes. An unquantified large volume of beach and dune sediments were transported into St. Andrews Bay. A relatively smaller volume of washover sediments were transported landward along Mexico Beach across U.S. Highway 98. Along Mexico Beach, the storm erosion left upland properties vulnerable to flooding from future storm events. **Figure 14** shows the net erosion plotted across Mexico Beach from just west of the Mexico Beach Canal Entrance (also known as Mexico Beach Inlet) eastward to the Gulf County line. The inlet is located between DEP reference monuments R127 and R128. To the west of the inlet, some "up-drift" accretion was measured. From the inlet, eastward to the county line (R128-R144), approximately -190,000 cubic yards of beach and dune sand was lost above MLW.

Figure 14. Net erosion along Mexico Beach, eastern Bay County (R122-R144) above MLW.

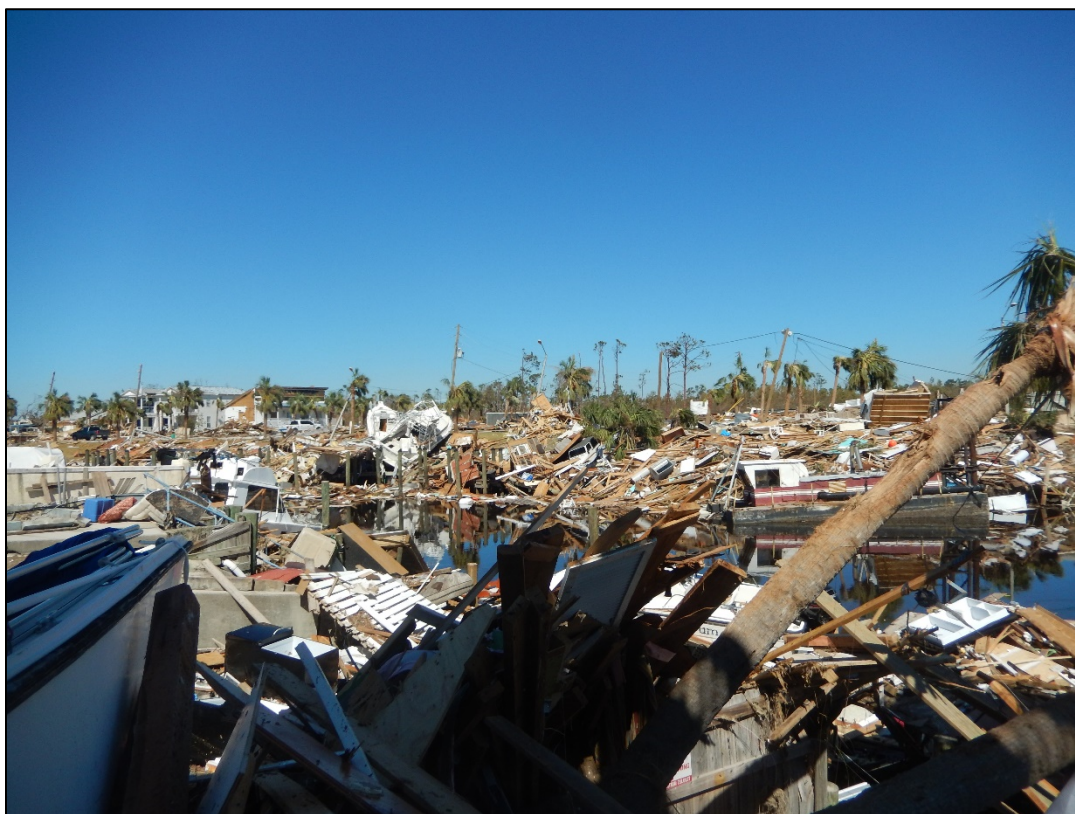
Figure 24. Mexico Beach Canal, R128.

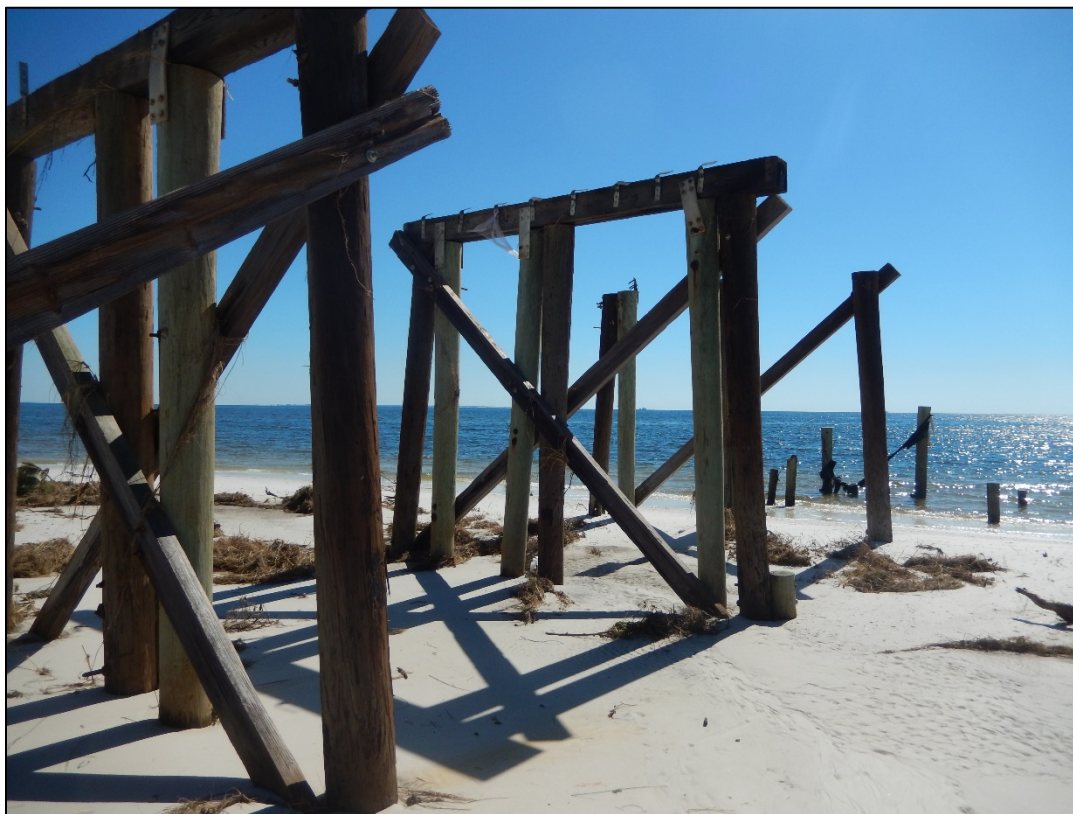
Figure 30. Mexico Beach pier destroyed near R129.

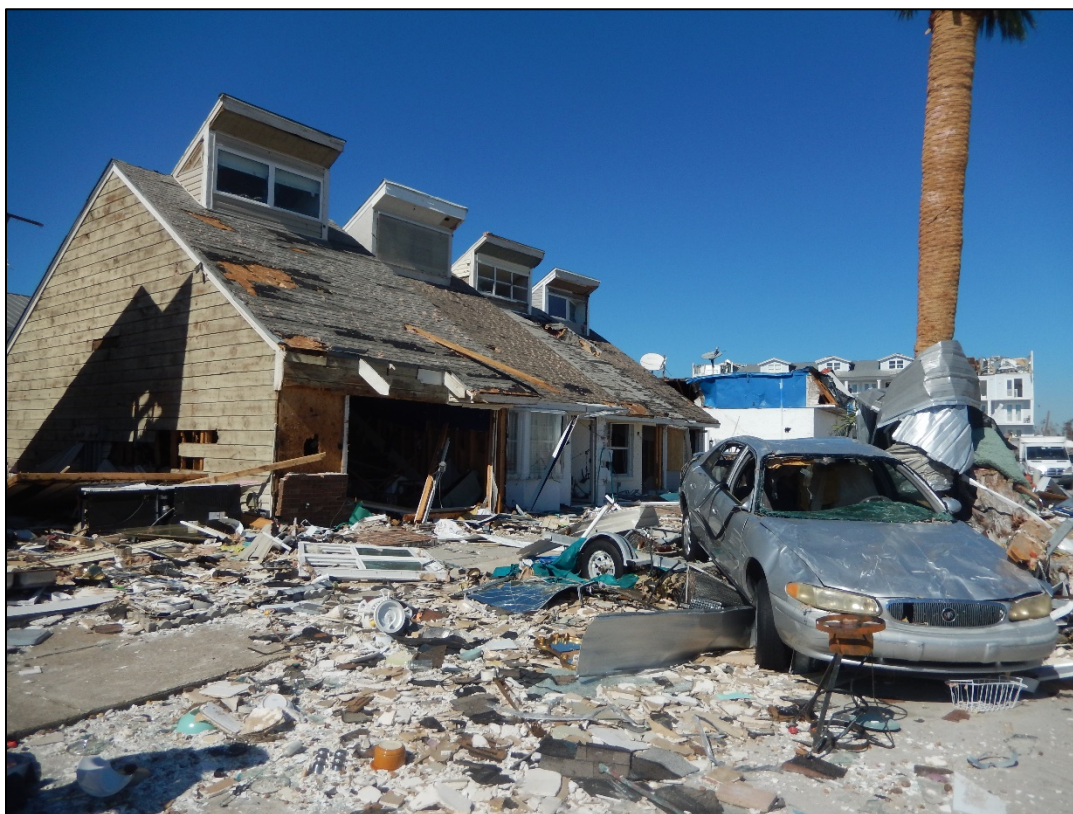
Figure 31. Multifamily dwelling destroyed near R129, Mexico Beach.

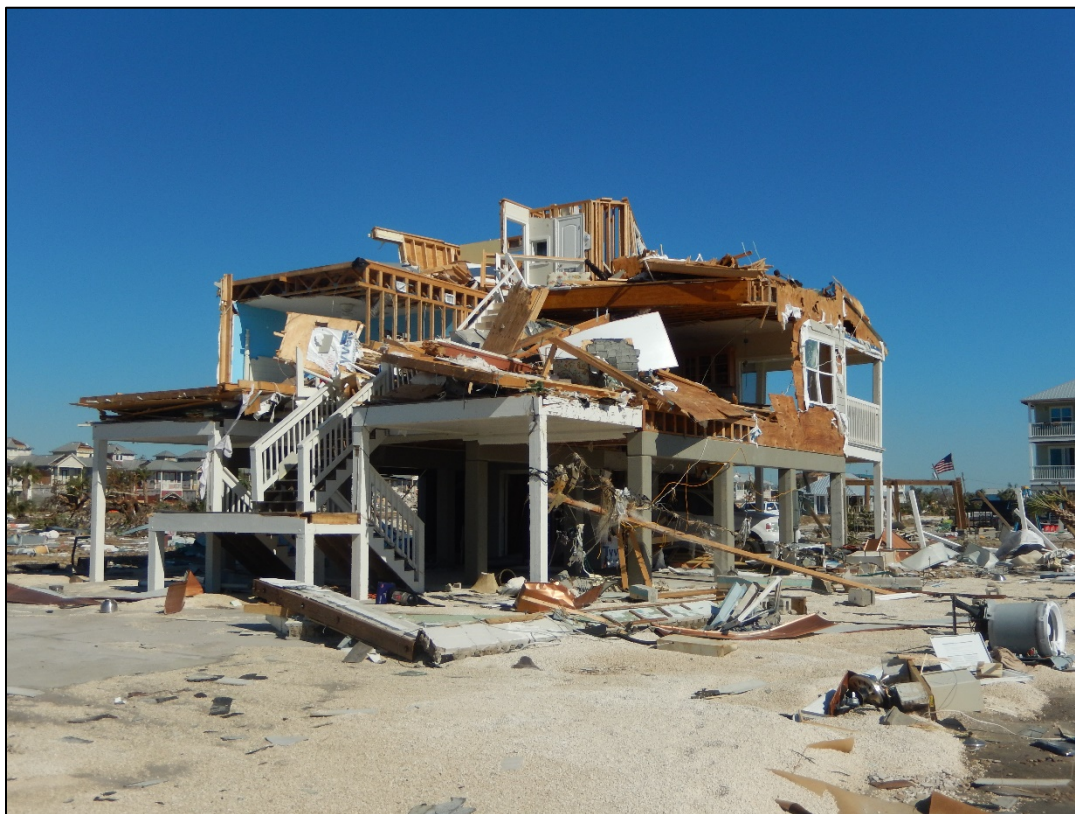
Figure 32. Pile-supported dwelling destroyed near R129, Mexico Beach.

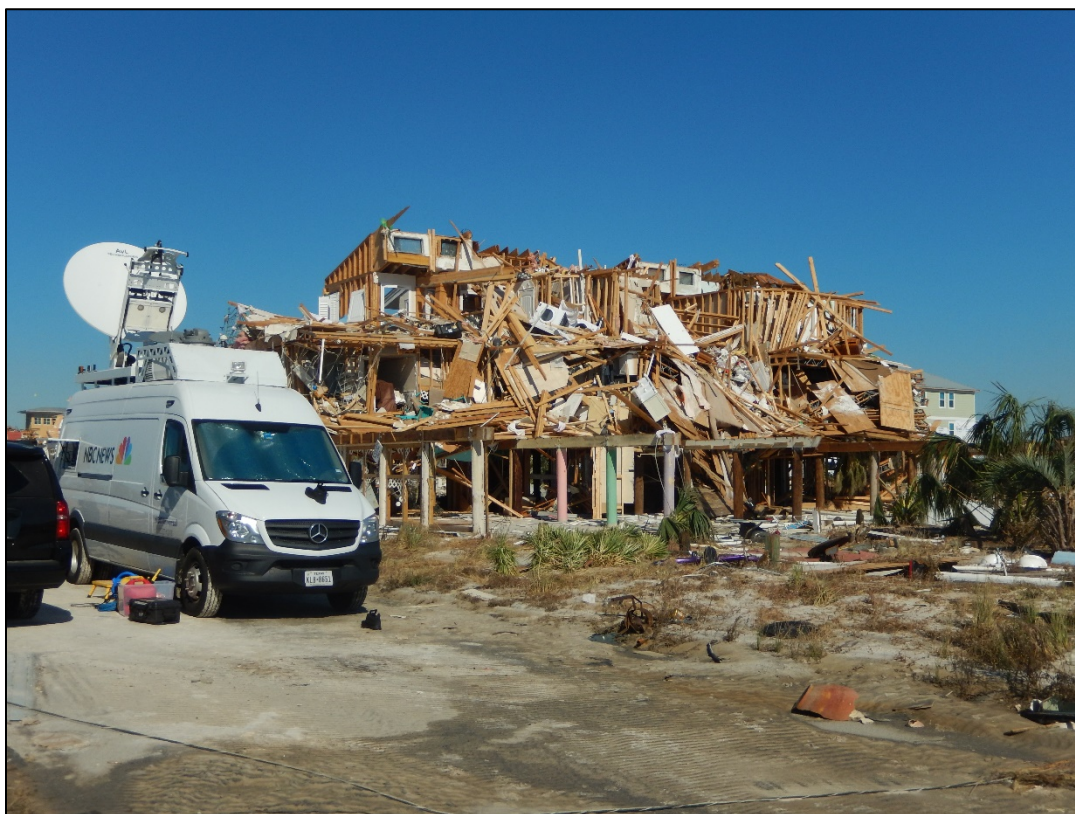
Figure 33. Pile-supported multifamily dwelling destroyed near R129, Mexico Beach.

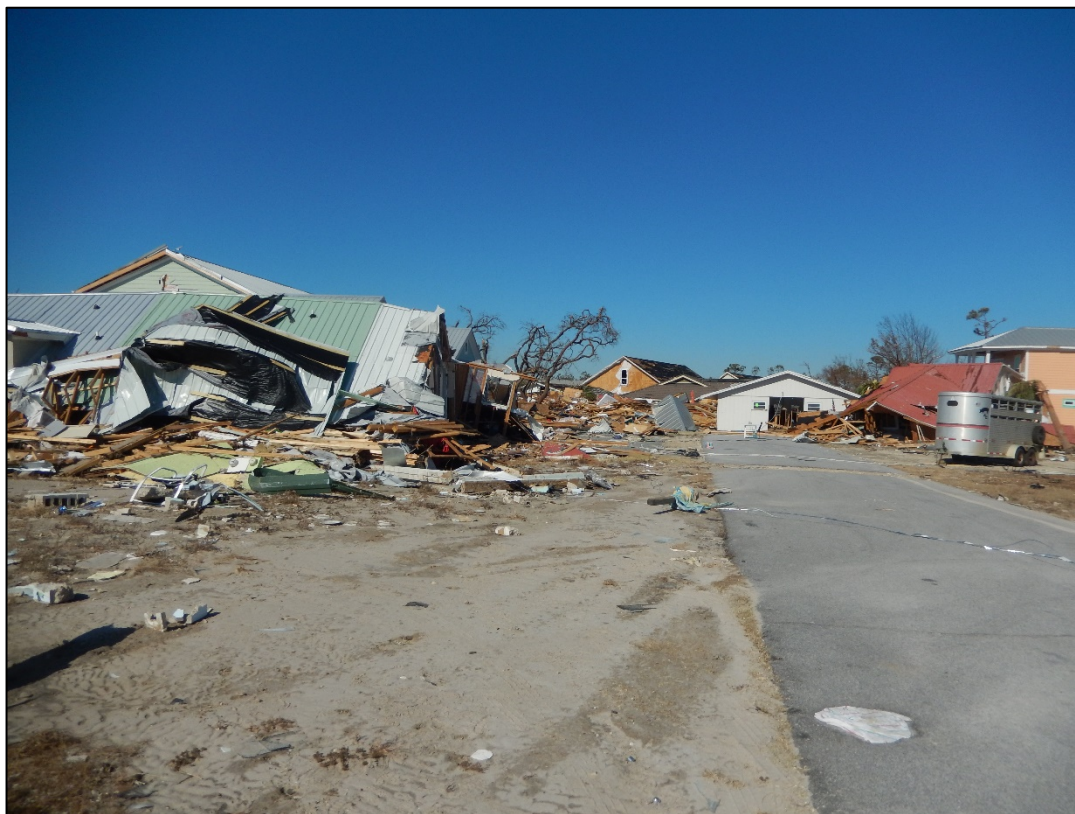
Figure 34. Buildings transported several hundred feet landward by the flood across U.S. 98 and deposited on 15th Street, R130, Mexico Beach.

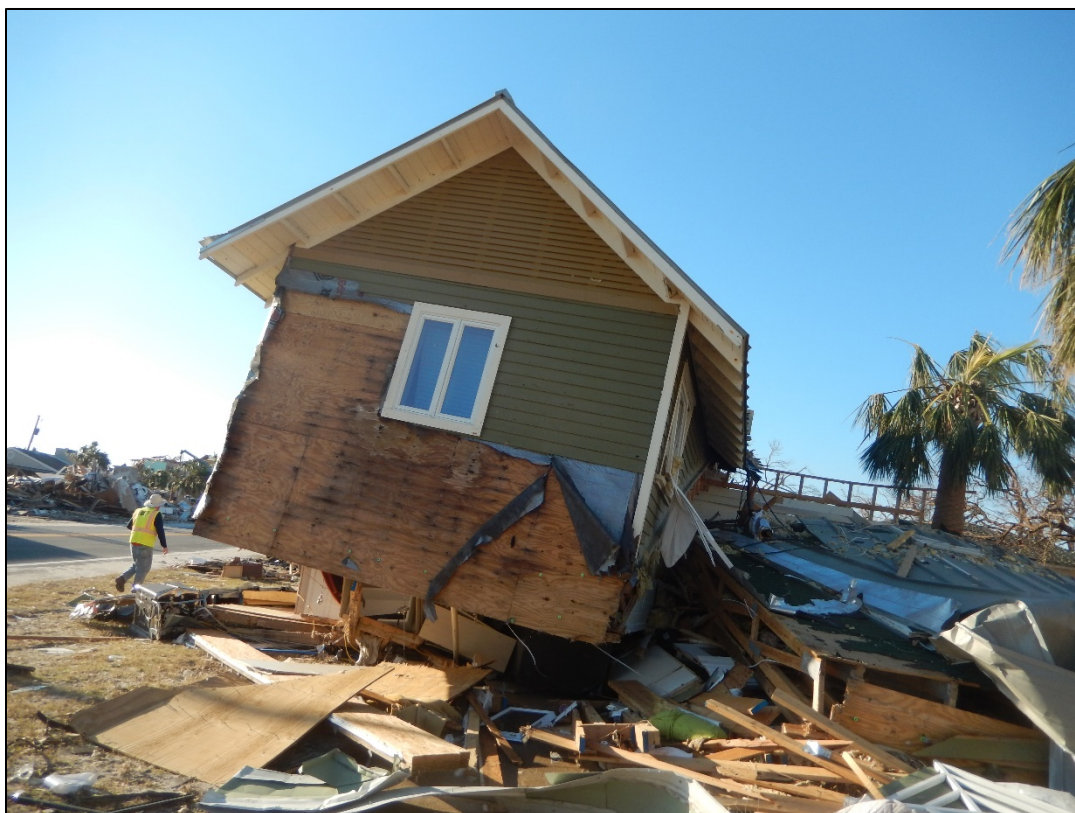
Figure 35. Beach dwelling transported across U.S. 98 by the storm surge, Mexico Beach.

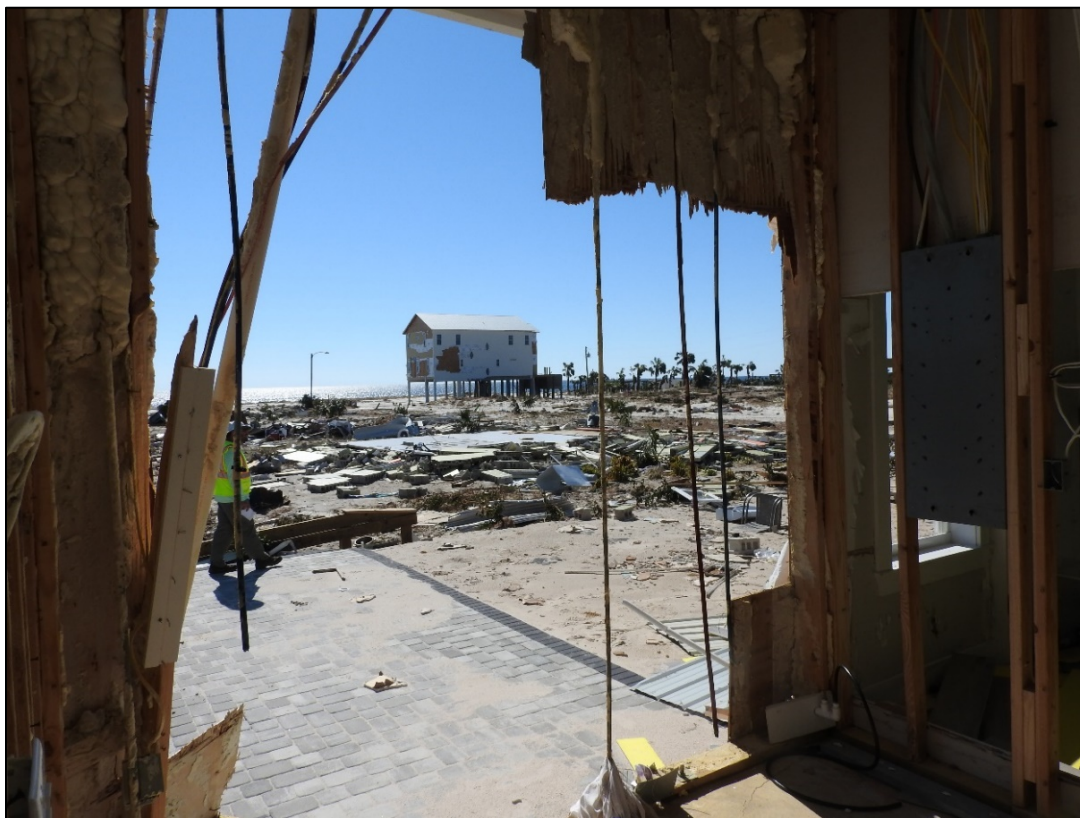
Figure 36. Dwellings destroyed by storm surge near R132, Mexico Beach.

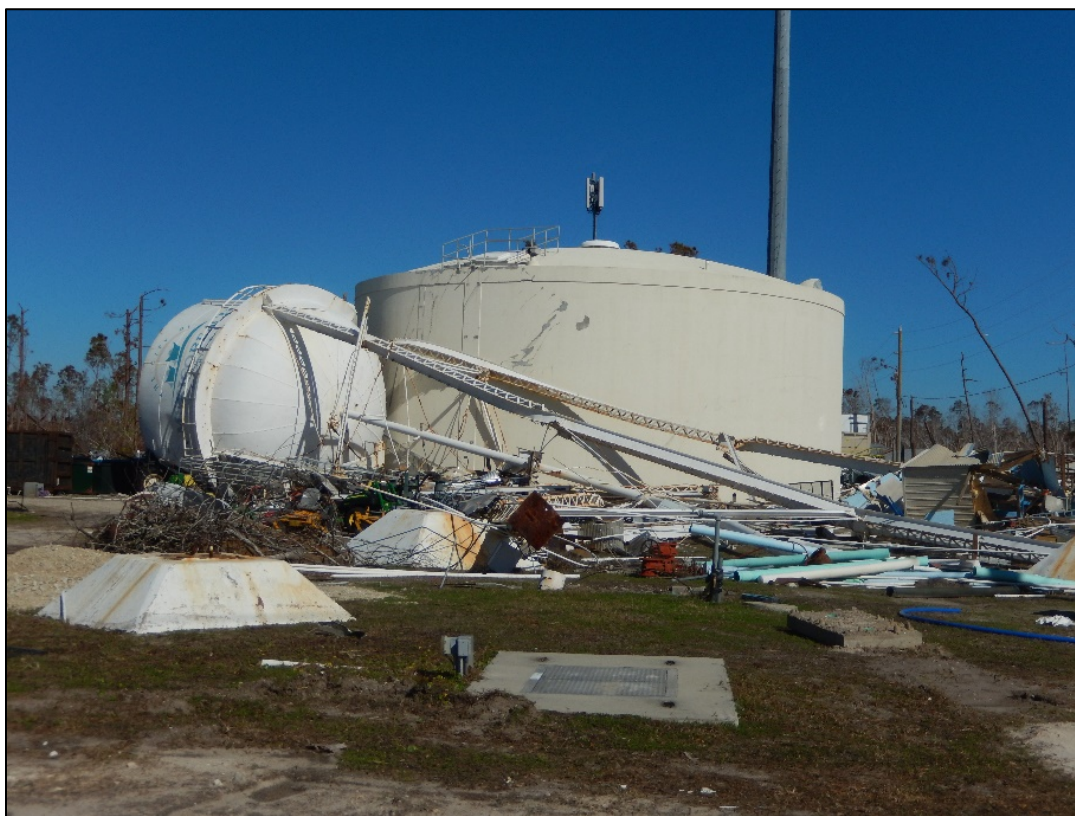
Figure 37. City water tower collapsed under high winds near R134, Mexico Beach.

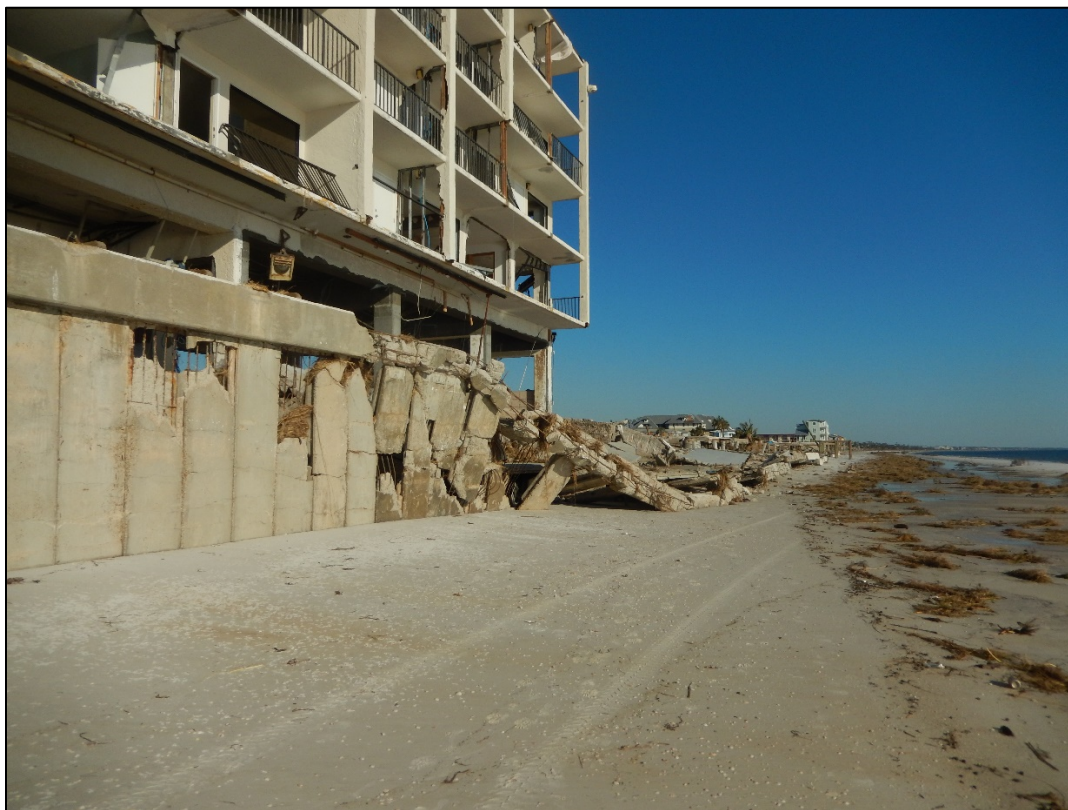
Figure 38. Over 700 feet of reinforced concrete seawall destroyed at R135, Mexico Beach.

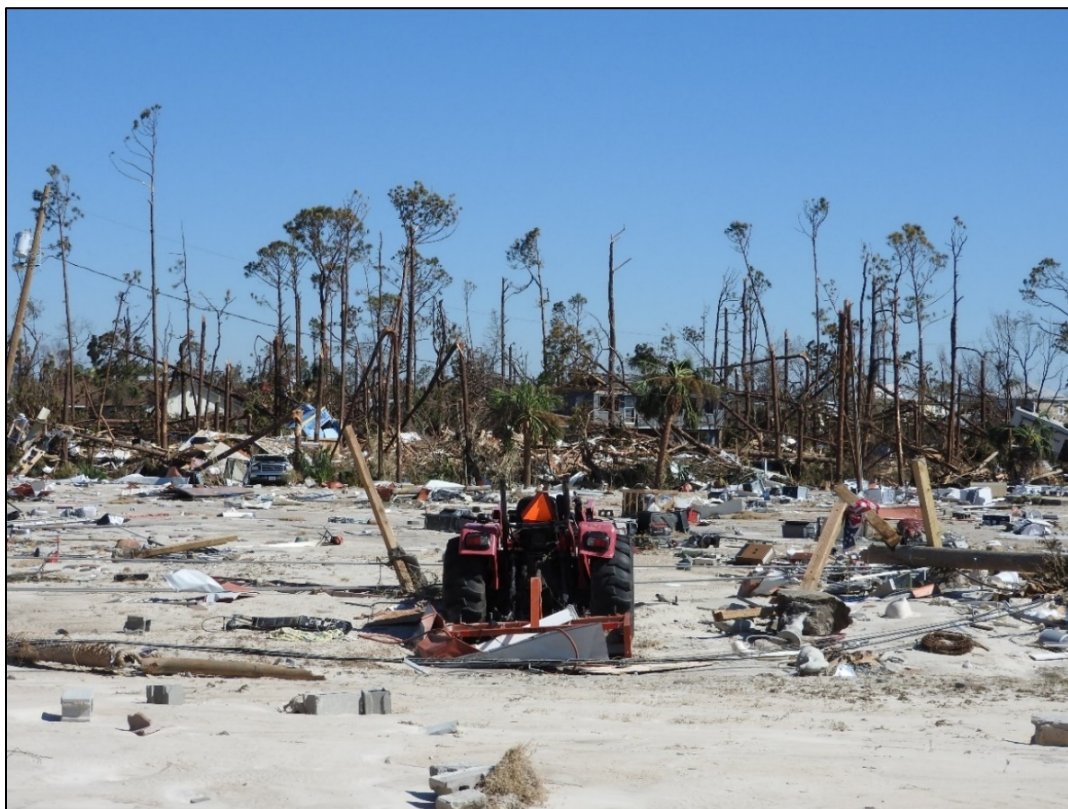
Figure 39. Storm surge transported debris and sand overwash across U.S. 98 near R135, Mexico Beach.

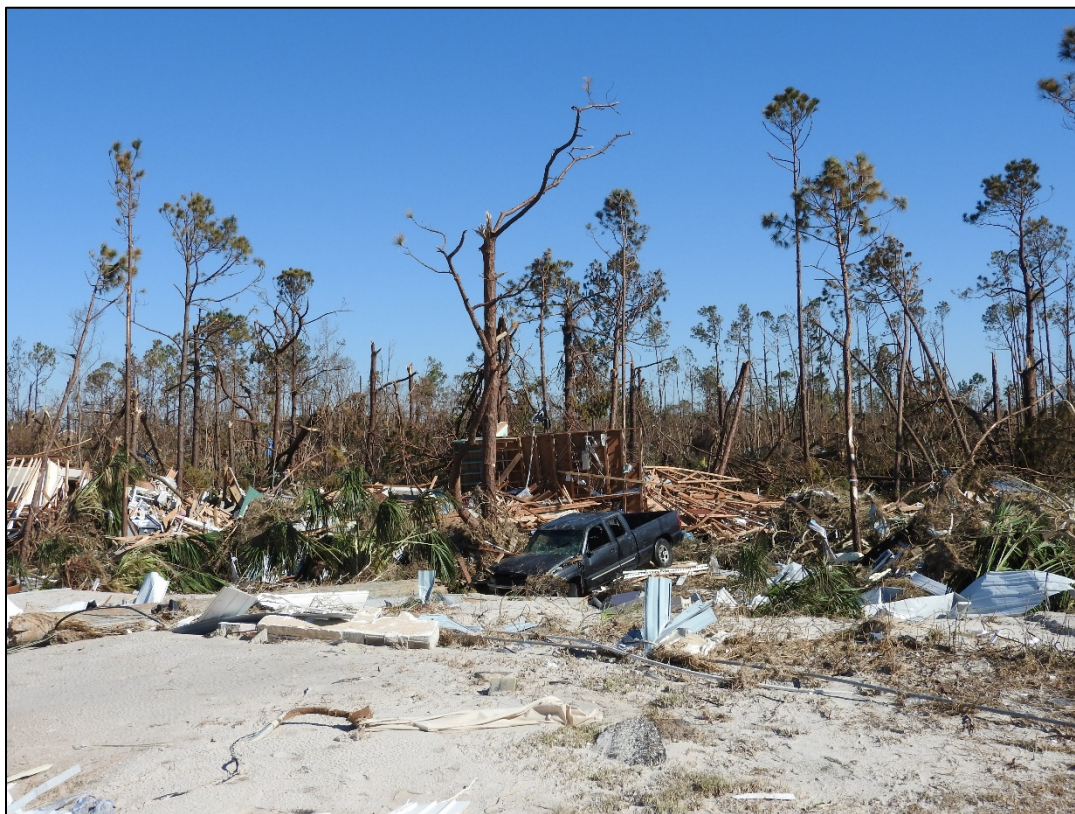
Figure 40. Debris transported by the storm surge inland near R136, Mexico Beach.

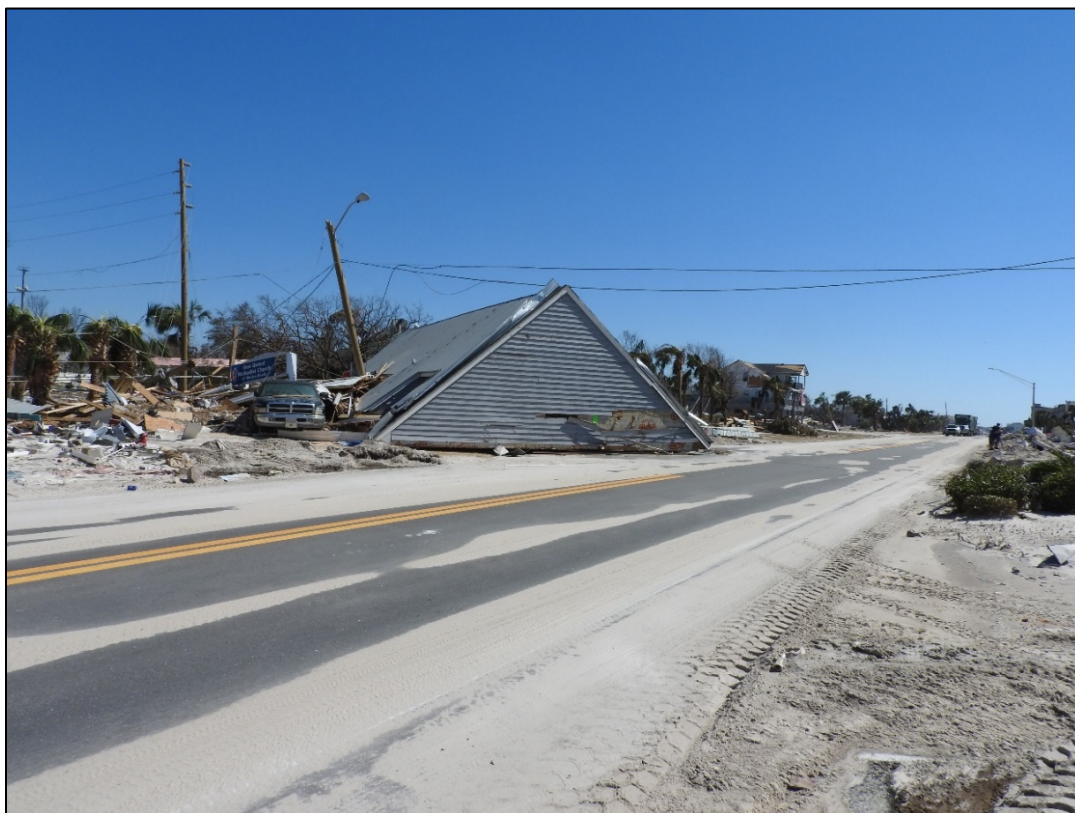
Figure 42. Roof of dwelling transported across U.S. 98 by the storm surge near R138, Mexico Beach.

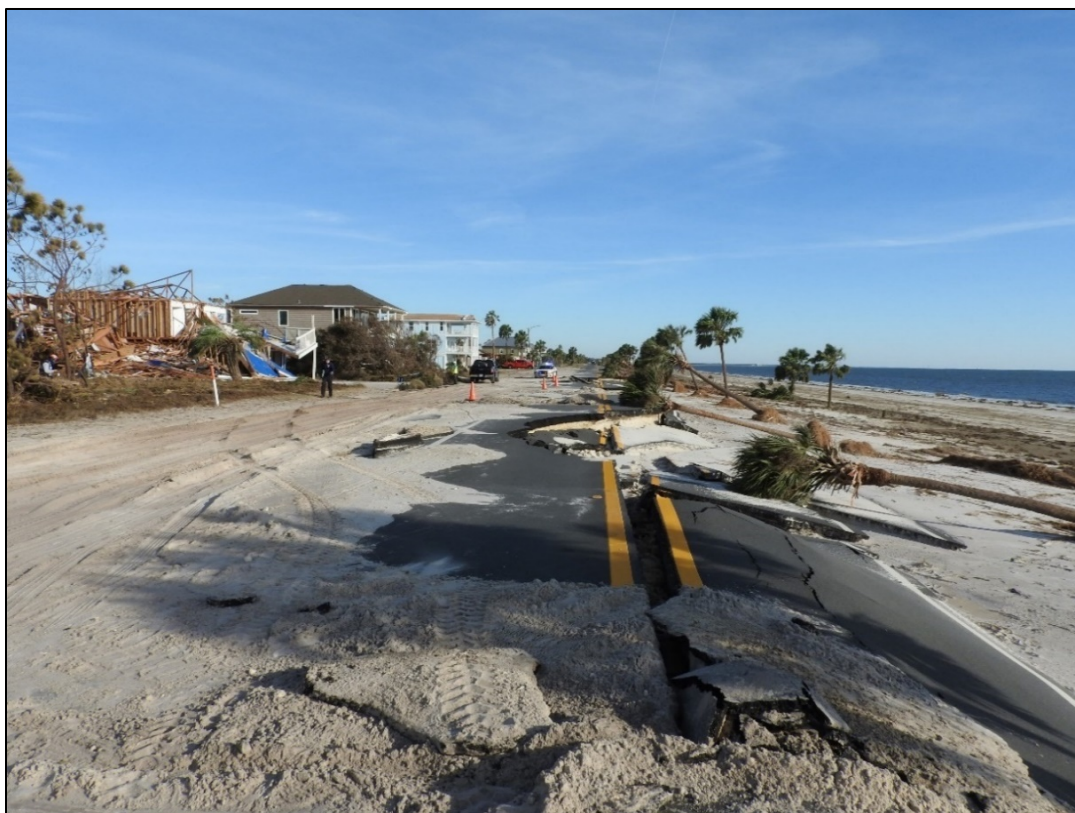
Figure 43. Segment of U.S. 98 destroyed near R139, Mexico Beach.

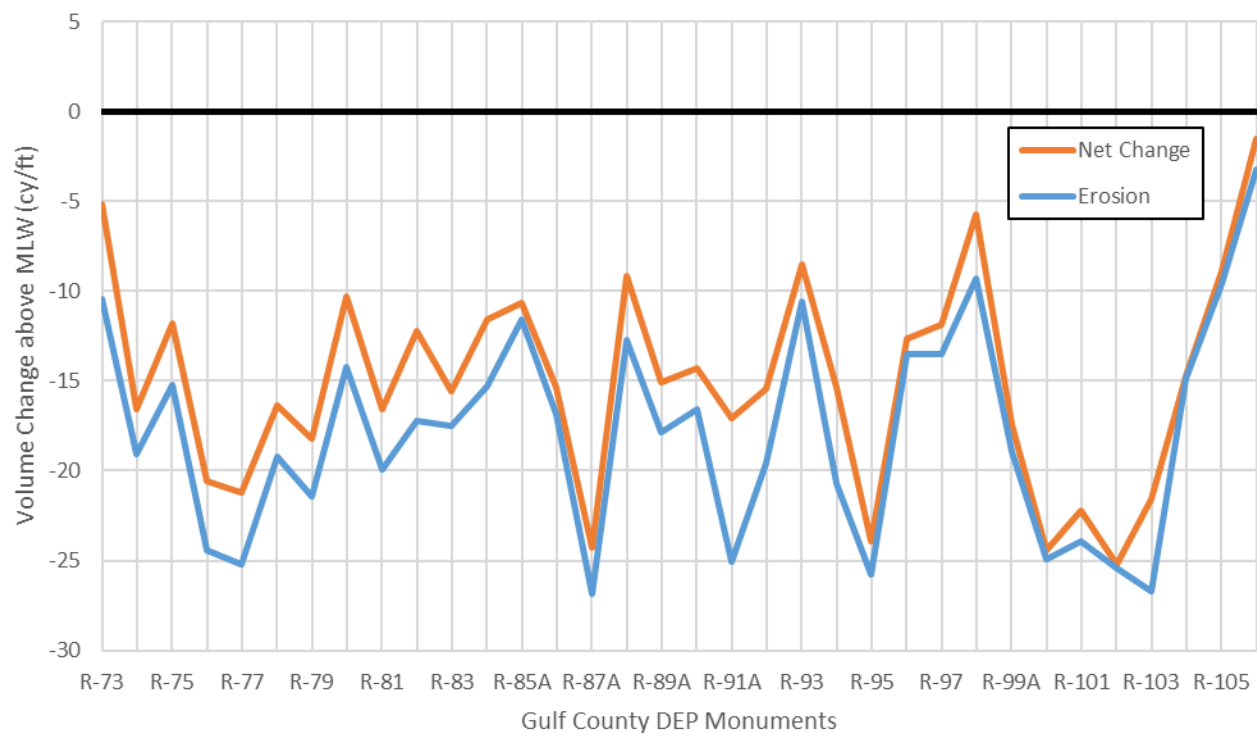
South of the breach, along the developed southern half of St. Joseph Peninsula (R73-R106) and the western shore of Cape San Blas (R107-R112), approximately -600,000 cubic yards of beach and dune sand was lost above MLW. **Figure 48** graphs the total erosion and net erosion along the southern half of St. Joseph Peninsula, where the average net erosion was -15.0 cubic yards per foot of shoreline above MLW. **Figure 49** graphs the total erosion and net erosion along the western shoreline of Cape San Blas, where the average net erosion was -15.7 cubic yards per foot of shoreline above MLW.

Figure 48. Total and net volume change along southern St. Joseph Peninsula above MLW.

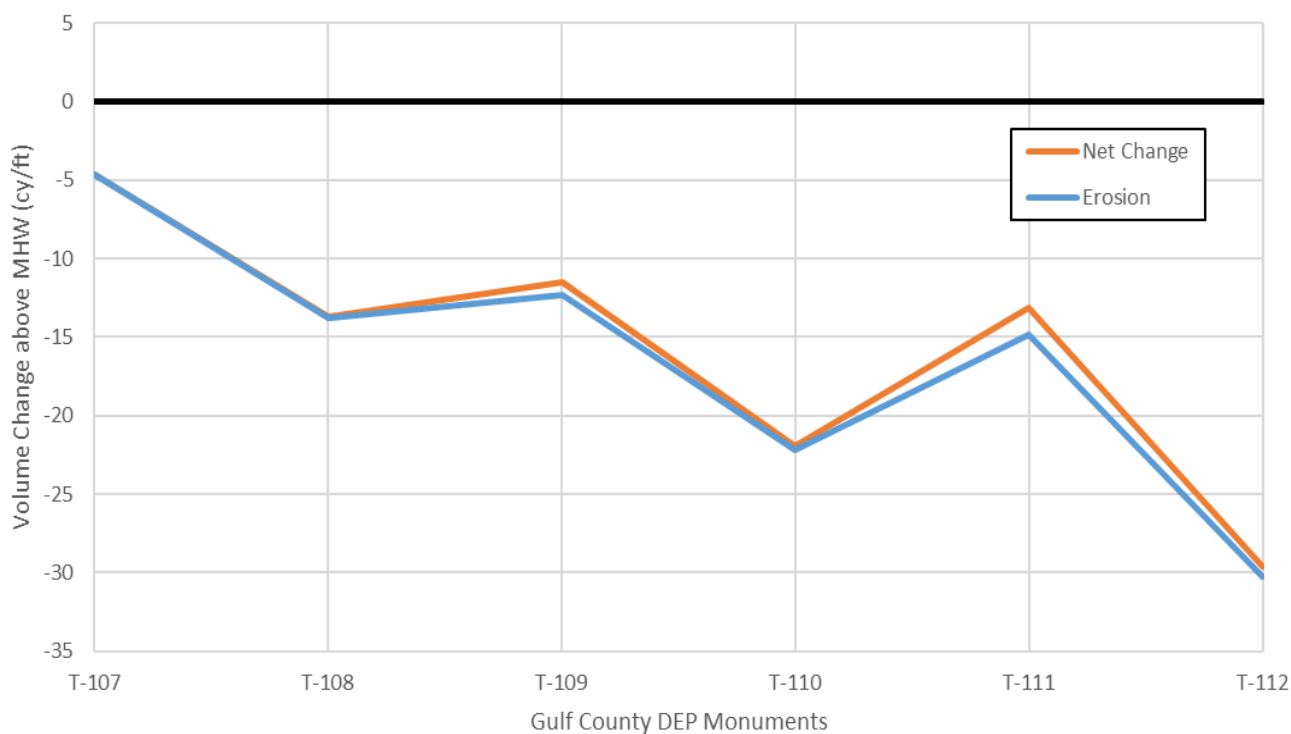
Figure 49. Total and net volume change along the western shoreline of Cape San Blas above MLW.

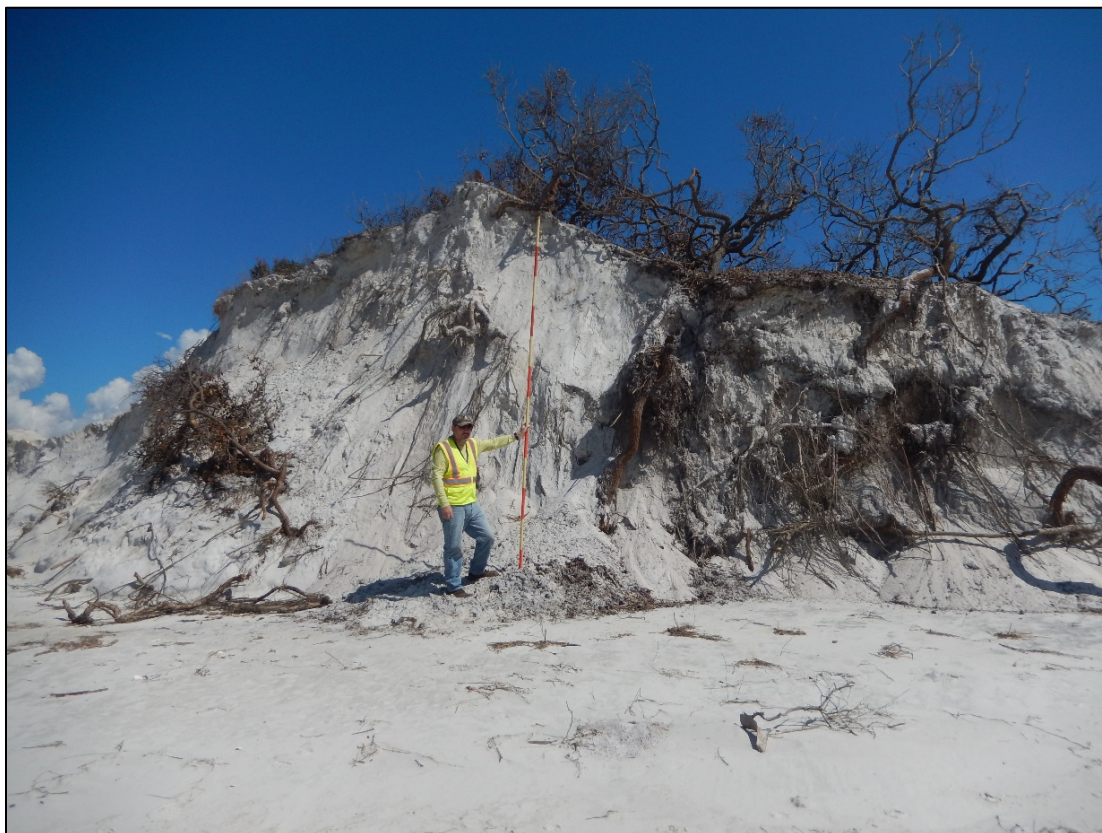
Major dune erosion at R74 within the state park is shown in **Figure 50**. Also, major dune erosion is seen looking south from R77 along the developed segment of St. Joseph Peninsula in **Figure 51**.

Figure 50. Major dune erosion (12-foot escarpment) near R74, St. Joseph Peninsula.

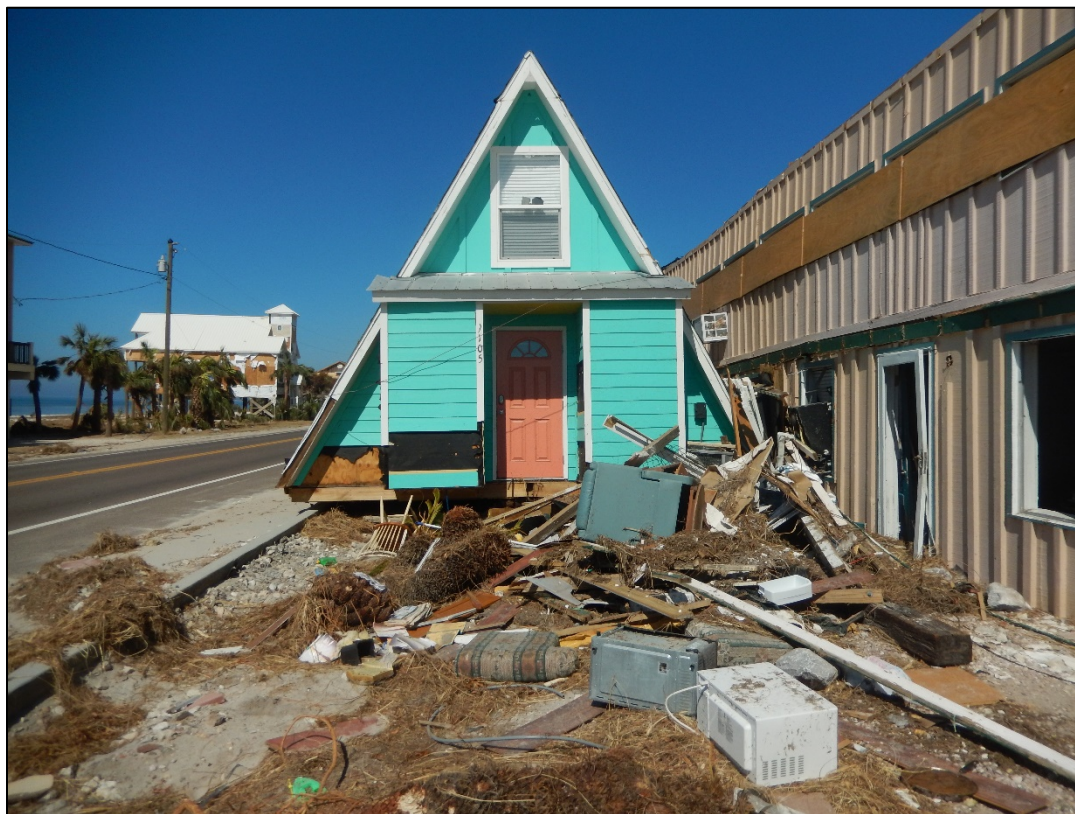
Figure 56. Dwelling transported across U.S. 98 by the storm surge near R2, Beacon Hill.

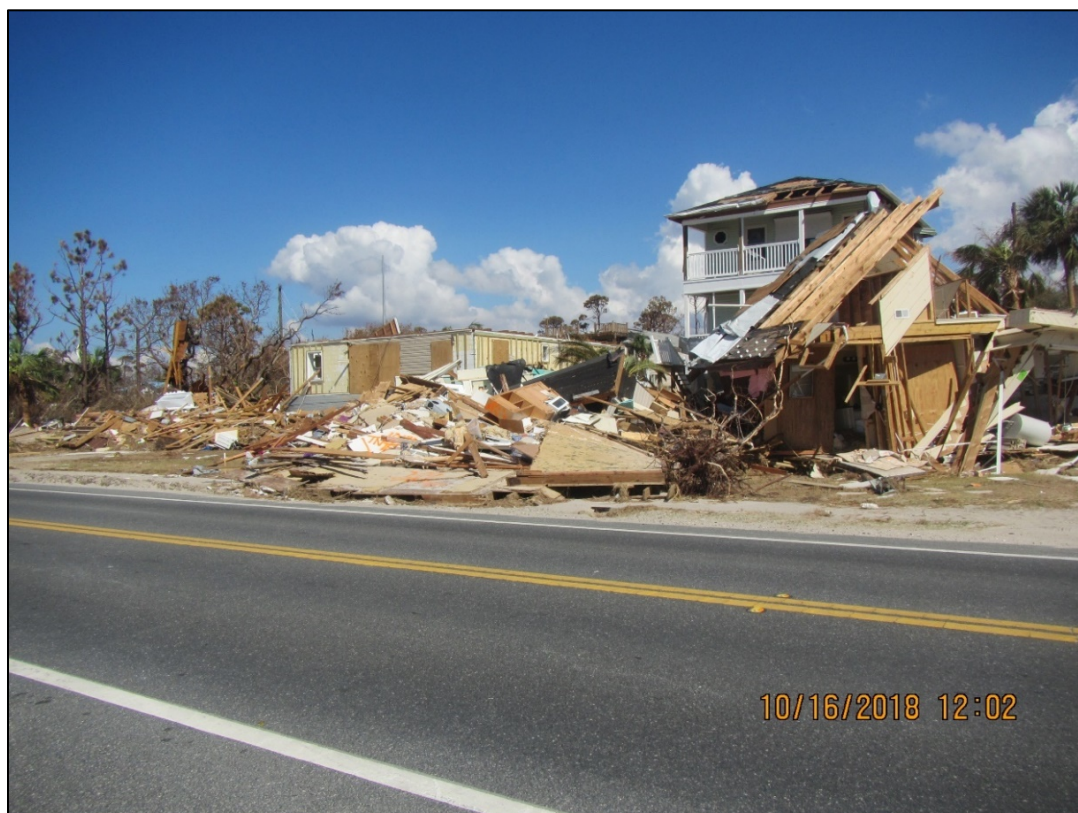
Figure 57. Dwellings along U.S. 98 destroyed near R3, Beacon Hill.

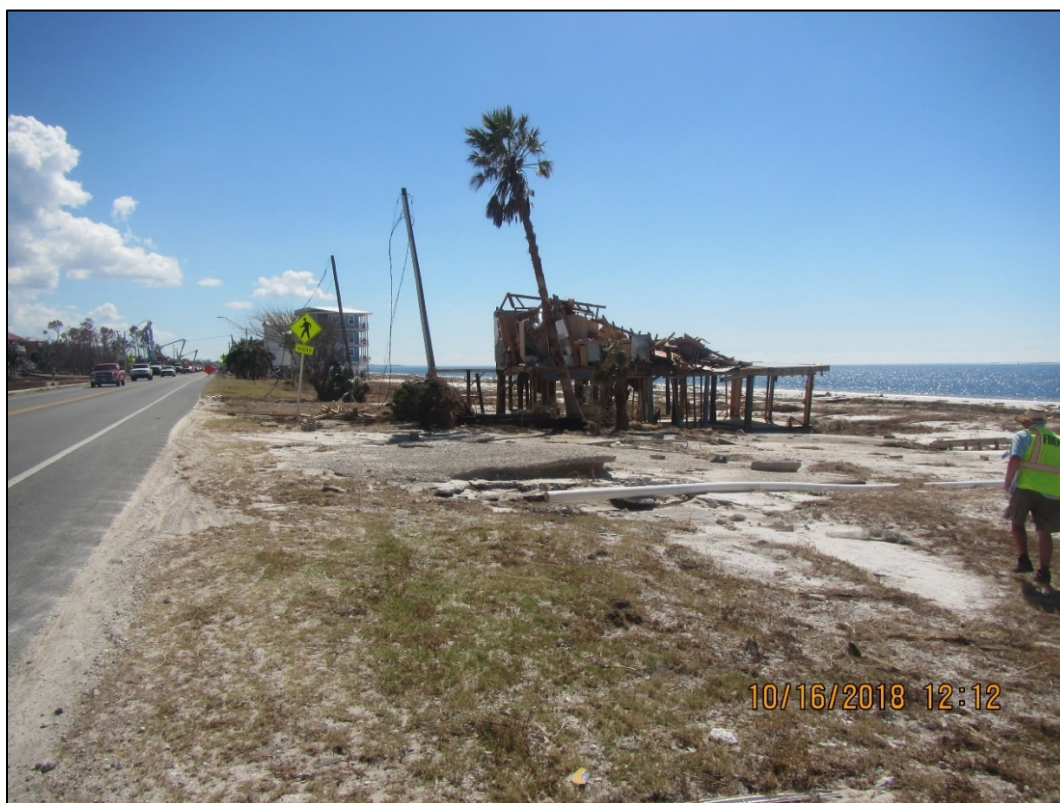
Figure 58. *Dwellings destroyed along U.S. 98 near R3.5, Beacon Hill.*

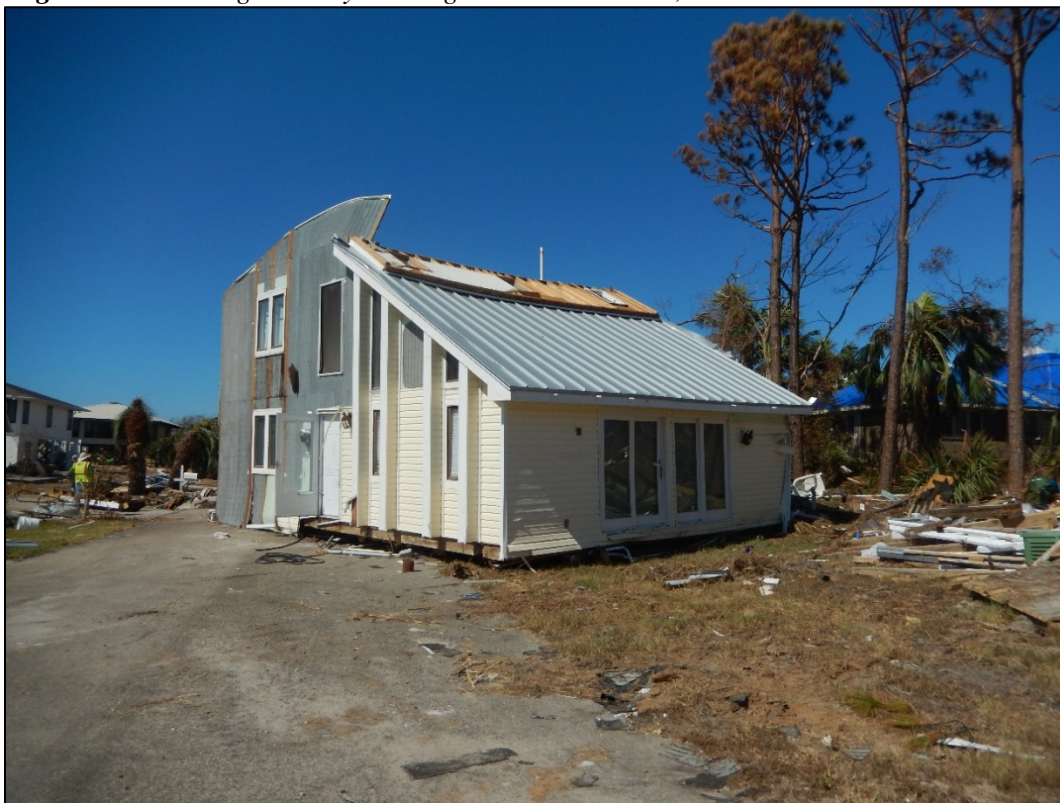
Figure 59. *Dwelling transported by storm surge onto Trade Winds Dr. near R6, Beacon Hill.*

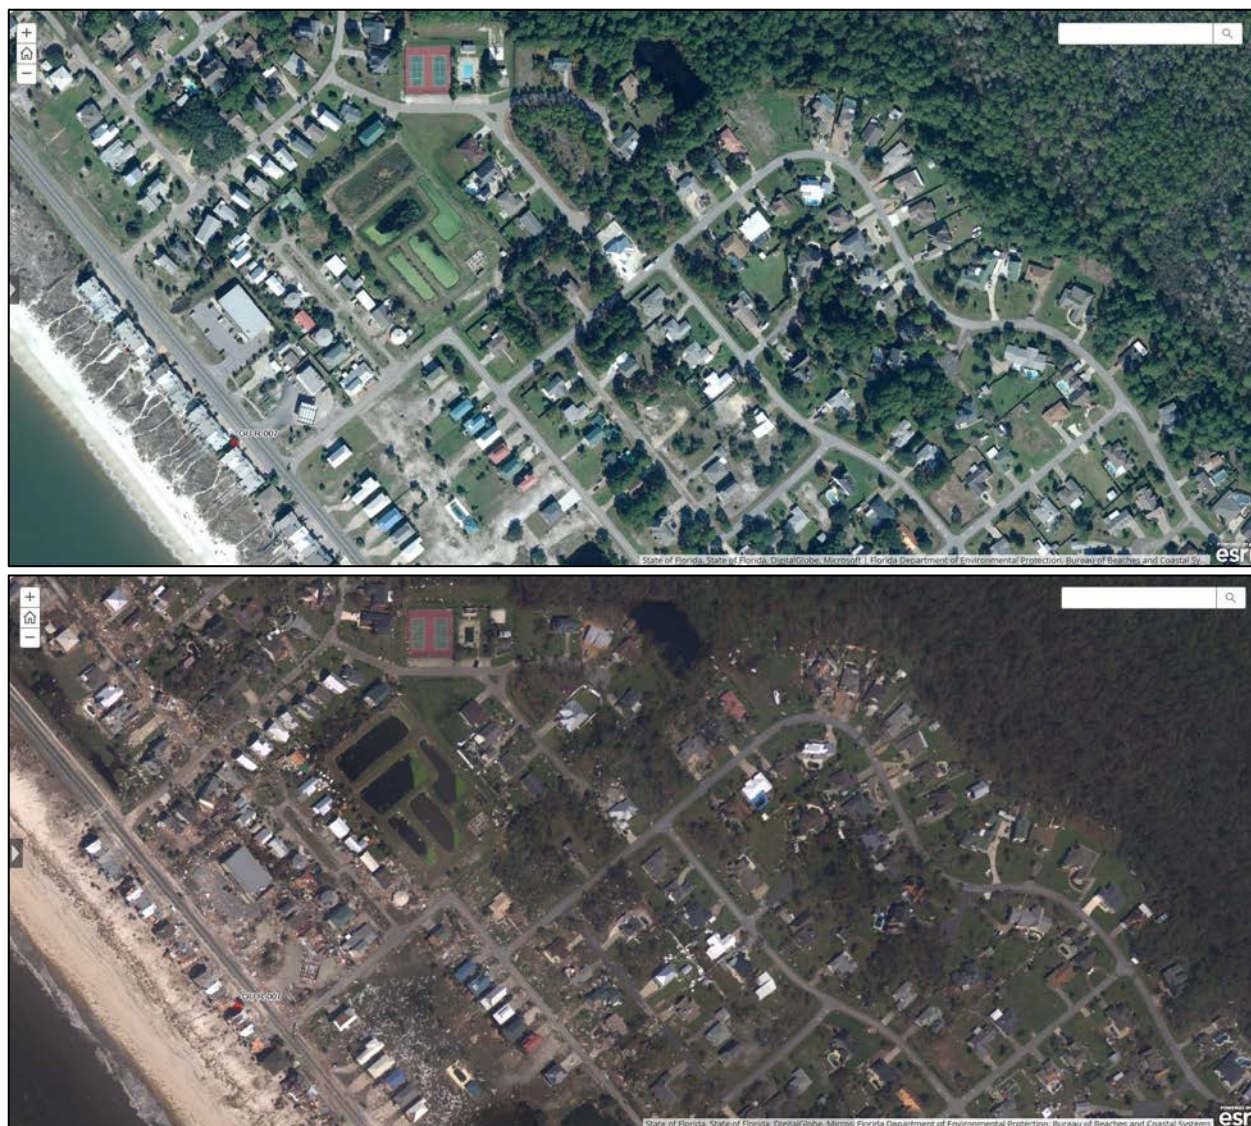
Figure 60. Aerial photo comparison in Beacon Hill (R7). Source: Vexcel Imaging/ NICB Geospatial Intelligence Center.
