***Hurricane Michael Post-Storm
Beach Conditions and Coastal Impact Report***

**Division of Water Resource Management
Florida Department of Environmental Protection**

**January 2019
(Revised April 2019)**

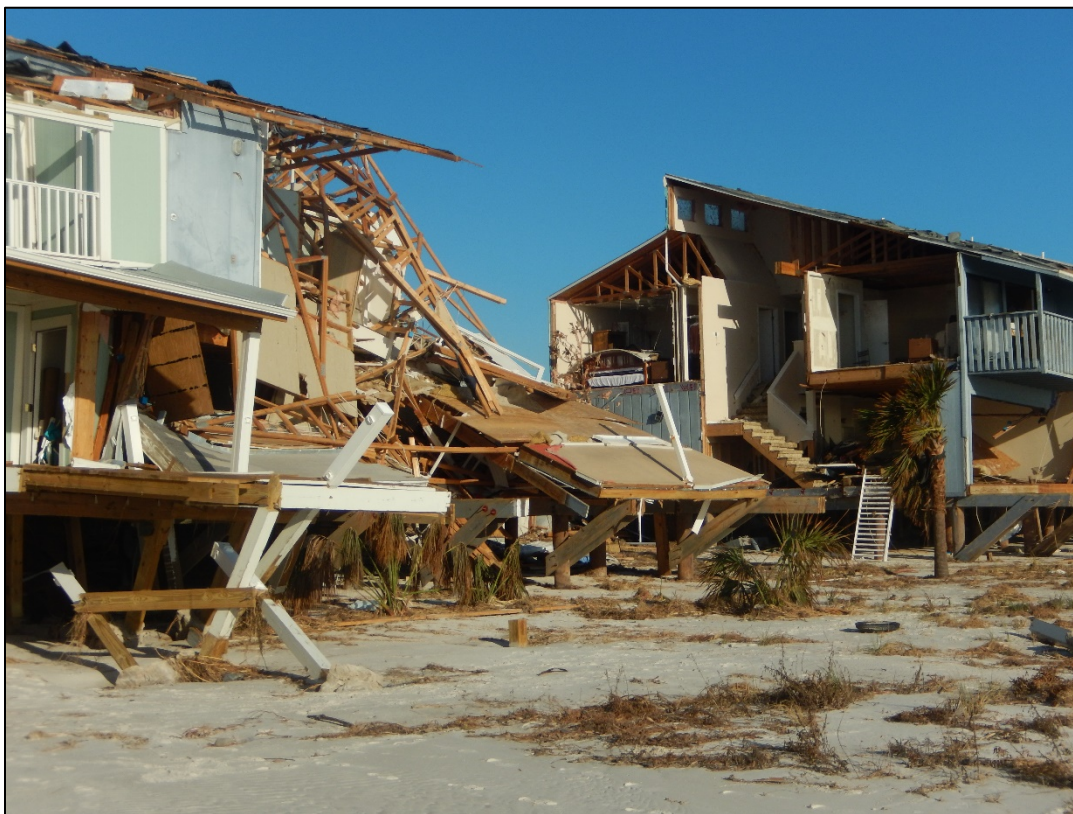
Figure 61. Townhouses destroyed near R7, Beacon Hill.

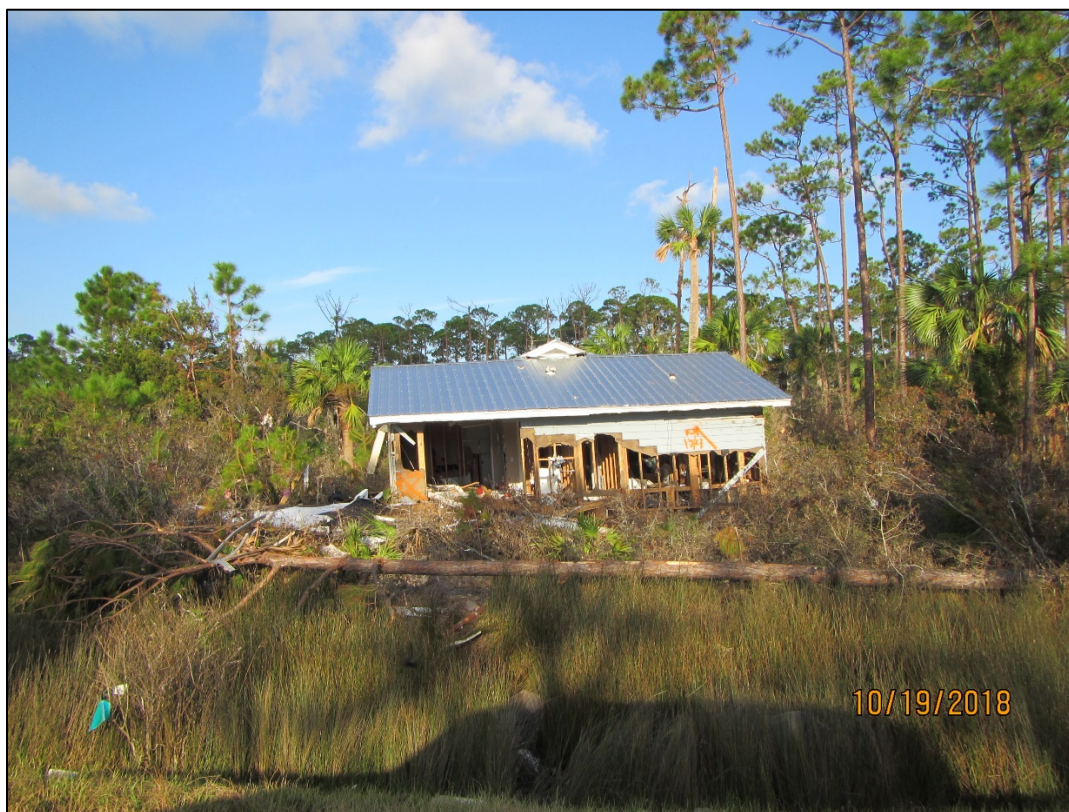
Figure 67. Destroyed dwelling transported across S.R.30A by the storm surge, St. Joseph Bay.

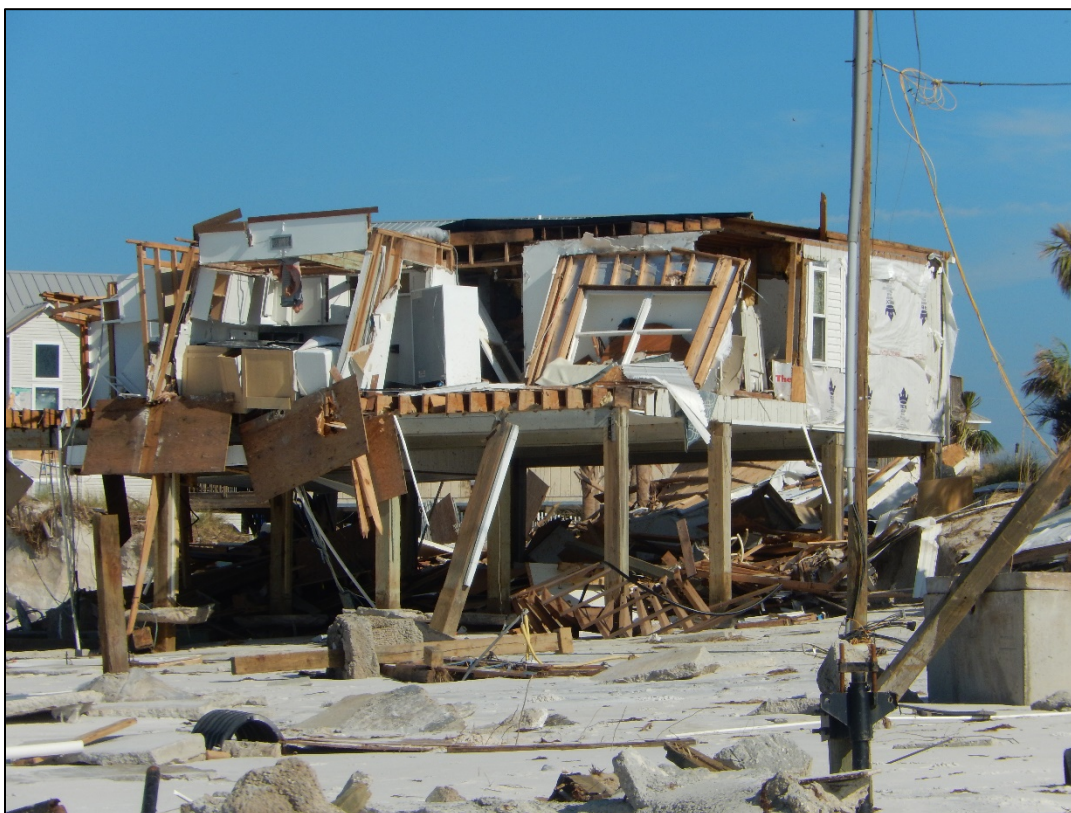
Figure 70. Pile-supported dwelling destroyed near R97.5, St. Joseph Peninsula.

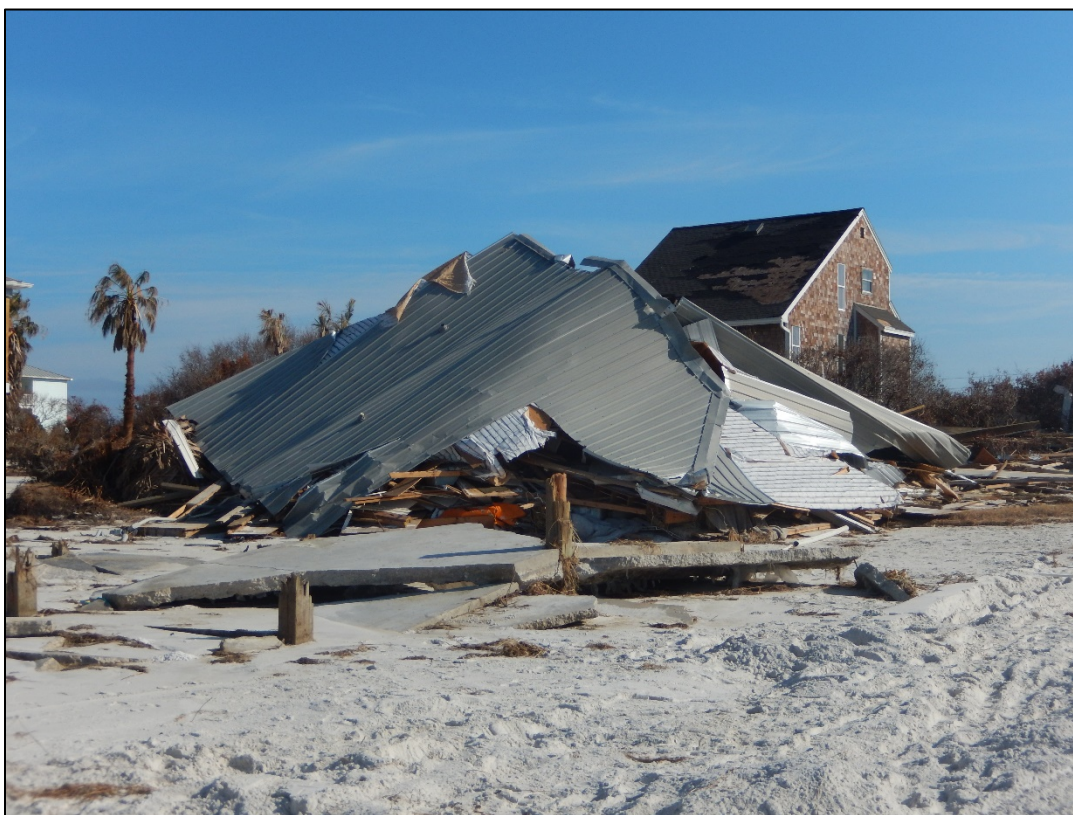
Figure 71. Dwelling destroyed near R99.5, St. Joseph Peninsula.

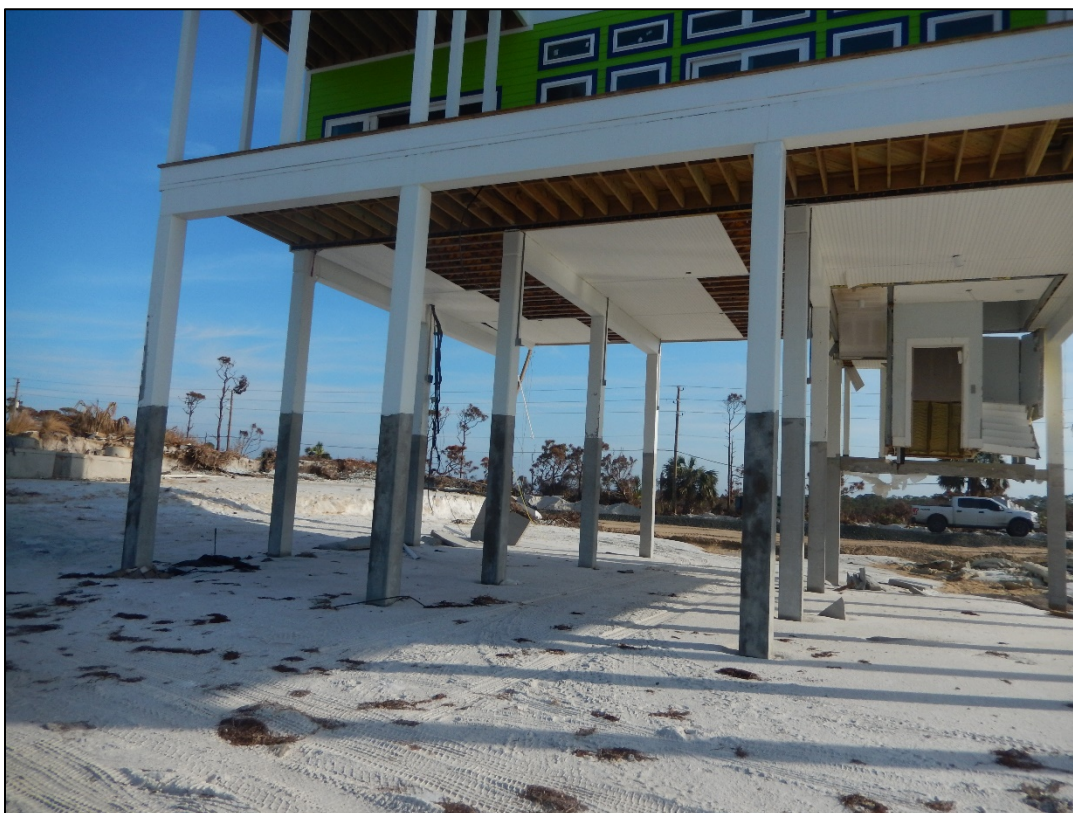
Figure 72. Over six feet of vertical loss of grade beneath structure near R104.

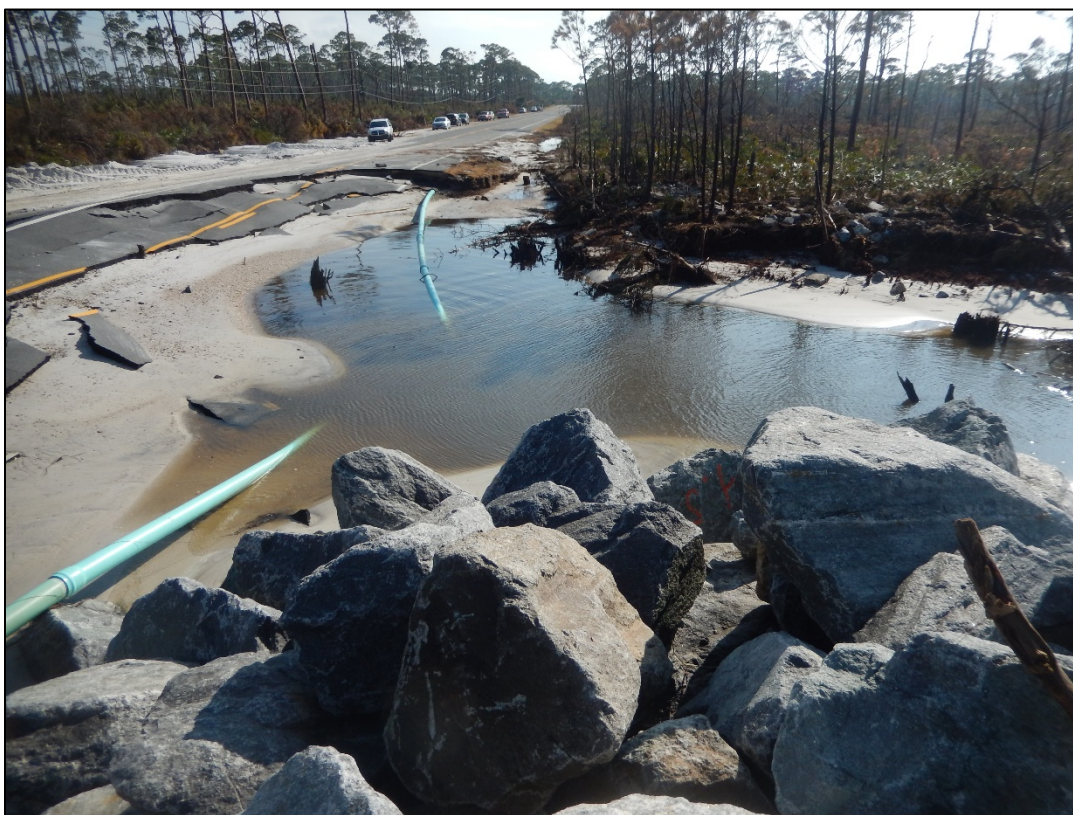
Figure 75. County Road 30E destroyed south of the Stump Hole boulder mound, R107.

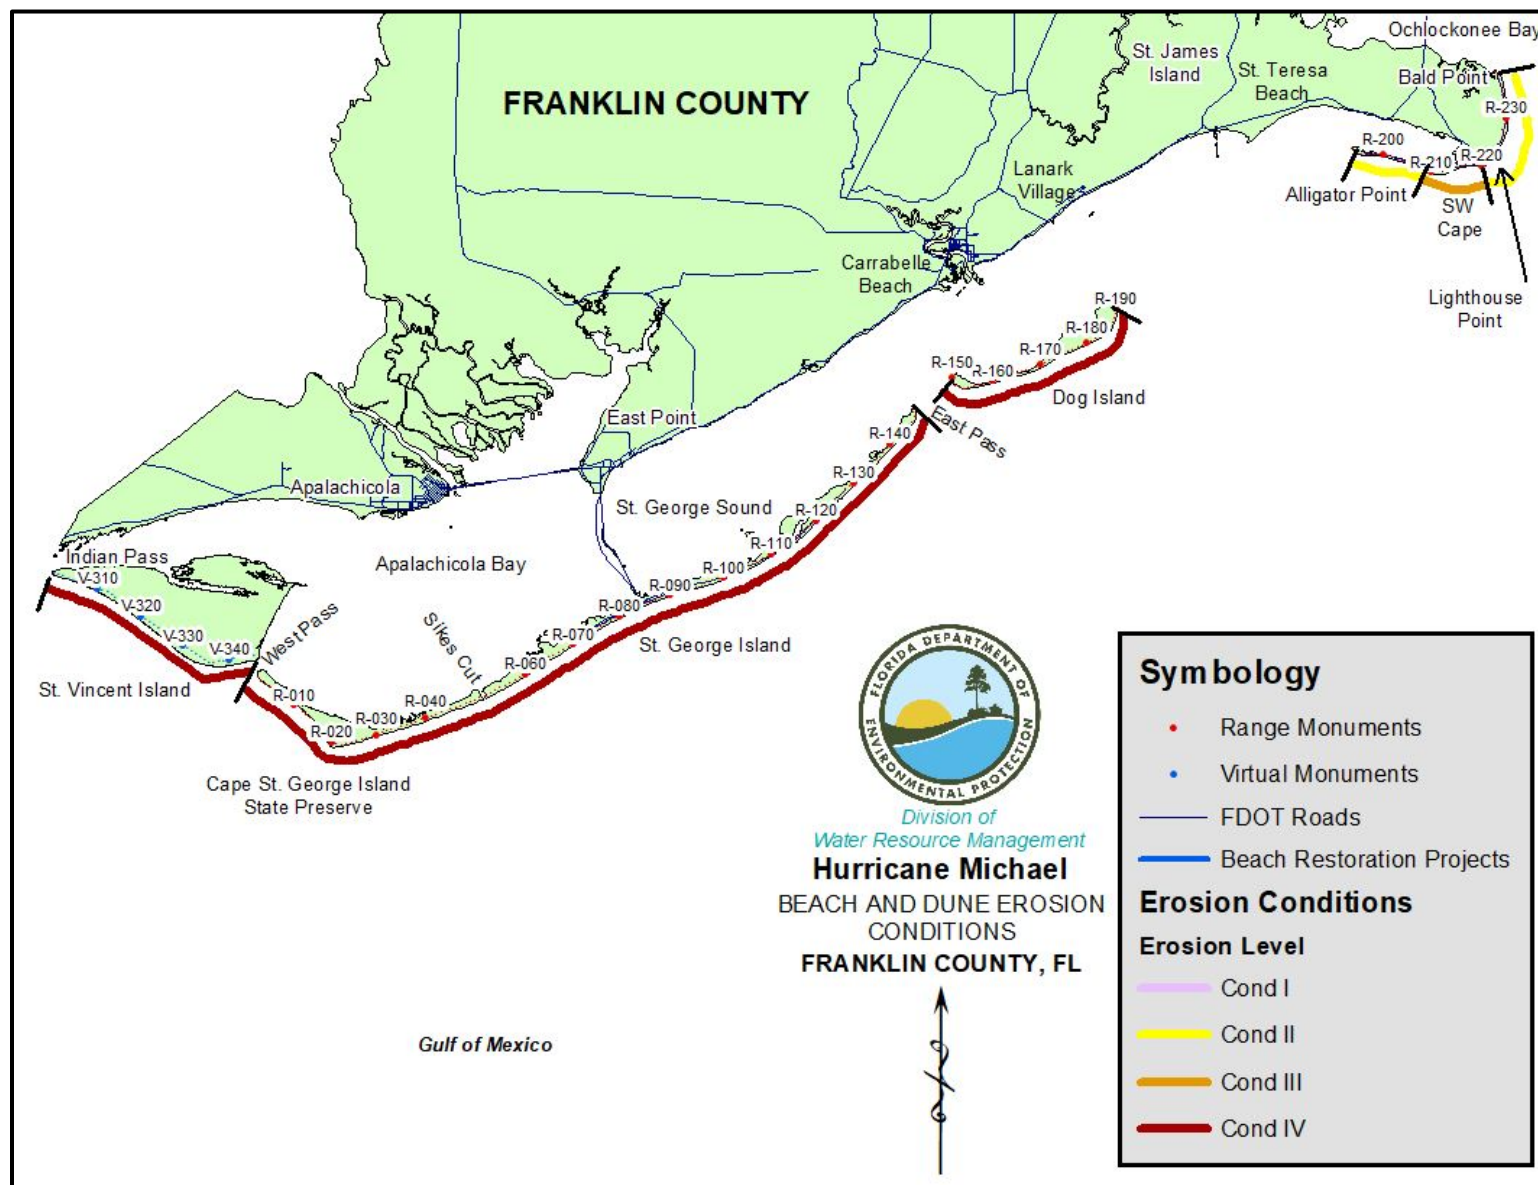
Figure 79. Franklin County beach and dune erosion conditions from Hurricane Michael.

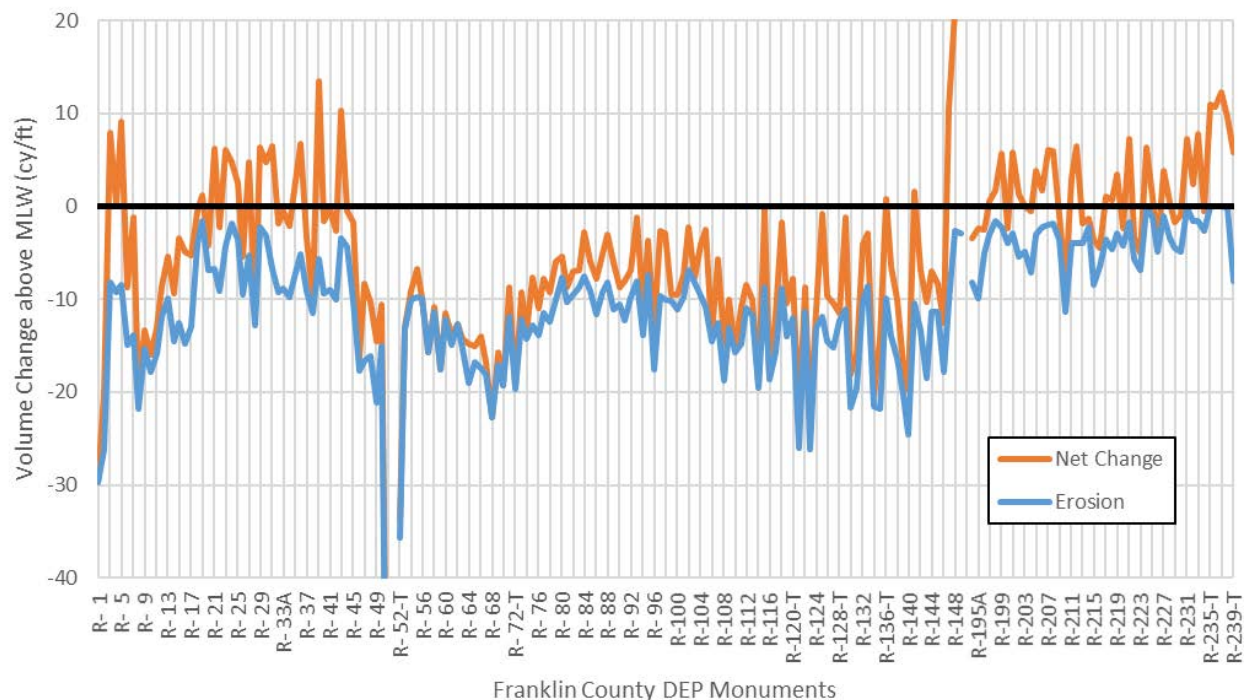
U.S. Army Corps of Engineers LIDAR survey compared to the latest pre-storm survey for all DEP monument locations above Mean Low Water (MLW). In much of Franklin County, the frontal dunes were essentially removed, and large amounts of eroded material were deposited upland. Therefore, calculations were made of the total volume eroded as well as the volume eroded with this upland deposition included, or the net erosion volume. Pre-storm data was not available for St. Vincent Island or Dog Island, but computations were made of the rest of the gulf front shoreline on the coastal barriers. Computations showed a total erosion volume of approximately two million cubic yards of beach and dune sand for the remainder of the county, of which approximately one-half were lost from the system, and therefore, a net erosion volume of approximately one million cubic yards was calculated above MLW. **Figure 82** graphs the total erosion and net erosion along Franklin County above MLW.

Figure 82. Total and net volume change along Franklin County above MLW.

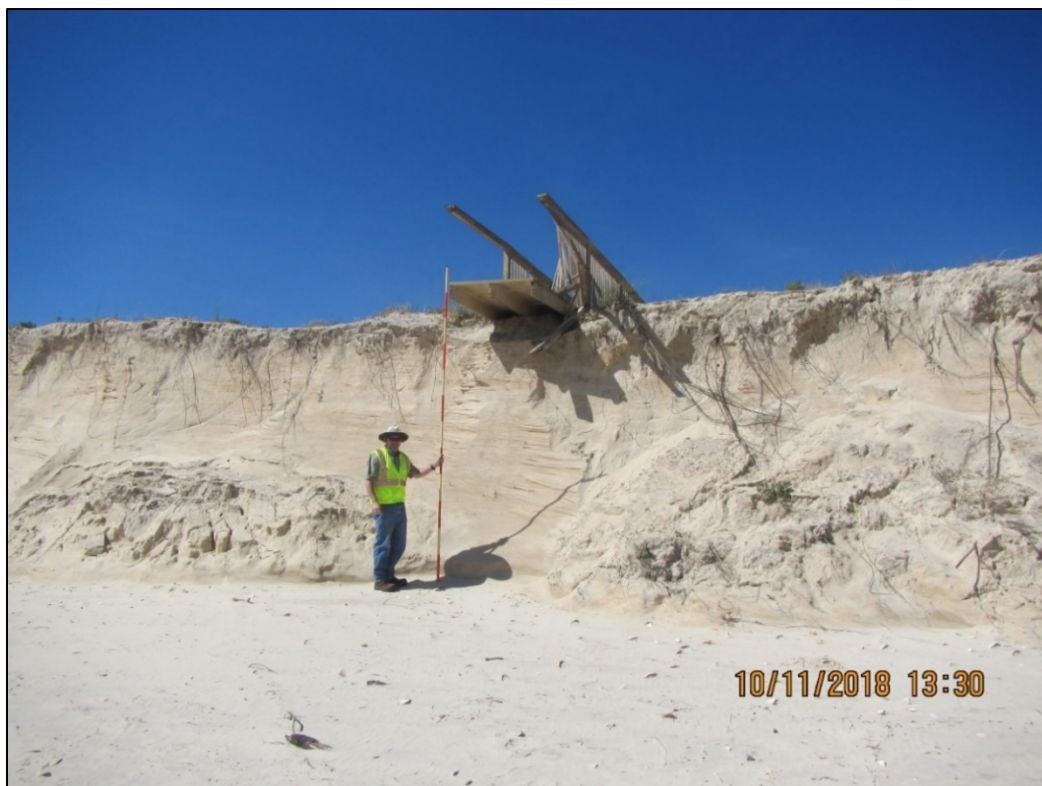
Along St. Vincent Island, Little St. George Island, and St. George Island, major beach and dune erosion (Condition IV) was sustained. Severe dune erosion was sustained at Bob Sikes Cut at R52 (**Figure 83**). Along St. George Island Plantation (R52-R73), the dunes retreated as much as 50 feet (**Figure 84**).

Figure 84. Major dune erosion at R72, St. George Island.

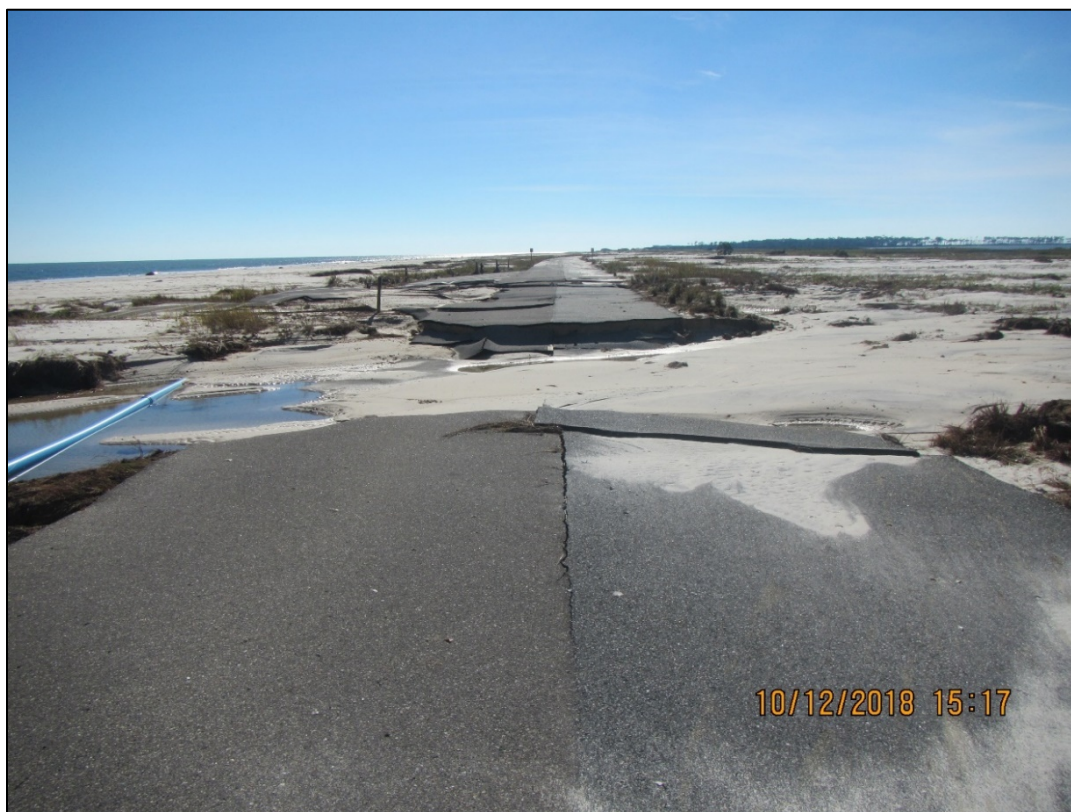
Figure 91. Dunes leveled and park road destroyed at R114, St. George Island.

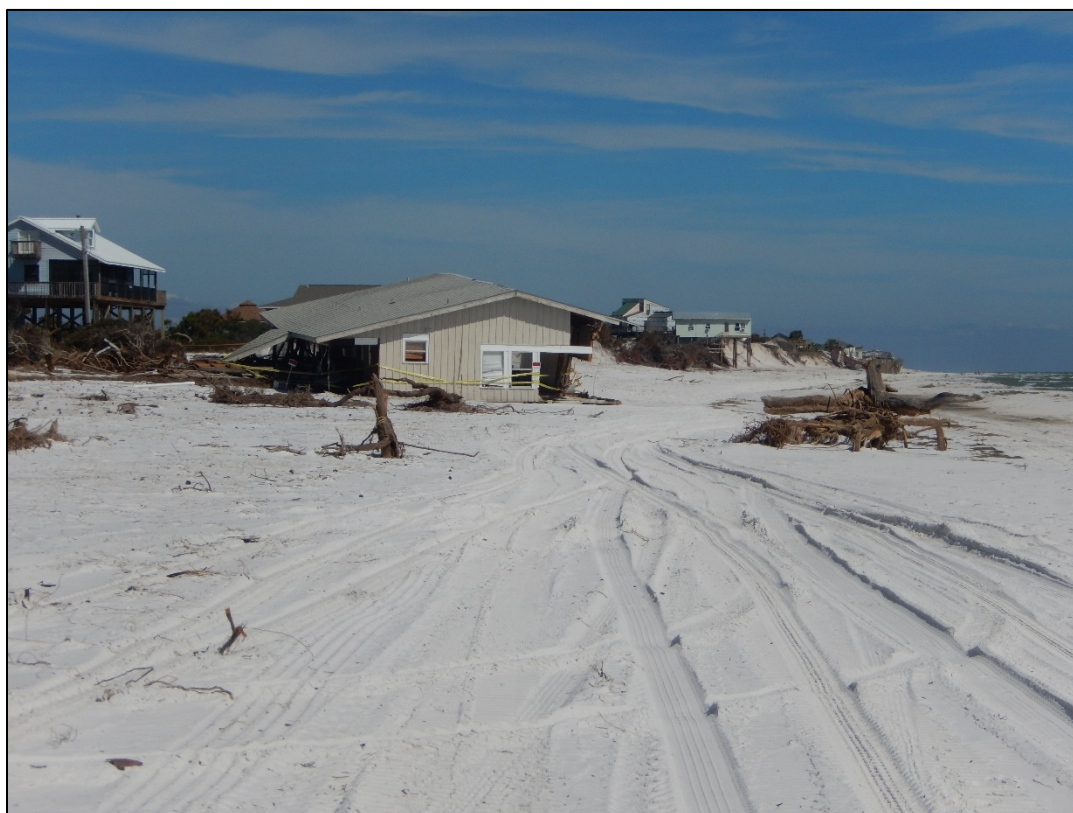
Figure 94. Dwelling destroyed near R174, Dog Island.

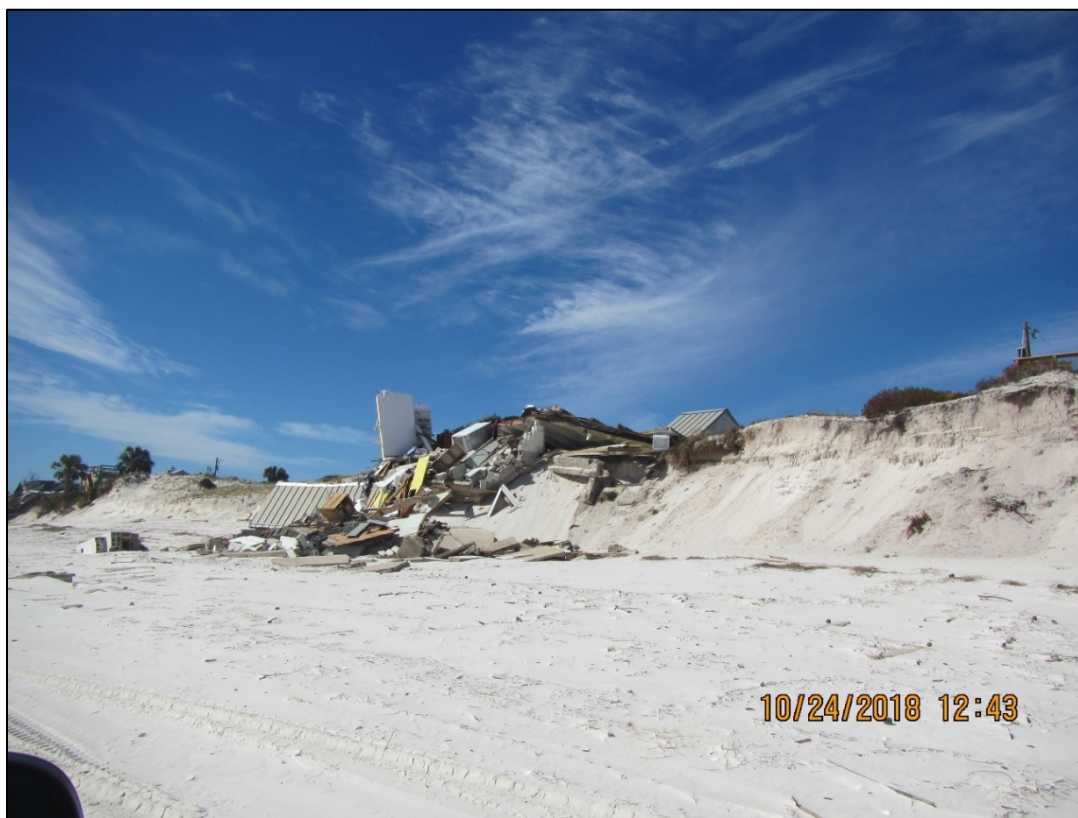
Figure 95. Dwelling destroyed near R176, Dog Island.

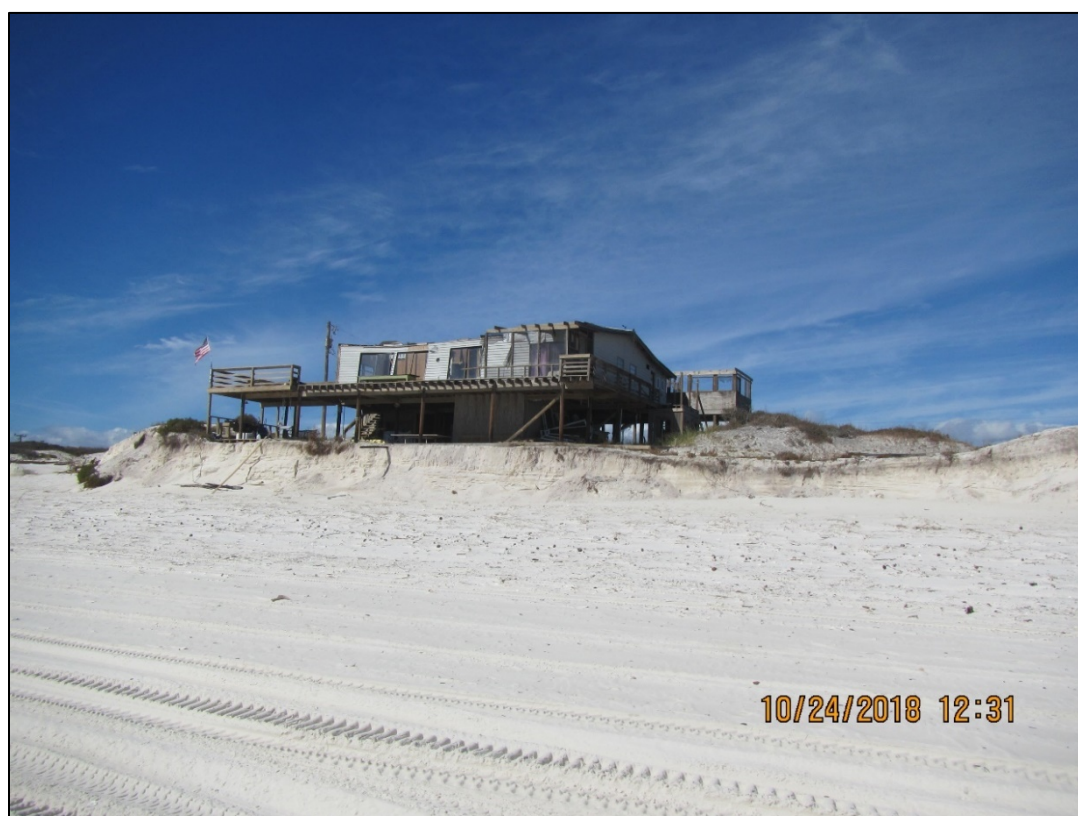
Figure 96. Dwelling destroyed near R178, Dog Island.

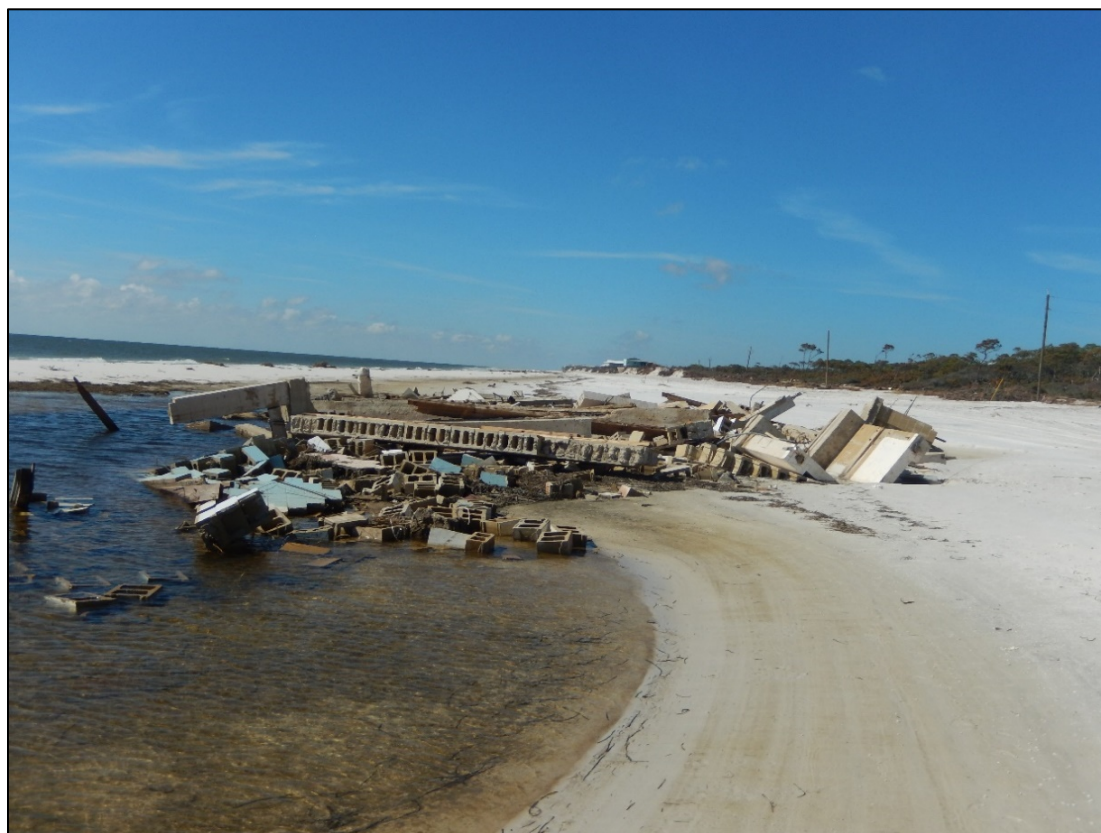
Figure 98. Pelican Inn destroyed near R183, Dog Island.

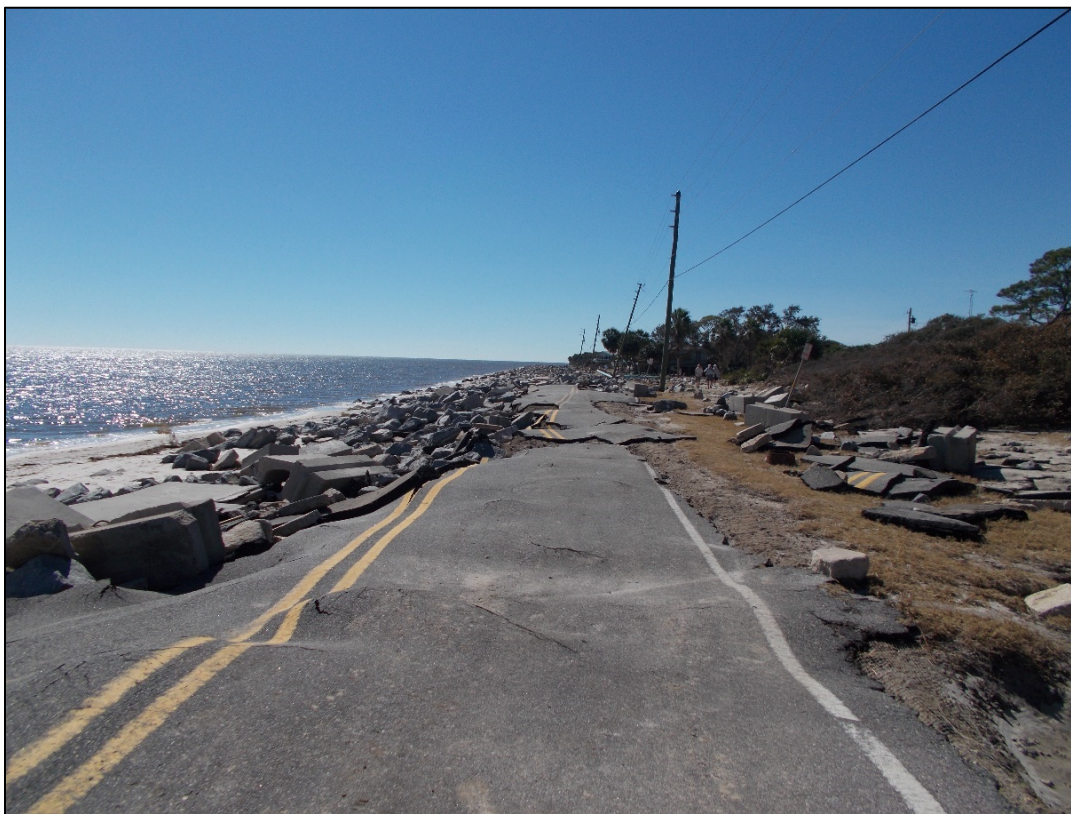
Figure 99. 3,000 feet of road and revetment destroyed between R211-R214, Southwest Cape.

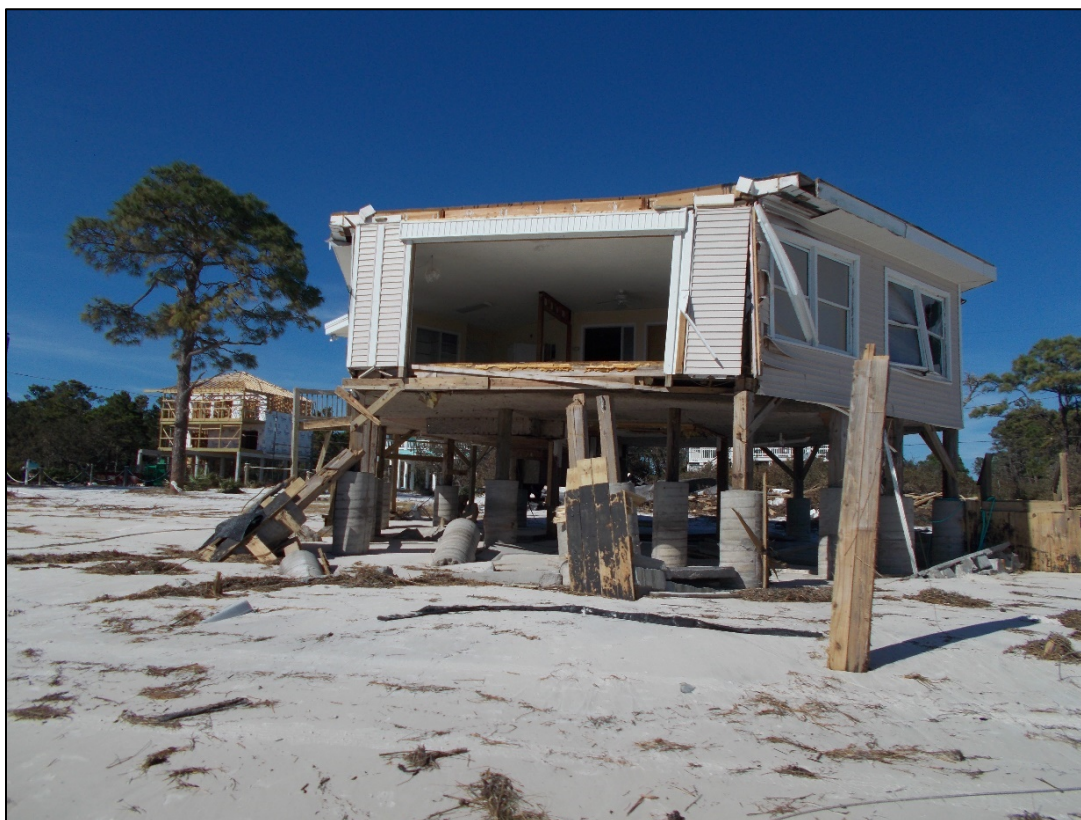
Figure 100. Dwelling destroyed near R210, Southwest Cape.

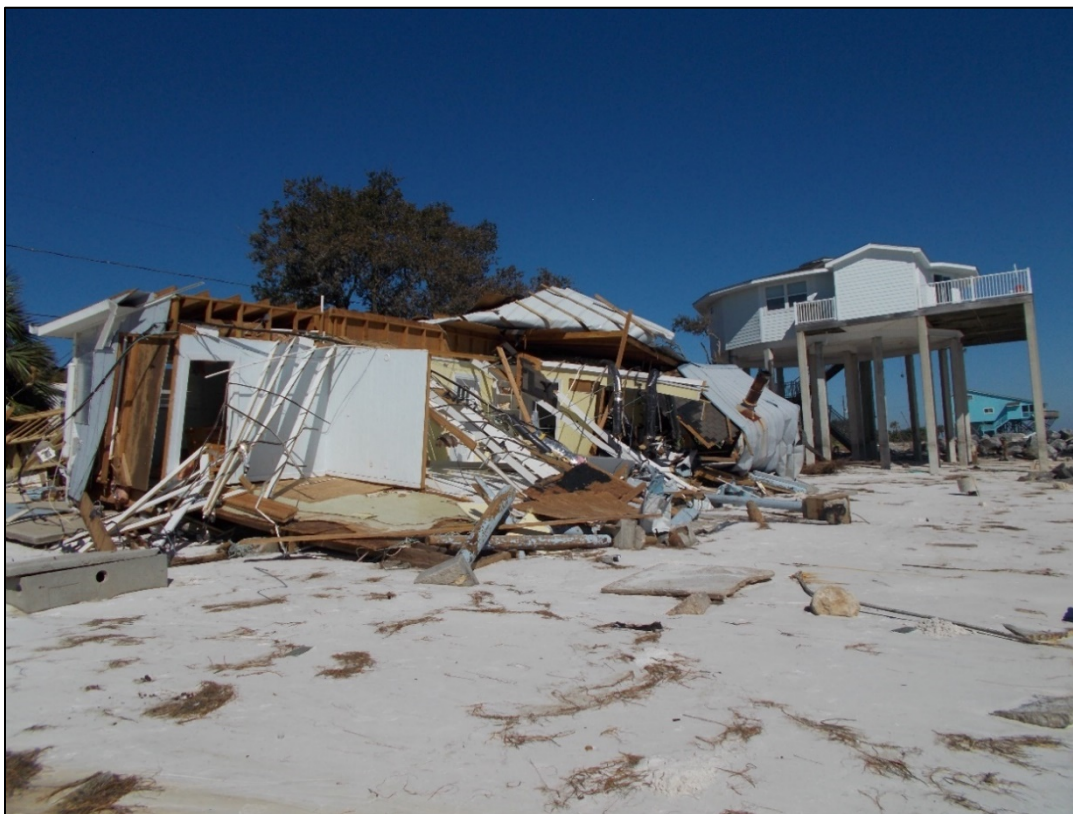
Figure 101. Dwelling destroyed near R211, Southwest Cape.

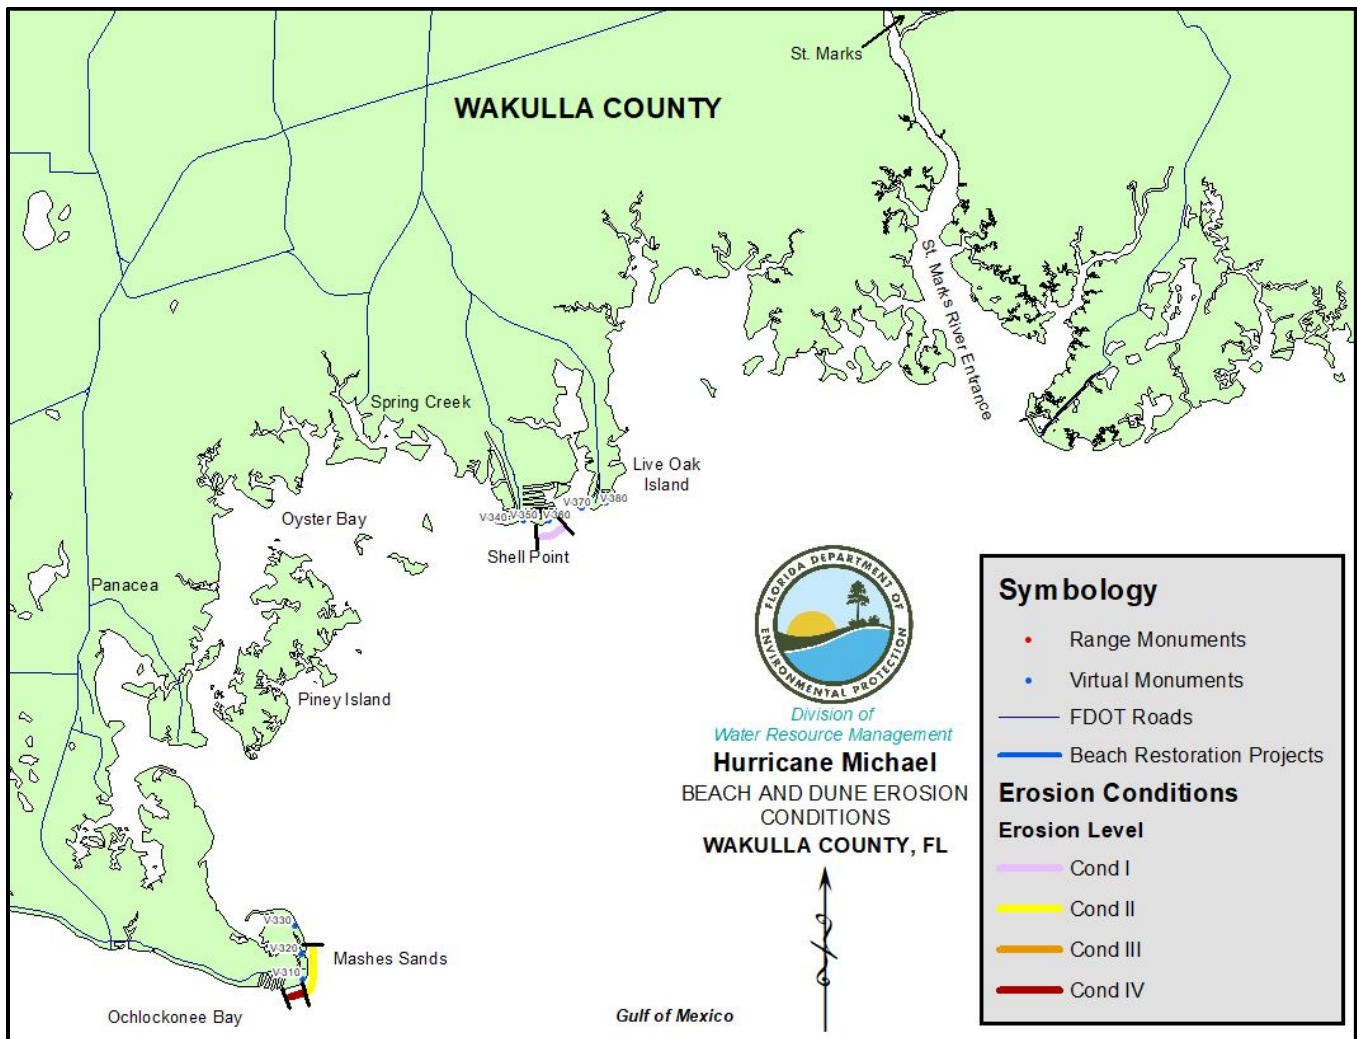
Figure 103. Wakulla County beach and dune erosion conditions from Hurricane Michael.
